# Concrete of tomorrow: corrosion performances in marine environment

**Abstract.** Concrete is the most construction material used worldwide, but it often faces durability issues due to rebar corrosion, and cement production can be energy consuming. Attempts to improve its resilience versus corrosion while reducing its carbon footprint are ongoing at an international level. In this objective, in France within the frame of the national project PERFDUB, a series of reinforced concrete walls were cast with innovative concrete design, two shapes of rebars and two concrete covers. The standard performances of the different concrete mix designs were evaluated at a laboratory scale. Then the walls were exposed in the French La Rochelle harbor, in tidal zone in order to monitor the evolution of the corrosion of the bars for a period of twenty years. The first results of the electrochemical follow-up of these reinforced walls are presented in this paper.

Within the frame of the French national project PERDUB [1], an intensive series of studies mixing lab scale, natural ageing and durability modelling was launched in 2015. The aims of the project are multiple. One of these is to provide in

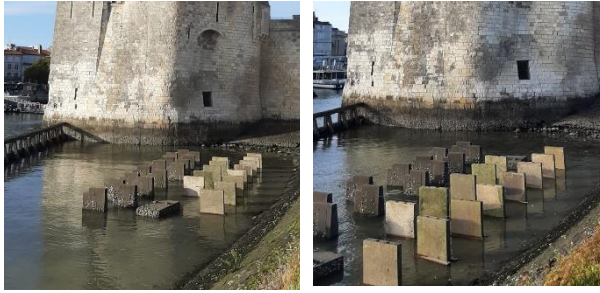
**Fig. 9.** During the tide's descent, the bottom of the walls remains a longer time immersed.

Another phenomenon can be observed on the potential maps, which exhibit an electronegative gradient from the top to the bottom of the walls on both faces, but clearer with the lowest concrete cover (RL10 and HA10, Fig. 6). The explanation could come from the duration of the tide's descent on the one hand, as the bottom of the walls stays wet a longer time (Fig. 8). On the other hand, when the tidal coefficient is low, the walls are not totally immersed (Fig. 9), which means that the top of the walls remains in the open air and can dry, while the bottom is totally under water.

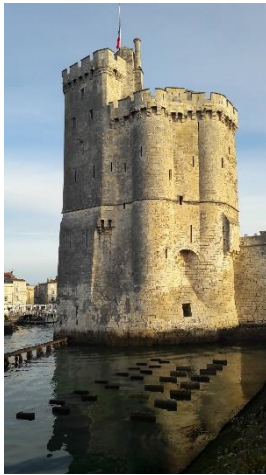
**Fig. 10.** At high tide of low coefficient, the top of the walls remains in the open air.
