Flood damage inspection and risk indexing data for an inventory of bridges in Central Greece

Data Article

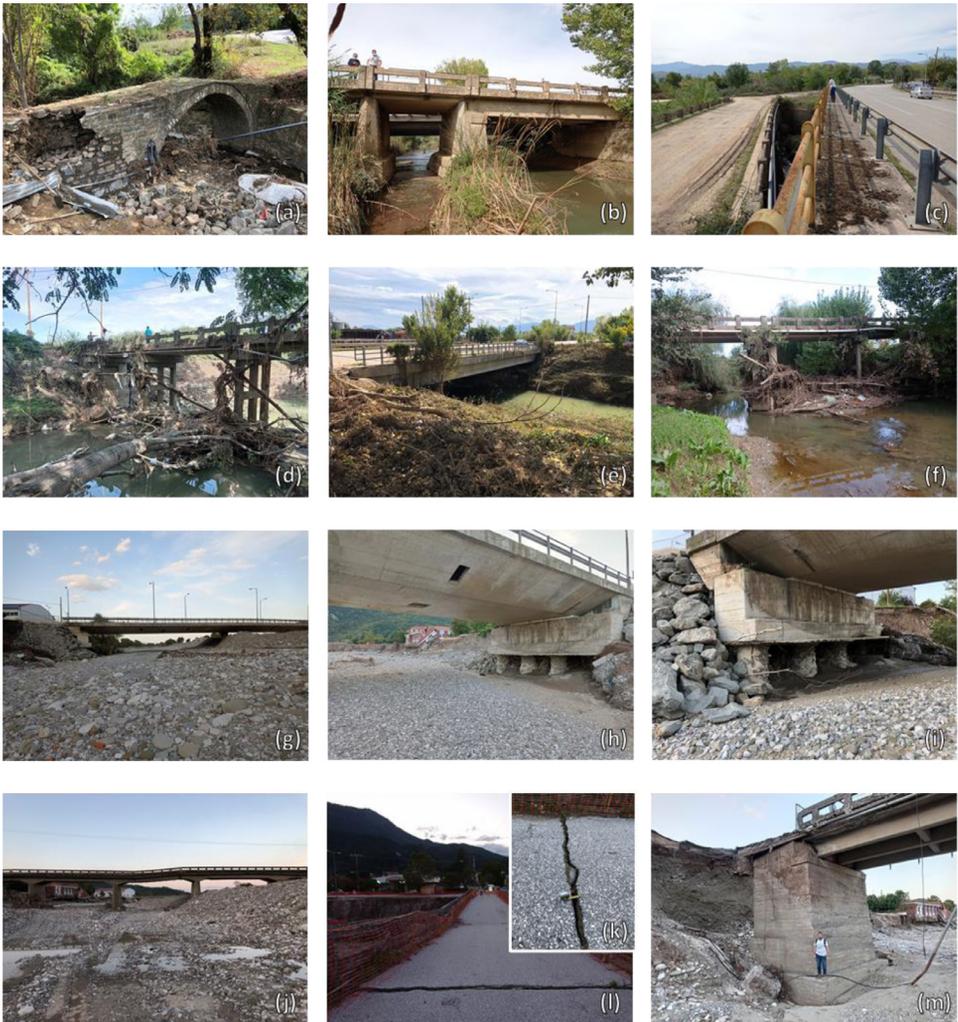
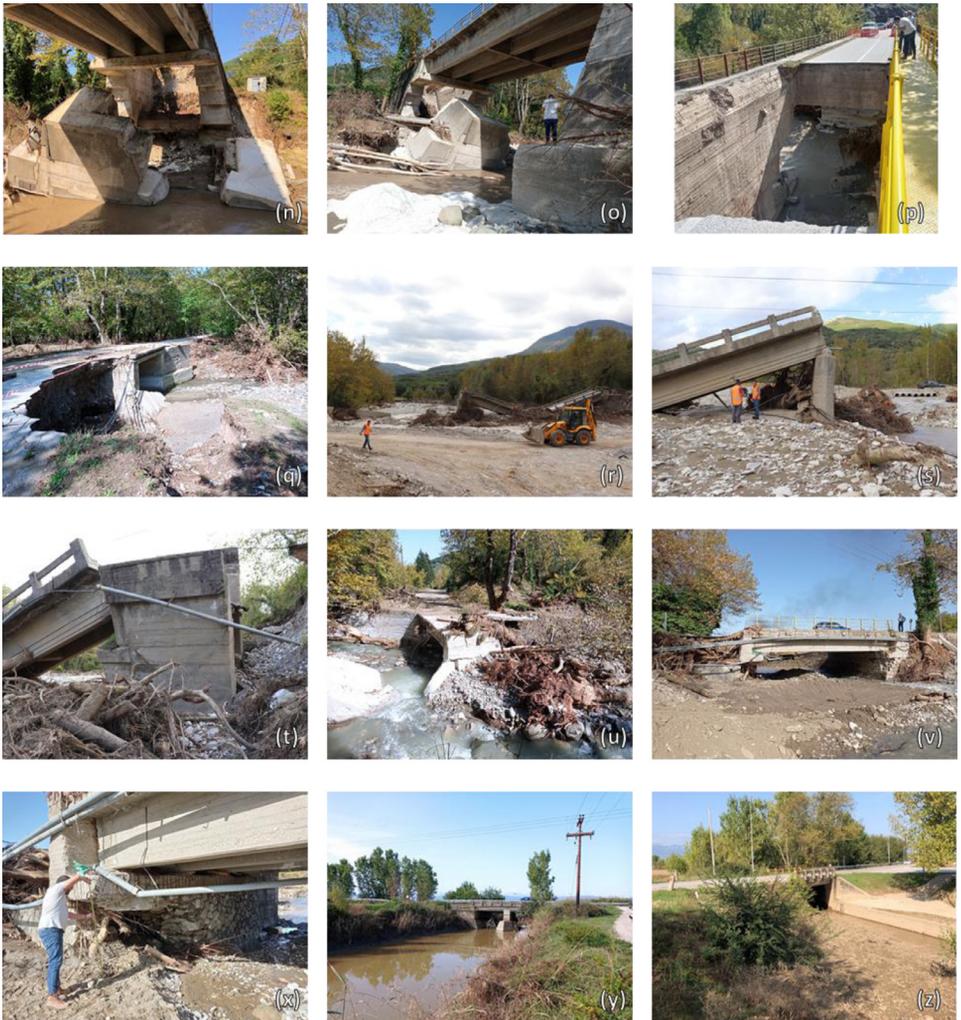
Fig. 1. Photos of the inspected bridges: (a) No. 2; (b) No. 3; (c) No.3A on the left and No. 4 on the right; (d) No. 4; (e) No. 5; (f) No. 6; (g) – (i) No. 7; (j) – (m) No. 8; (n) – (p) No. 9; (q) No. 10; (r) – (t) No. 11; (u) No. 12; (v) – (x) No. 13; (y) No. 14; (z) No. 15.

Fig. 1. Continued

Fig. 2 plots the predicted damage level for each bridge (Loli et al, 2022) compared to the actual (inspected) damage level, for the bridges that were included in the reconnaissance study. The type and extent of damage (from minimal to severe) are visible in the images that are included in the dataset (and summarized in Fig. 1). Note that the image naming refers to the bridge reference number.

A total of 15 bridges exhibiting diverse responses to flood impacts, from minimal damage to complete failure (Fig. 1), were inspected during 2 reconnaissance missions conducted in the prefecture of Karditsa (an area that suffered severe flooding). The first field deployment, using conventional site characterization and structure inspection tools, was carried out from 3 – 4 October 2020. The images of bridges included in this dataset (portrayed in Fig. 1) were taken by

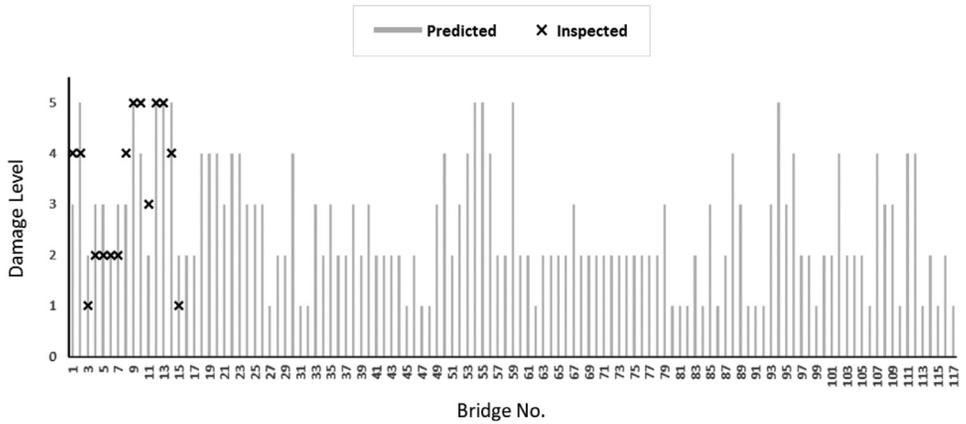
Fig. 2. Predicted damage level for the entire bridge portfolio compared to observed damage level for the 15 bridges that were inspected after Medicane Ianos.
