## Flood damage inspection and risk indexing data for an inventory of bridges in Central Greece

# Flood damage inspection and risk indexing data for an inventory of bridges in Central Greece

This dataset is related to the research paper entitled “Bridge-specific flood risk assessment of transport networks using GIS and remotely sensed data” published in the Science of the Total Environment. It provides the information necessary for the reproduction of the case study that was used for the demonstration and validation of the proposed risk assessment framework. The latter integrates indicators for the assessment of hydraulic hazards and bridge vulnerability with a simple and operationally flexible protocol for the interpretation of bridge damage consequences on the serviceability of the transport network and on the affected socio-economic environment. The dataset encompasses (i) inventory data for the 117 bridges of the Karditsa Prefecture, in Central Greece, which were affected by a historic flood that followed the Mediterranean Hurricane (Medicane) Ianos, in September 2020; (ii) results of the risk assessment analysis, including the geospatial distribution of hazard, vulnerability

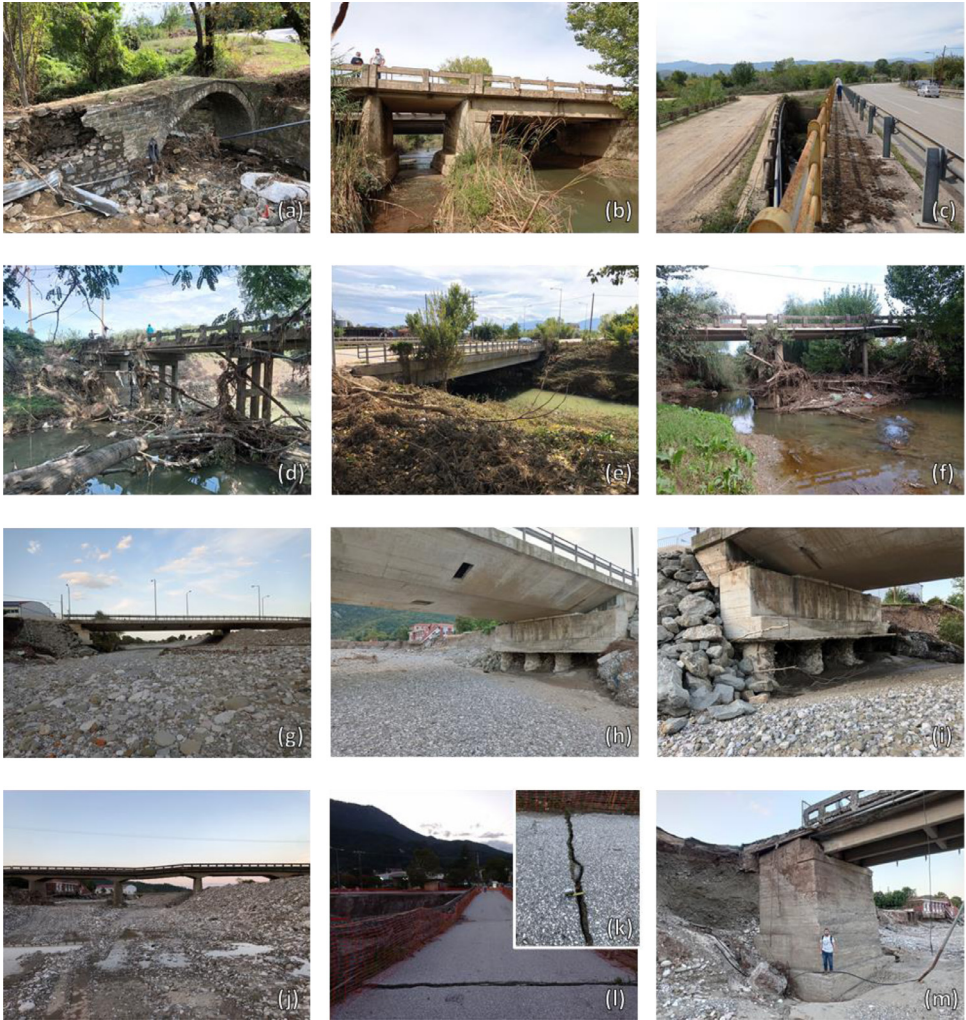
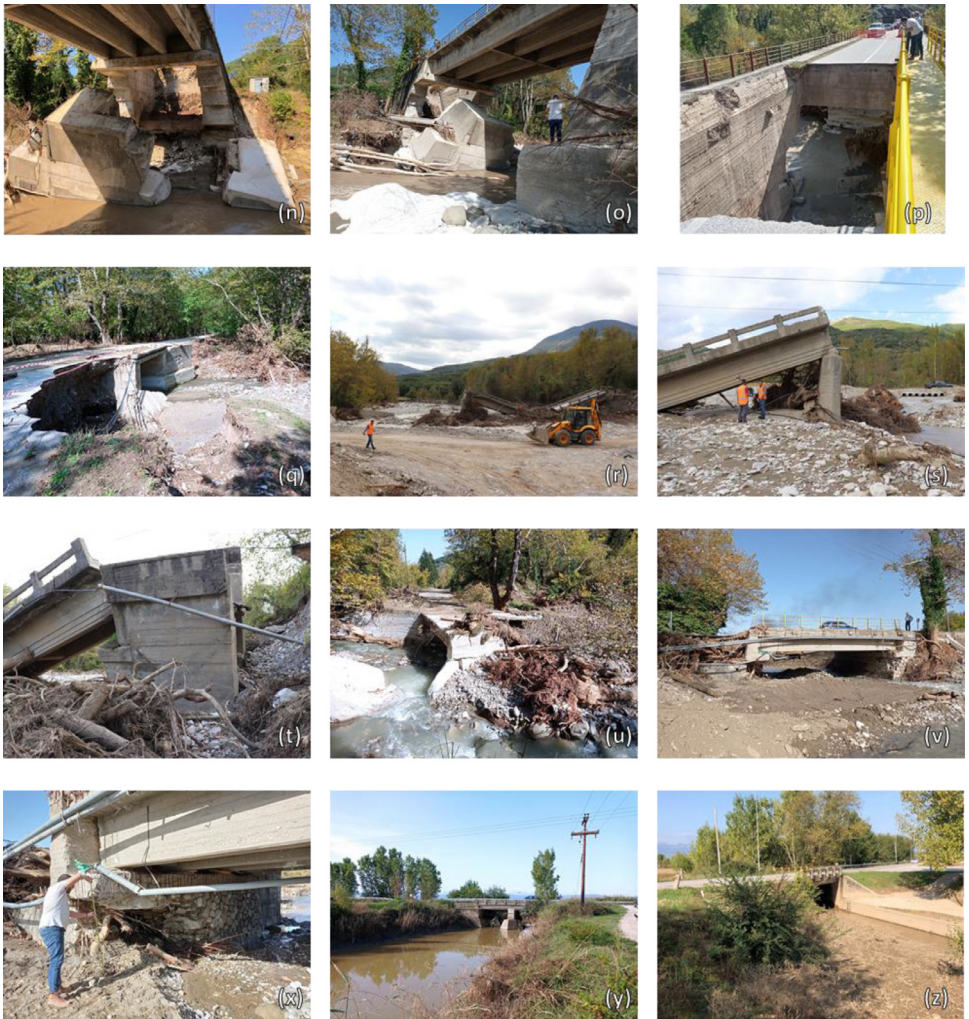
**Fig. 1.** Photos of the inspected bridges: (a) No. 2; (b) No. 3; (c) No.3A on the left and No. 4 on the right; (d) No. 4; (e) No. 5; (f) No. 6; (g) – (i) No. 7; (j) – (m) No. 8; (n) – (p) No. 9; (q) No. 10; (r) – (t) No. 11; (u) No. 12; (v) – (x) No. 13; (y) No. 14; (z) No. 15.

A total of 15 bridges exhibiting diverse responses to flood impacts, from minimal damage to complete failure (Fig. 1), were inspected during 2 reconnaissance missions conducted in the prefecture of Karditsa (an area that suffered severe flooding). The first field deployment, using conventional site characterization and structure inspection tools, was carried out from 3 – 4 October 2020. The images of bridges included in this dataset (portrayed in Fig. 1) were taken by

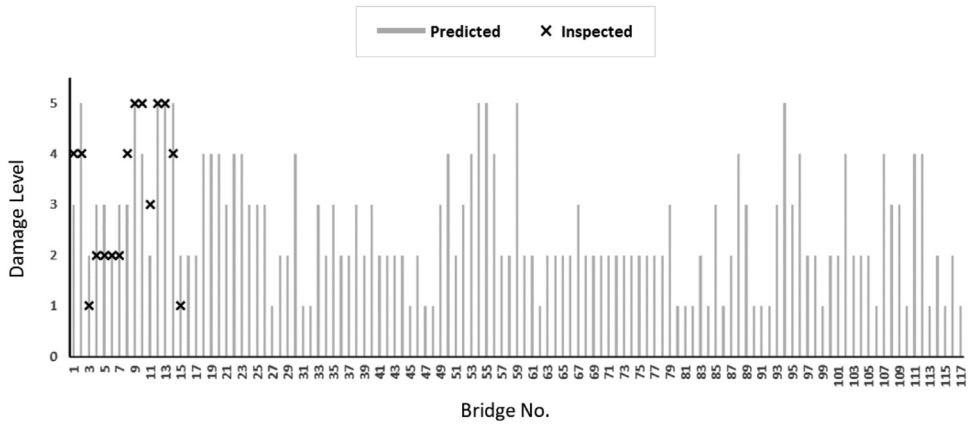
**Fig. 2.** Predicted damage level for the entire bridge portfolio compared to observed damage level for the 15 bridges that were inspected after Medicane Ianos.

Fig. 2 plots the predicted damage level for each bridge (Loli et al, 2022) compared to the actual (inspected) damage level, for the bridges that were included in the reconnaissance study. The type and extent of damage (from minimal to severe) are visible in the images that are included in the dataset (and summarized in Fig. 1). Note that the image naming refers to the bridge reference number.

Column B in the DATA\_Karditsa\_RiskAnalysis.xlsx lists the observed (actual) DL of the inspected bridges after Medicane Ianos. This information was used to validate the effectiveness of a novel framework for the assessment of flood risk to bridges [4] in predicting flood-induced damage on bridges after Medicane Ianos. The predicted DL for the entire inventory (117 bridges) is listed in Column S of the same file (and plotted in Fig. 2). The risk assessment methodology is described in detail in the accompanying research article (Loli et al., 2022). It evaluates qualitatively, from very low to very high, (i) the hazard, associated with both scour and hydraulic actions; (ii) the vulnerability, a feature of the structure's characteristics; (iii) the consequences of bridge failure, an indicator of the bridge's importance; and (iv) the overall risk for the transport network. (i) – (iv) are included in the dataset for completeness and facilitation of future validation studies.
