Flood damage inspection and risk indexing data for an inventory of bridges in Central Greece

Subject	Engineering; Civil and Structural Engineering
Specific subject area	Management of natural hazard risk for infrastructure; Climate adaptation of transportation networks.
Type of data	Table (in one .xlsx document) Image (.jpg)
How the data were acquired	<p>Damage inspection data were acquired through field reconnaissance visits to the locations of bridges affected by the flood that followed Medicane Ianos. The field visits, when the photos were captured, took place 2 weeks after the Medicane, i.e. 3–4 October 2020. In addition to traditional field reconnaissance and mapping methods, the authors employed UAVs for aerial mapping of damaged structures [6] and in-situ testing for the characterization of the concrete material in damaged structures [5].</p> <p>A bridge inventory of all the bridges that exist in the County of Karditsa (117 structures), in Central Greece, was composed through the translation and processing of survey reports published by the Ministry of Environment and Energy of Greece: https://floods.ypeka.gr/index.php?option=com_content&view=article&id=1094&Itemid=799</p> <

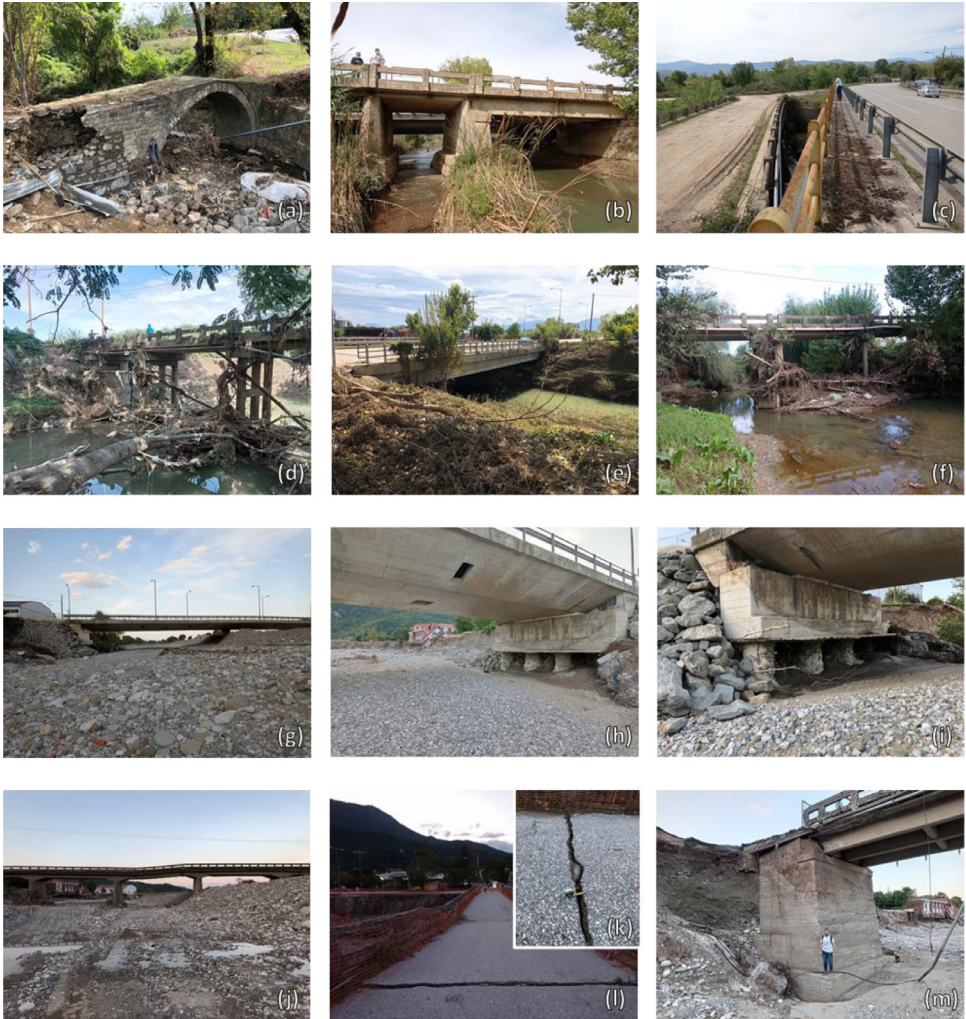
Fig. 1. Photos of the inspected bridges: (a) No. 2; (b) No. 3; (c) No.3A on the left and No. 4 on the right; (d) No. 4; (e) No. 5; (f) No. 6; (g) – (i) No. 7; (j) – (m) No. 8; (n) – (p) No. 9; (q) No. 10; (r) – (t) No. 11; (u) No. 12; (v) – (x) No. 13; (y) No. 14; (z) No. 15.

Fig. 1. Continued

Fig. 2 plots the predicted damage level for each bridge (Loli et al, 2022) compared to the actual (inspected) damage level, for the bridges that were included in the reconnaissance study. The type and extent of damage (from minimal to severe) are visible in the images that are included in the dataset (and summarized in Fig. 1). Note that the image naming refers to the bridge reference number.

A total of 15 bridges exhibiting diverse responses to flood impacts, from minimal damage to complete failure (Fig. 1), were inspected during 2 reconnaissance missions conducted in the prefecture of Karditsa (an area that suffered severe flooding). The first field deployment, using conventional site characterization and structure inspection tools, was carried out from 3 – 4 October 2020. The images of bridges included in this dataset (portrayed in Fig. 1) were taken by

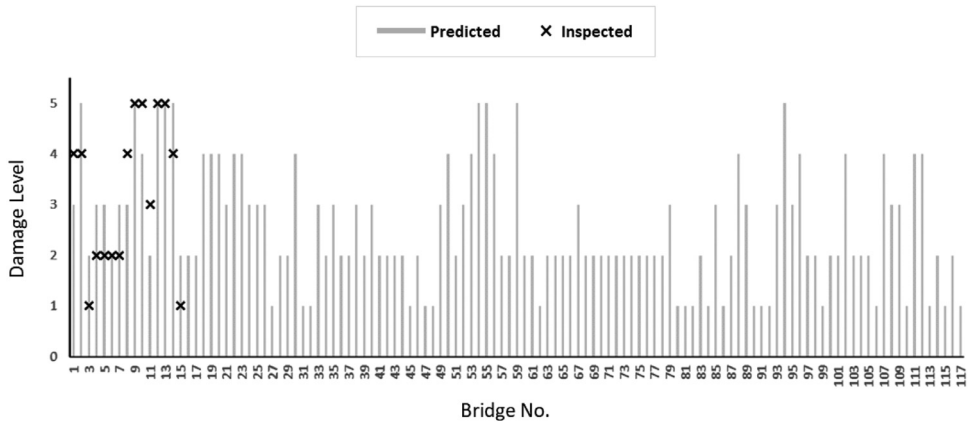
Fig. 2. Predicted damage level for the entire bridge portfolio compared to observed damage level for the 15 bridges that were inspected after Medicane Ianos.
