GPR Monitoring of Artificial Debonded Pavement Structures throughout Its Life Cycle during Accelerated Pavement Testing

Xavier Dérobert, Vincent Baltazart, Jean-Michel Simonin, Shreedhar Savant Todkar, Christophe Norgeot, Ho-Yan Hui

Xavier Dérobert, Vincent Baltazart, Jean-Michel Simonin, Shreedhar Savant Todkar, Christophe Norgeot, et al. GPR Monitoring of Artificial Debonded Pavement Structures throughout Its Life Cycle during Accelerated Pavement Testing. *Remote Sensing*, 2021, 13 (8), pp.1474. 10.3390/rs13081474 . hal-04278503

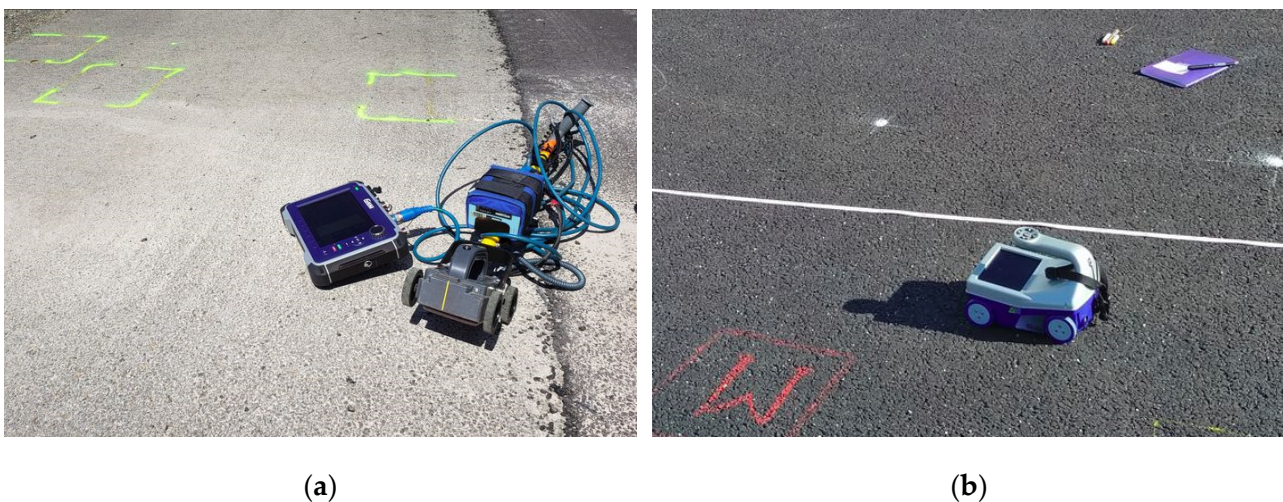
Figure 3. Impulse radar systems: (a) SIR4000 model with a 1.5 GHz antenna, (b) 2.6 GHz StructureScan.

In this section, the different GPR systems used during the two experiment stages are presented. A first group is characterized as impulse radar systems. As commercial common systems, they correspond to standards for major classical applications. Thus, three ground-coupled impulse radar were operated during this experiment, using GSSI systems; a SIR3000 device associated to a 2.6 GHz antenna during the first series in 2012, and for the 2019 series, a SIR4000 system combined with a 1.5 GHz antenna and a 2.6 GHz StructureScan (Figure 3).

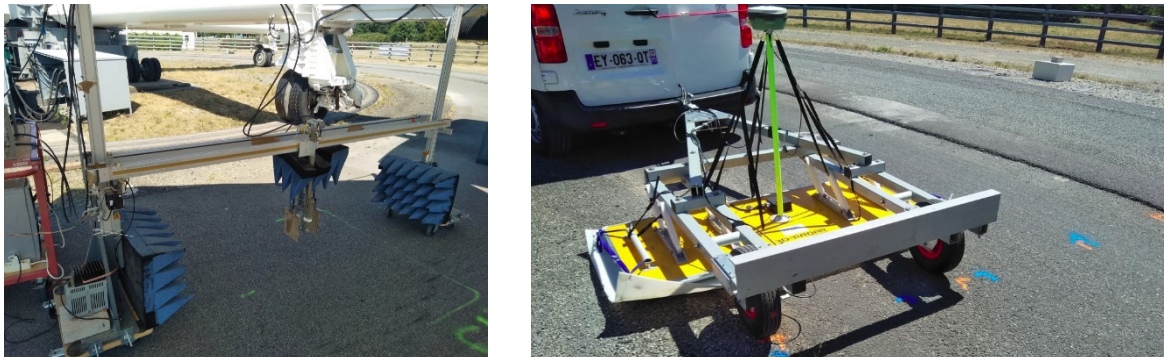
range of frequency, leading, after an inverse Fourier transform, to radar data equivalent to multiple 1.5 GHz B-scan. The array system is pulled behind a vehicle and localized by an RTK centimetric global positioning system.

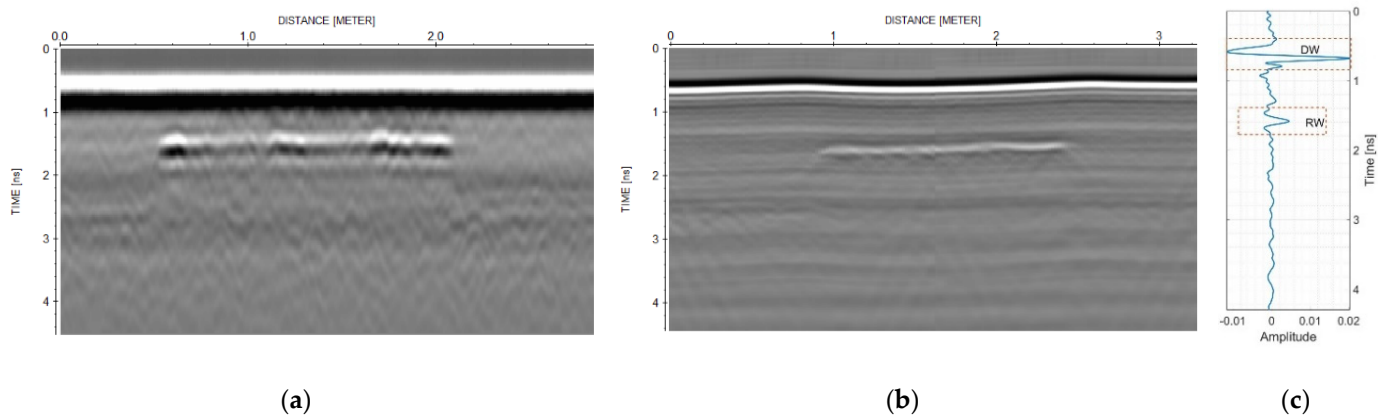
Figure 5. Examples of B-scans performed at 720 K loadings on the defect I11 (sand) by (a) the ground-coupled 2.6 GHz impulse system and (b) the air-coupled 5 GHz stepped-frequency system. (c) A-scan extracted from Figure 5b on the defect and showing the direct wave (DW) and the reflected wave (RW).

vertical time scales have been harmonized. The surface echo at the top shows the strongest amplitude, and it is called direct wave (DW) for both data types. The second strongest echo is the reflected wave (RW) from the sand-based debonded interface. The reflected echo from the healthy area shows a weaker amplitude at roughly the same time-depth.

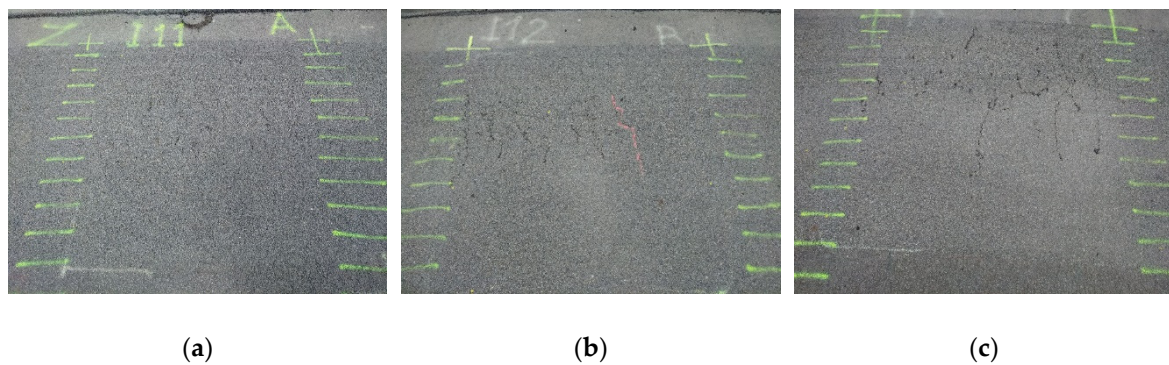
Figure 6. Photographs of defects (a) I-11 (sand), (b) I-12 (geotextile), and (c) I-13 (tack-coat free), at stage 800 K loadings. Paints correspond to the presumed longitudinal limits of the defects.

The experiments were stopped in August 2020 after noticeable damage was seen on the pavement surface, which, in a real situation, would require some repairs. Three major types of damages occurred: Cracking, micro-cracking, and rutting. The cracks initially appeared around 500 K loading over major defect zones beginning with I13 followed by I12 and I11. Beyond this loading, the cracking and micro-cracking evolved towards an unacceptable density (see Figure 6), while the healthy zones did not present any surface cracks.

Lastly, we note that at the internal radius area the RW amplitudes are stronger. It could be due to the transverse slope towards the center of the carousel, as shown in Figure 6, which trap the moisture at the border of the defects.

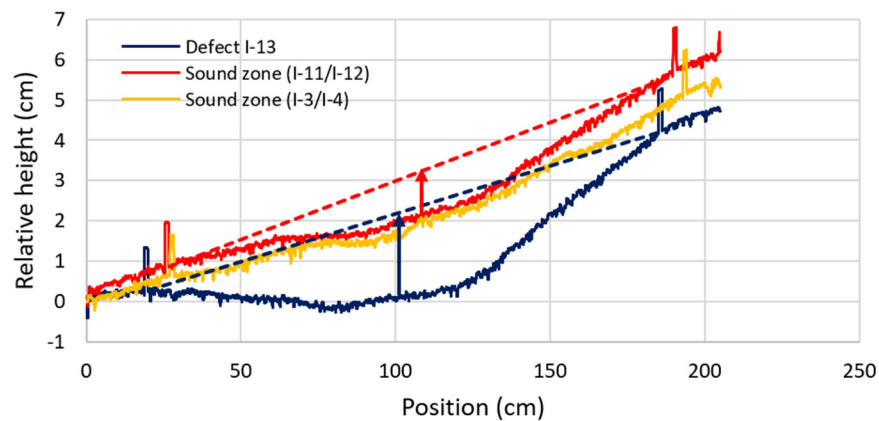
Figure 7. Example of cross section profiles done with a laser rugosimeter after 800 K loadings, with one centered on defect I-13 and two others done on healthy zones (between defects).

Moreover, several cross-section profiles, done with a laser rugosimeter system, were performed showing the rutting resulting from the heavy traffic. Figure 7 presents, as an example, the cross-section profiles done in the center of I-13 and in two healthy zones (between I-11 and I-13 and between I-3 and I-4), from the inner to the outer radius of the traffic path. Measurements show rutting of above 2 cm in depth at the center of the largest defects, while it remains under 1 cm in the healthy zones.

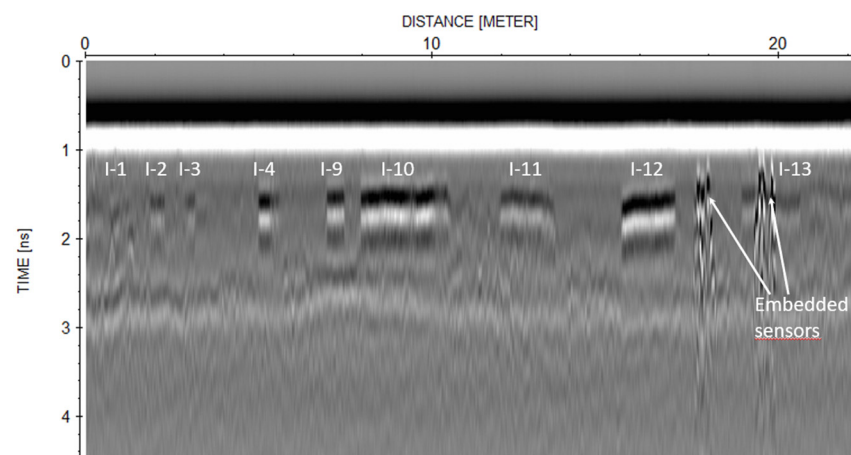
Figure 8. Example of longitudinal B-scan performed at 2.6 GHz along the complete test section.

Figure 8 presents a longitudinal profile along the center of the test section at 2.6 GHz. We note that every defect is detected (I-1 location being more ambiguous) and that defects composed of geotextile (I-4, I-9, I-10, and I-12, but not I-2) show similar echoes stronger than the others, explained by stronger dielectric contrasts. Several sensors, embedded to monitor the stress under the heavy traffic, are located in the center of I-13 and between I-12 and I-13. This is why results presented for defect I-13 in the next section will show a lack of values in the center of the data.

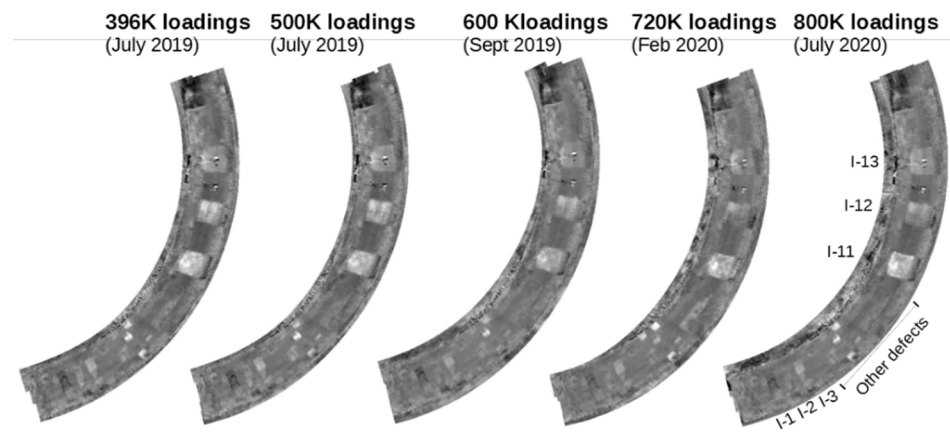
Figure 9. RW amplitude maps of the global test zone at the defect depth, extracted from 1.5 GHz C-scans.

C-scans were performed at 396 K, 500 K, 600 K, 720 K, and 800 K loading stages, using the commercial software 3D-radar Examiner. Figure 9 shows the horizontal slices of the C-scans taken at the interface (or defect depth). These slices give an overview of the global test section and its general evolution. Most of the defects are clearly visible and their geometry well drawn. Nevertheless, the thickness and the EM state of the top layer varies due to the implementation and evolution of the asphalt layer. Therefore, they can present some bias in estimating the importance of the defects. So, it is interesting to study the amplitude of the surface direct wave (DW) and the echo at the interface of the two asphalt layers (RW), as shown in Figures 10 and 11, picked in the area of I-11 to I-13.

From these maps, some general observations can be made. Firstly, the heavy traffic has not induced strong lateral expansion of the defects although numerous surface cracks that appeared in the two last loading stages. The evolution of the RW amplitudes is visible on Figure 10 for increasing vs. degradation for defects I-11 and I-13 until 720 K loading stage, with defect I-12 presenting a surprisingly high amplitude level at 600 K loading stage. The last measurement stage, done in July 2020 five months after the 720 K loading one (imposed COVID confinement), shows a decreasing trend. Such a decrease of EM contrast suggests an internal moisture evaporation and possible auto-repair of the structure.

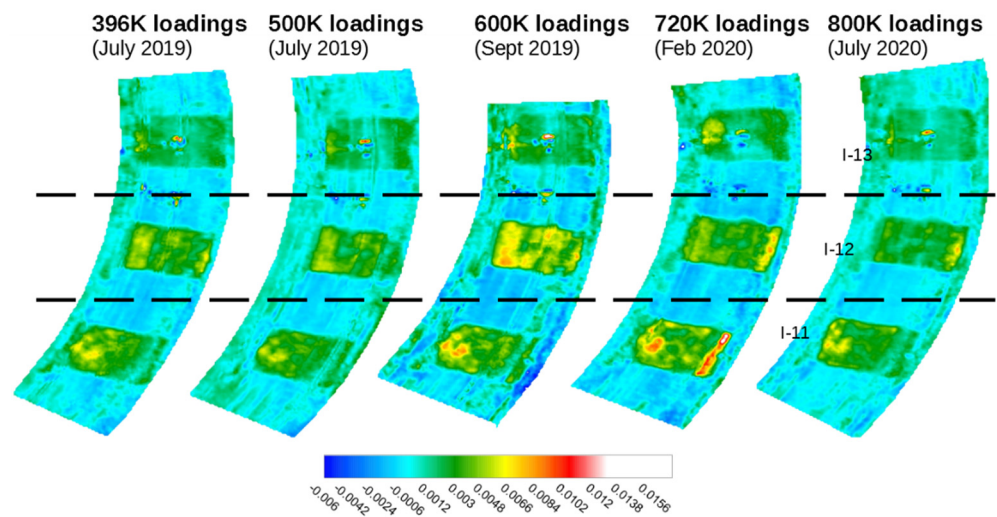
Figure 10. Maps of the reflected echo at the defect interface extracted from C-scans in the area of I-11 to I-13 (values in Legend refer to the amplitude of the received signal).

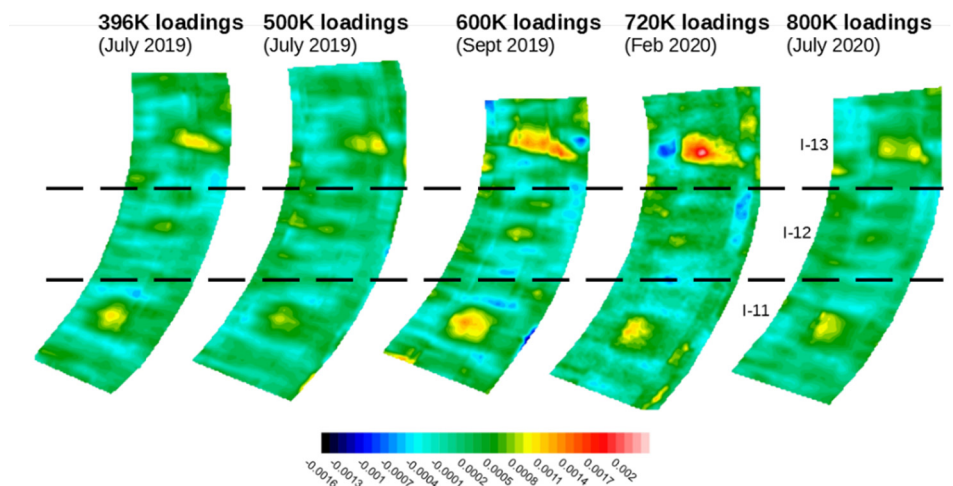
Figure 11. Maps of the surface direct wave extracted from C-scans in the area of I-11 to I-13 (values in Legend refer to the amplitude of the received signal).

The DW maps from Figure 11 show that stronger amplitudes from the central zones of defects I-13 and I-11 (and a second-order of defect I-12) may be related to traffic. They could be attributed to greater concentration of constraints inducing visible cracking in Figure 6, and so, an increase of surface porosity and a lower permittivity. Another possibility could be the effect of the rutting (several millimeters) on the direct wave due to loss of contact of the antenna array on the ground.

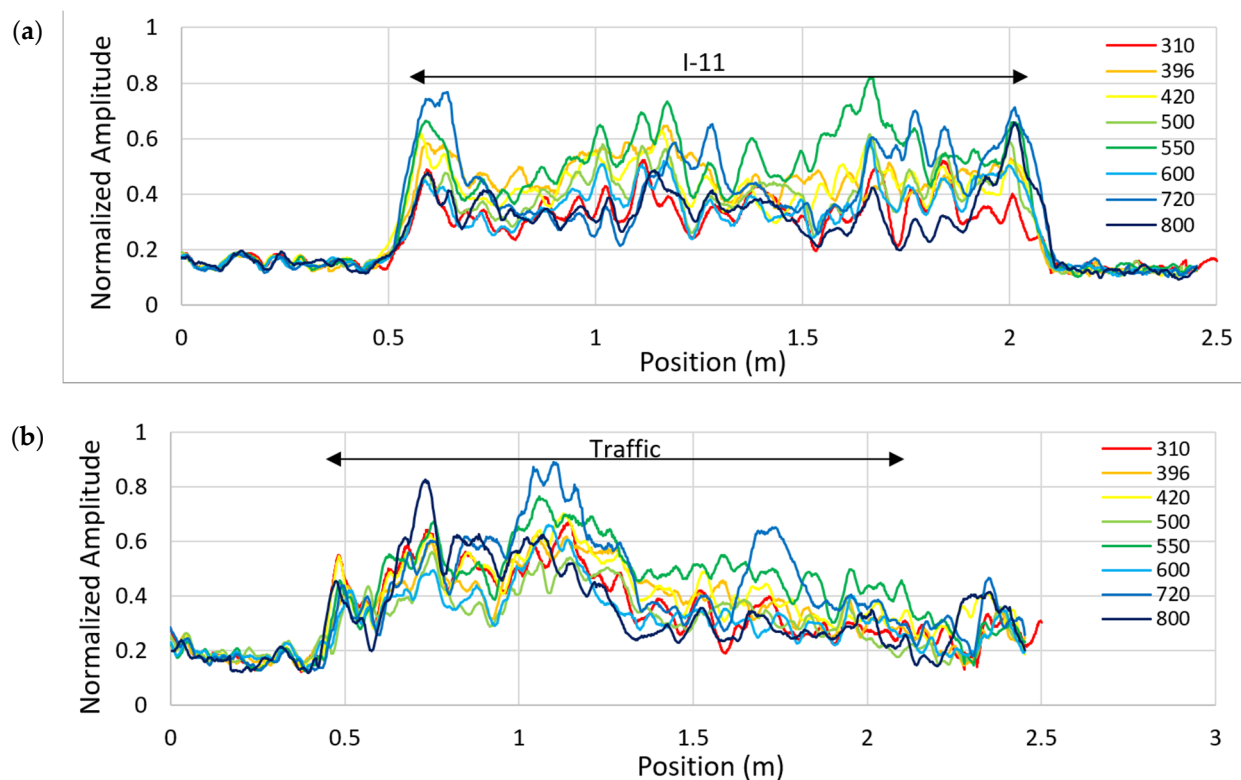
Figure 12. 2.6 GHz Norm. RW amplitudes on sand (I-11) in the (a) long. and (b) transv. direction vs. K loadings.

Figures 12–14 gather normalized RW amplitudes, namely RW/DW as defined in Section 2.3, picked on the defects I-11, I-12 and I-13 from the 2.6 GHz data over all the loading stages.

- In the healthy zones out and under traffic, normalized RW remains stable. Apart from a natural aging of the pavement layers, heavy traffic has had no effect on the road structure from GPR point-of-view. Moreover, due to low EM contrasts, sometimes echo picking was not easy and could lead to errors in their detection/location.
- Defects are clearly visible with a high level of RW amplitude but with strong local variations. These variations could be due to local heterogeneities enhanced by internal

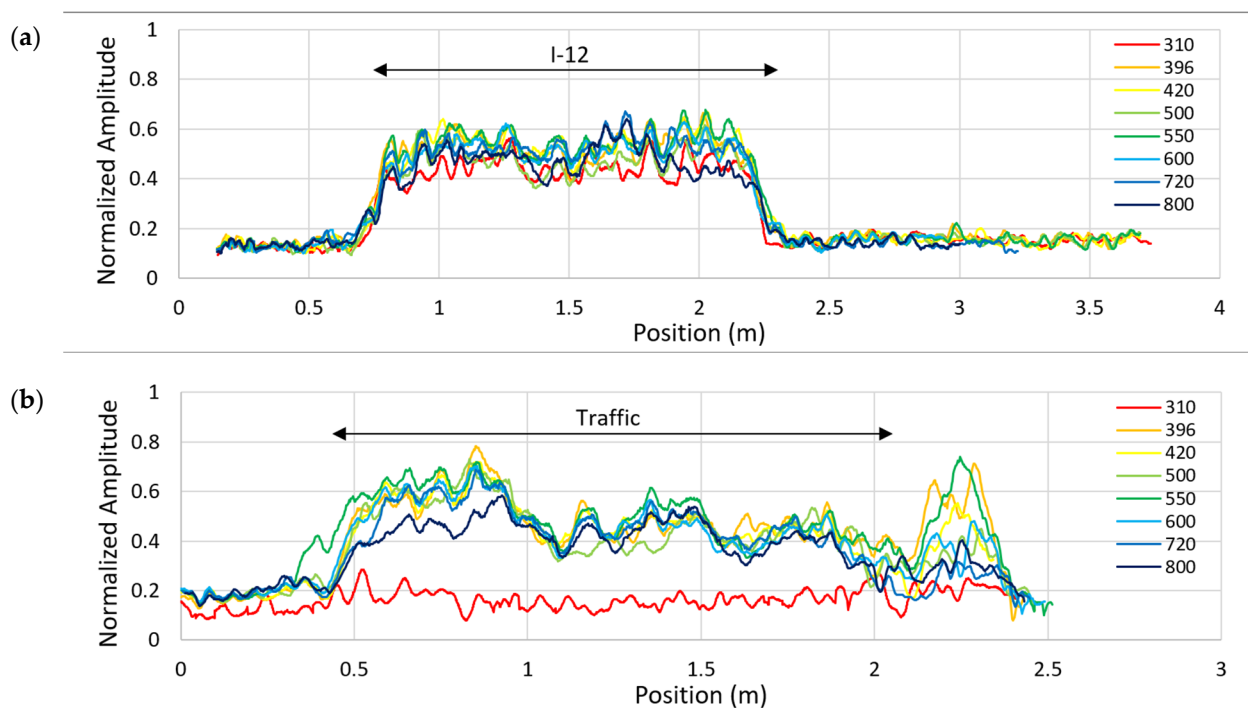
Figure 13. 2.6 GHz Norm. RW amplitudes on geotextile (I-12) in the (a) long. and (b) transv. direction vs. K loadings.

moisture content and by the fact that GPR antennas did not pass on exactly the same path. As an example, when studying B-scans performed on the geotextile defect in Figure 13a, standard deviations in the defect area are twice to four times greater than the ones in the sound area. Geotextile and sand-based defects show stronger radar echoes due to higher EM contrasts.

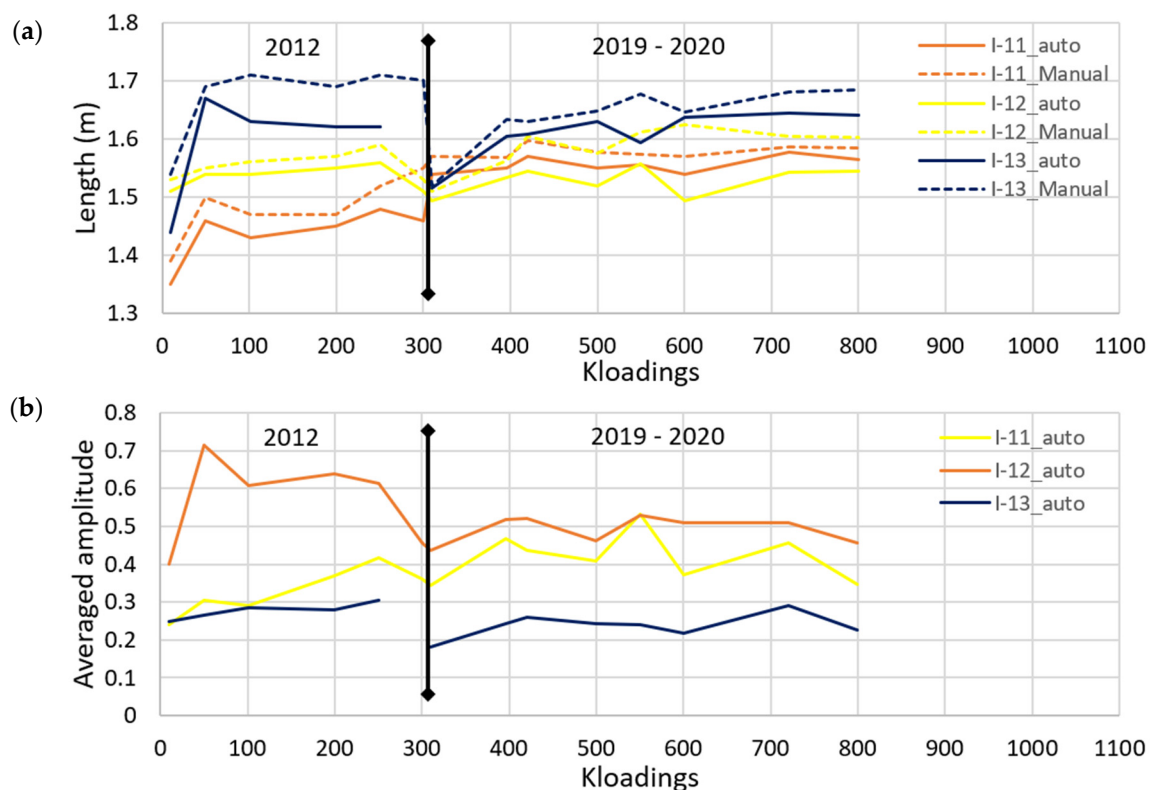
Figure 15. (a) Extensions and (b) averaged normalized amplitudes of 2.6 GHz RW on defects I-11 to I-13.

- When studying the amplitude evolution vs. traffic, we cannot make a direct link. Variations mainly come from moisture content inside the defect due to the weather conditions from the previous days, and perhaps in a second step, from variations of temperature. Table 3 summarizes this information, while giving an average value of amplitude all along the defects (Figure 15b).

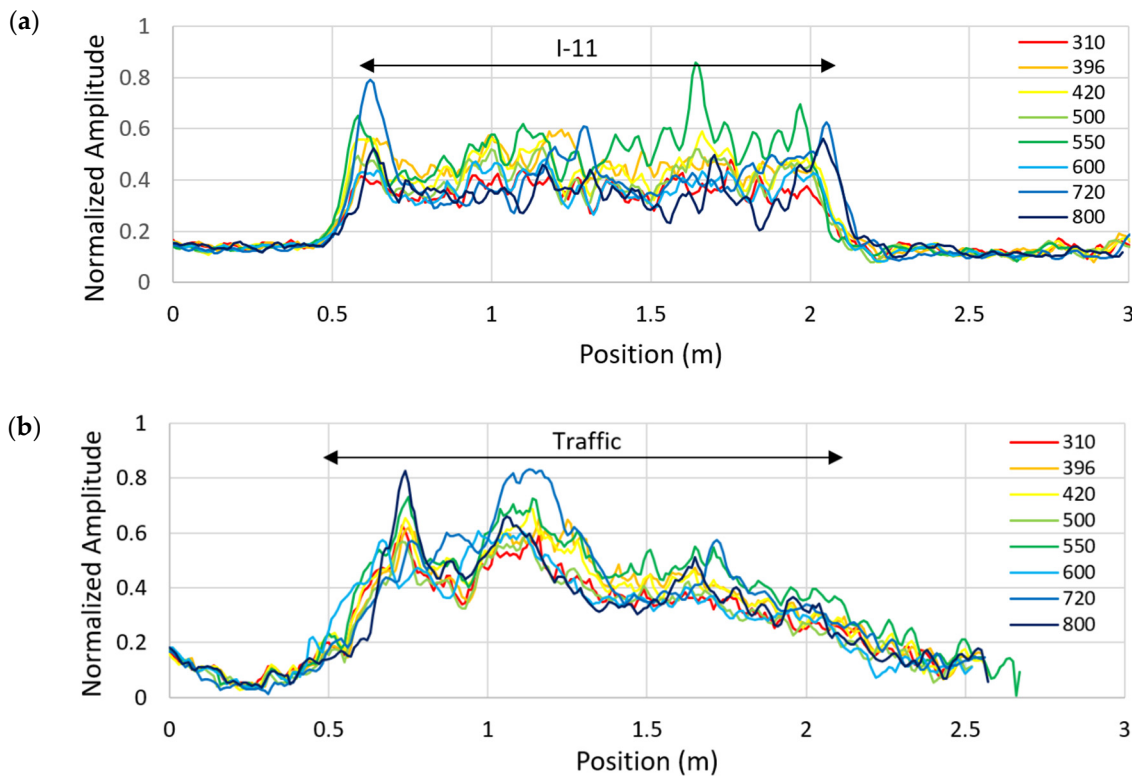
Figure 16. 1.5 GHz Norm. RW amplitudes on sand (I-11) in the (a) long. and (b) transv. direction vs. K loadings.

Figures 16–18 gather normalized RW amplitudes picked on the defects I-11, I-12, and I-13 vs. loading, from the 1.5 GHz data. Considering longitudinal results on the central axis of the traffic, we observe roughly stable levels without any general trend vs. traffic. Similar to 2.6 GHz results, transversal 1.5 GHz values present a general trend of RW decrease while moving towards the outer edge of the test track.

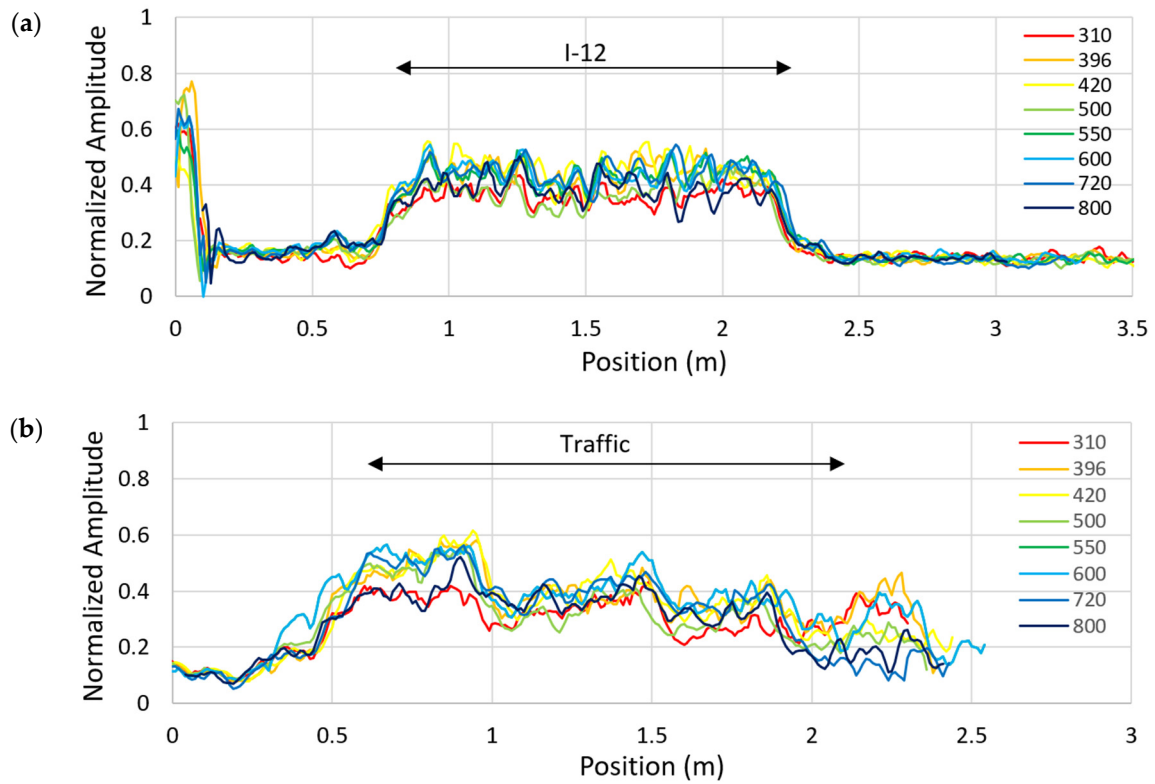
Figure 17. 1.5 GHz Norm. RW amplitudes on geotextile (I-12) in the (a) long, and (b) transv. direction vs. K loadings.

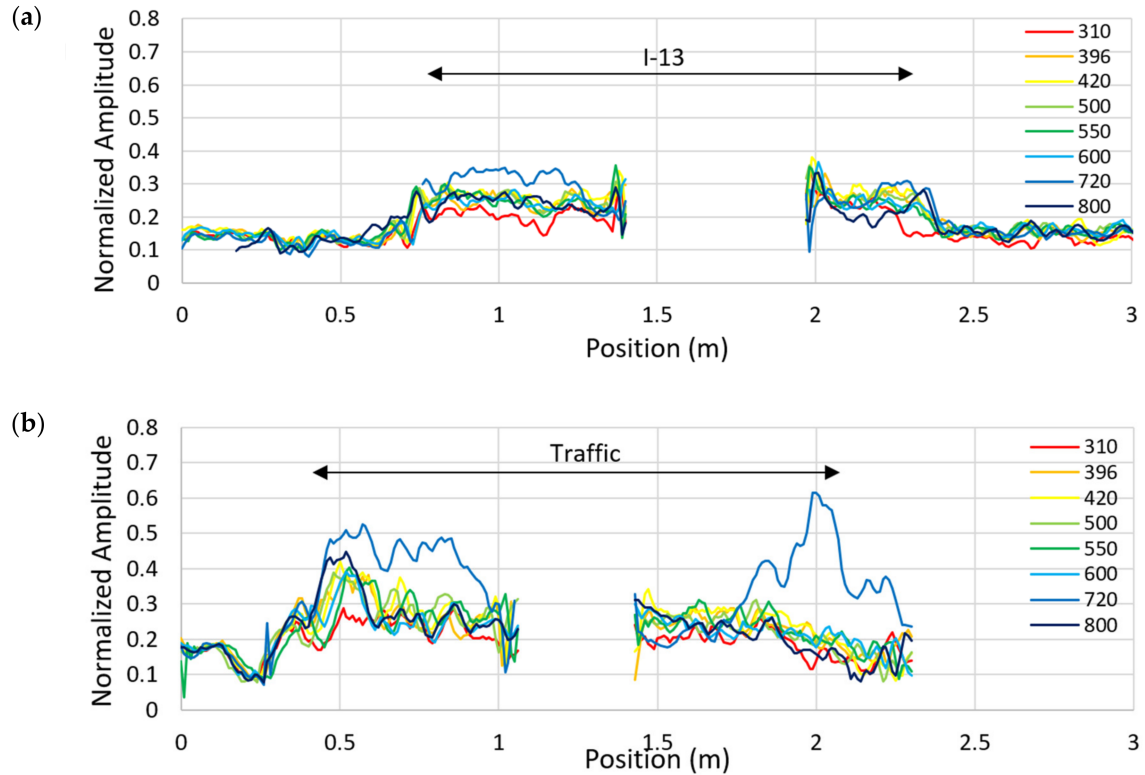
Figure 18. 1.5 GHz Norm. RW amplitudes on tack-coat free (I-13) in the (a) long, and (b) transv. direction vs. K loadings.

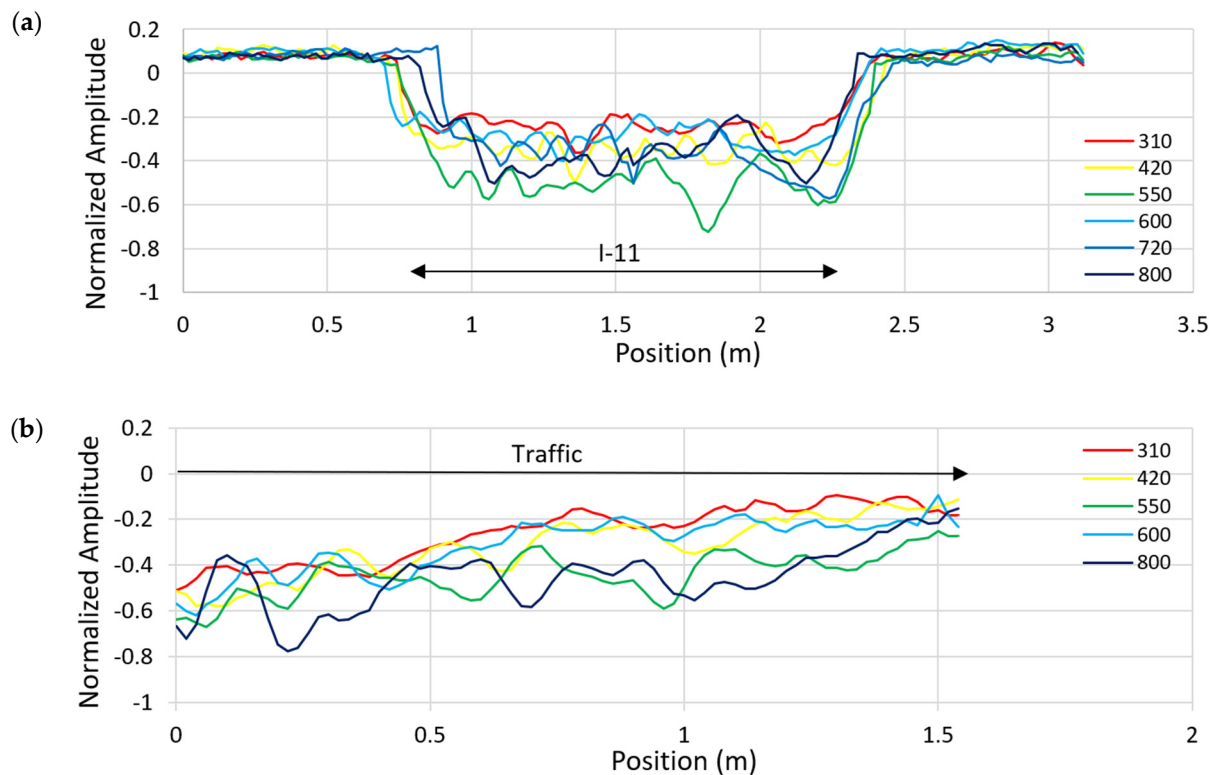
Figure 19. 5 GHz Norm. RW amplitudes on sand (I-11) in the (a) long. and (b) transv. direction vs. K loadings.

When measurements are done with air-coupled antennas, the polarity of the DW and RW are inverted and the amplitude ratios present negative values. We observed, in Figures 19–21, similar results to those from 2.6 GHz, with stable values for longitudinal profiles and a general trend for the transverse ones. As the acquisition length of the univ. Eiffel’s robotic antenna-holder system is limited to 1.6 m, longitudinal acquisitions were performed twice per defect. For the processing of these B-scans, they were gathered before picking, with the results being shown in Figures 19a, 20a and 21a. Results obtained at 5 GHz show the same trend as the 2.6 and 1.5 GHz ones.

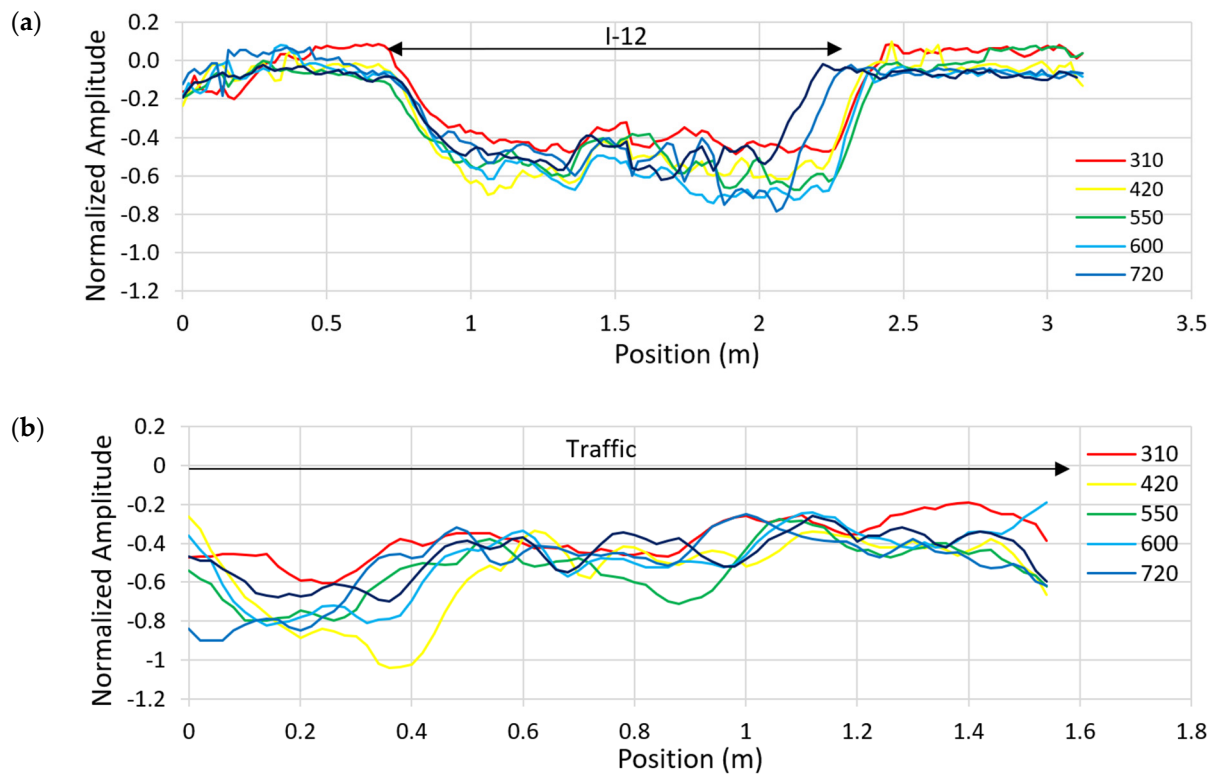
Figure 20. 5 GHz Norm. RW amplitudes on geotextile (I-12) in the (a) long. and (b) transv. direction vs. K loadings.

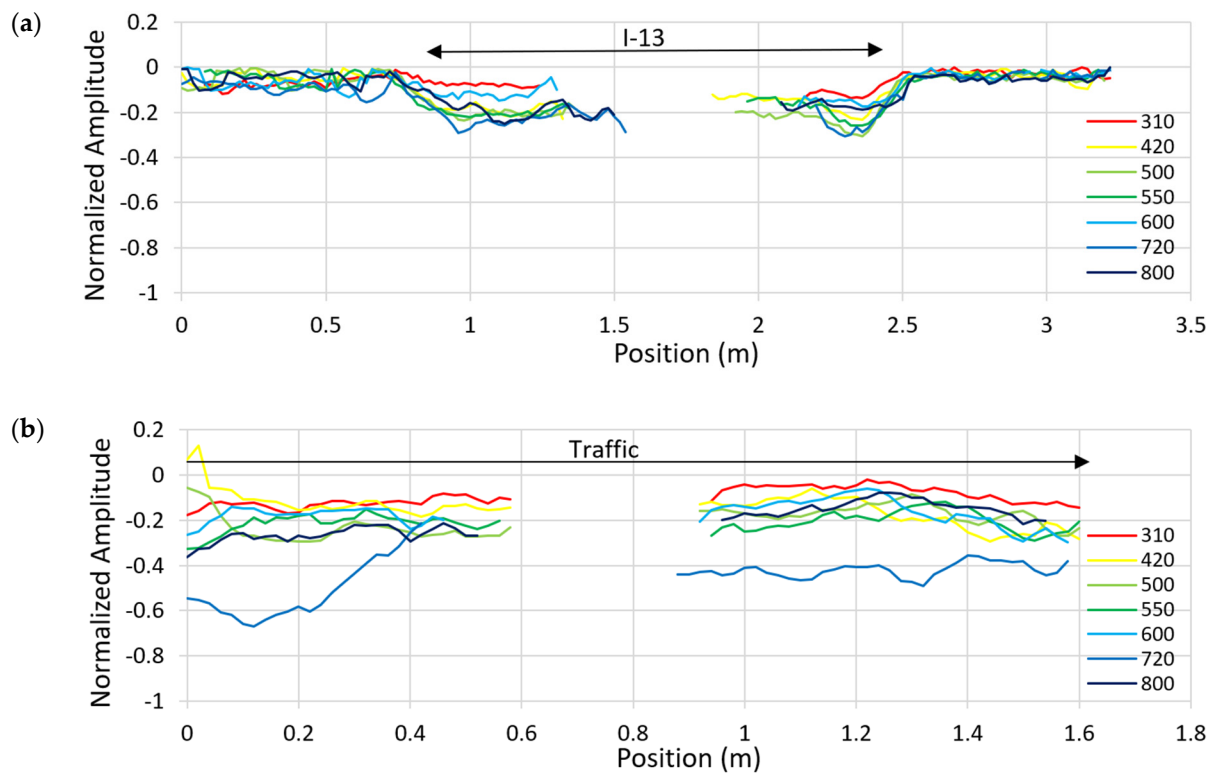
Figure 21. 5 GHz Norm. RW amplitudes on tack-coat free (I-13) in the (a) long. and (b) transv. direction vs. K loadings.

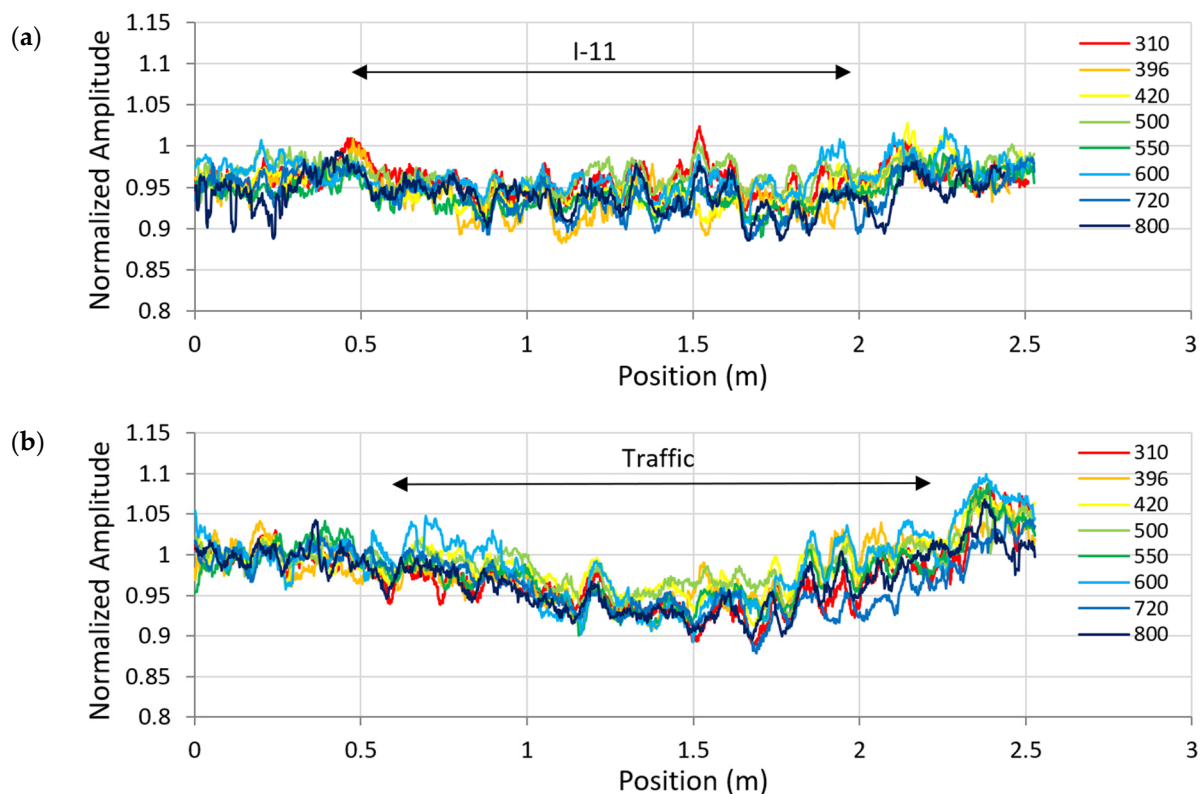
Figure 22. 2.6 GHz Norm. DW amplitudes on sand (I-11) in the (a) long. and (b) transv. direction vs. K loadings.

Concerning transverse data, we can note a general trend proportional to the traffic density, shown in Figures 22b, 23b and 24b, in a V shape with the minimum amplitude corresponding to the maximum of traffic. As the data come from ground-coupled acquisition, the decrease of the normalized amplitudes could be associated with an increase of the relative permittivity of the first asphalt, which narrows the radiation pattern and thus decreases the DW amplitude. This finding, when associated with the increase of cracks in the first layer, can be interpreted as an increase of moisture content trapped in this opened porosity.

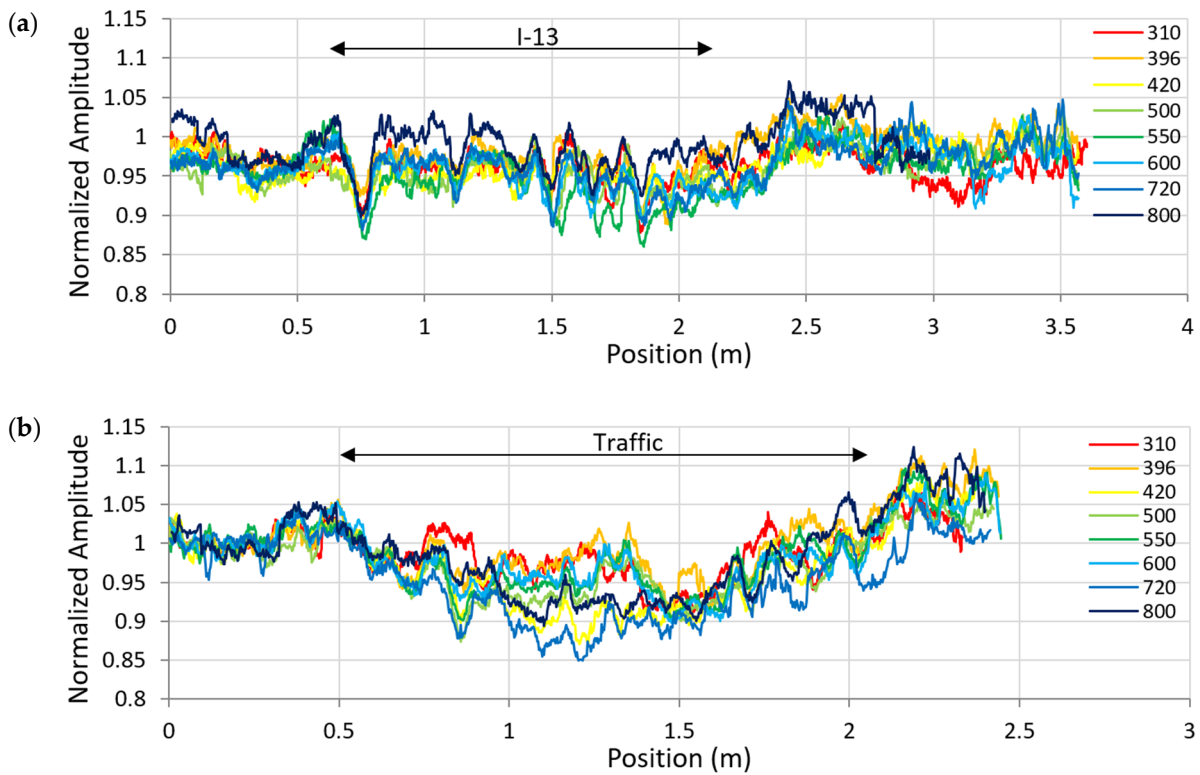
Figure 24. 2.6 GHz Normalized DW amplitudes on tack-coat free (I-13) in the (a) long, and (b) transv. direction vs. K loadings.

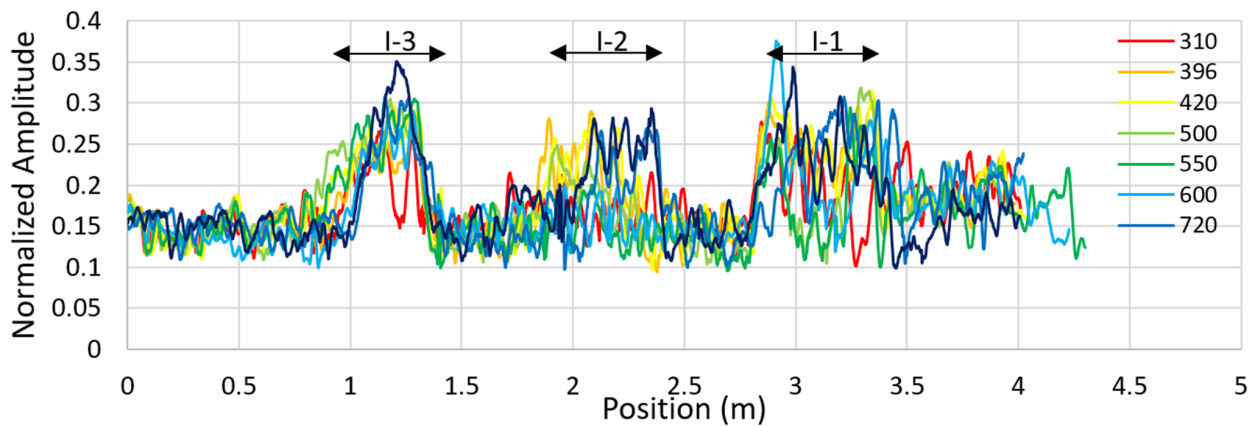
Figure 25. 2.6 GHz Normalized RW amplitudes on defects I-3 to I-1, in the longitudinal direction vs. K loadings.

Defects I-1 to I-3 correspond respectively to defects I-11 to I-13 with a narrow width of 50 cm. Measurements were only done at 1.5 and 2.6 GHz, with GSSI systems during the second stages of experiment. Only 2.6 GHz data are processed and presented in this section as the 1.5 GHz and 2.6 GHz data are very similar. From Figures 25–28, we note that the narrowness of the defects induces different behavior under traffic than I-11 to I-13. The amplitudes do not appear to be stable along the longitudinal traces of I1 to I3. Additionally, no V-shaped variation in trends is seen for the transversal results over the largest defects. This phenomenon could be explained by the loading transfer in the asphalt partially supported by the healthy borders, and then not damaging the surveyed interface.

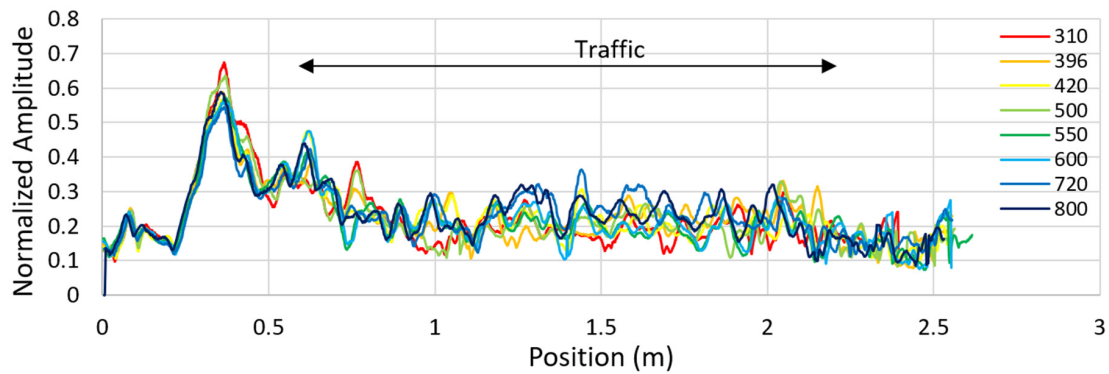
Figure 26. 2.6 GHz Normalized RW amplitudes on sand (I-1), in the transversal direction vs. K loadings.

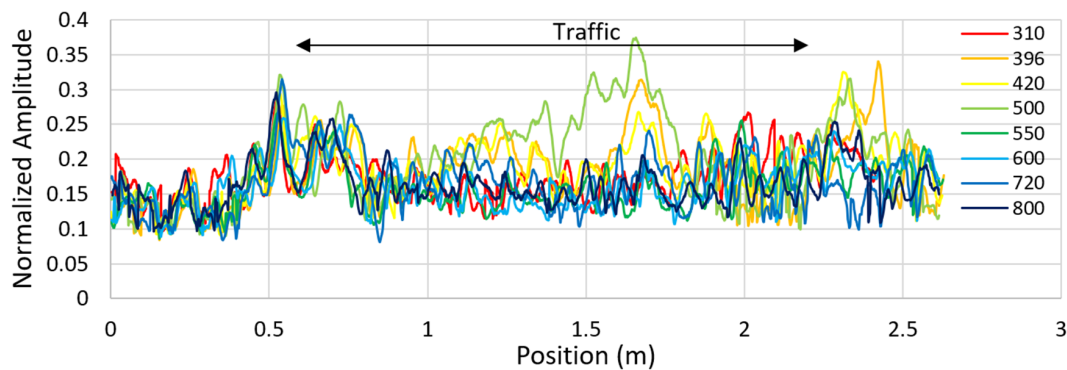
Figure 27. 2.6 GHz Normalized RW amplitudes on geotextile (I-2), in the transversal direction vs. K loadings.

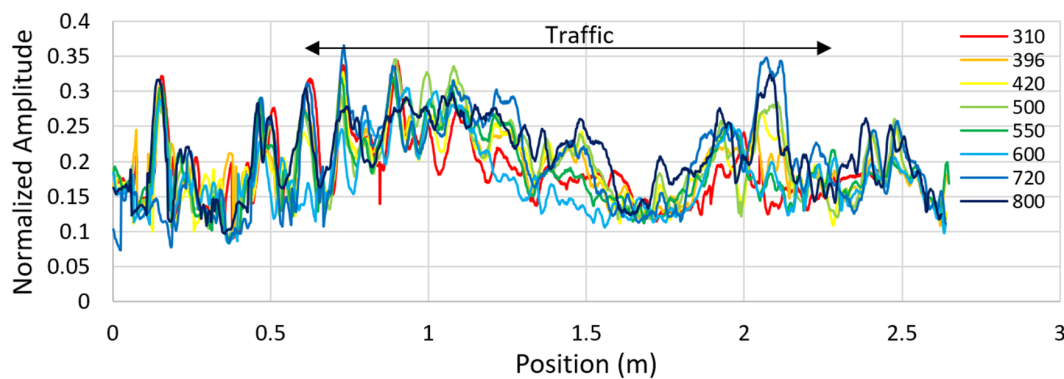
Figure 28. 2.6 GHz Normalized RW amplitudes on tack-coat free (I-3), in the transversal direction vs. K loadings.
