GPR Monitoring of Artificial Debonded Pavement Structures throughout Its Life Cycle during Accelerated Pavement Testing

Xavier Dérobert, Vincent Baltazart, Jean-Michel Simonin, Shreedhar Savant Todkar, Christophe Norgeot, Ho-Yan Hui

Xavier Dérobert, Vincent Baltazart, Jean-Michel Simonin, Shreedhar Savant Todkar, Christophe Norgeot, et al. GPR Monitoring of Artificial Debonded Pavement Structures throughout Its Life Cycle during Accelerated Pavement Testing. *Remote Sensing*, 2021, 13 (8), pp.1474. 10.3390/rs13081474 . hal-04278503

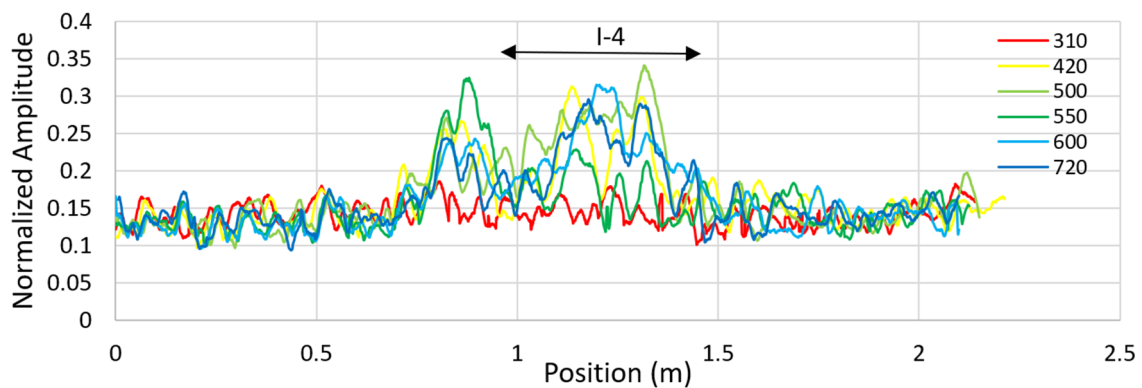
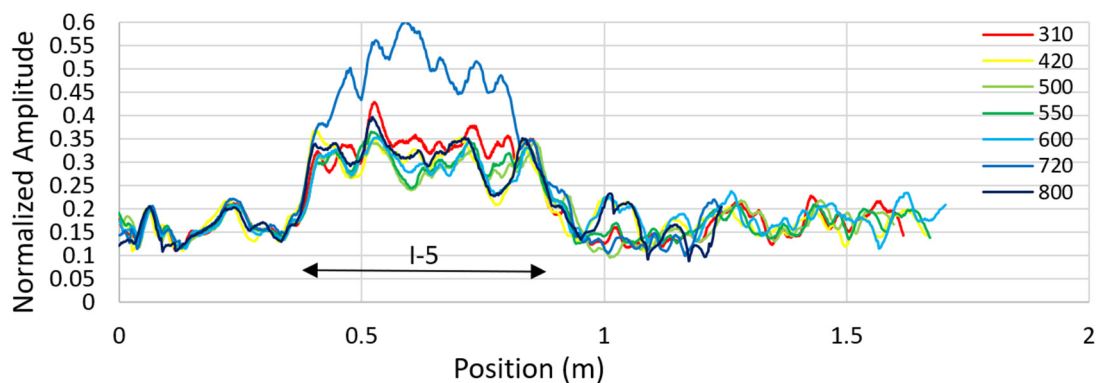
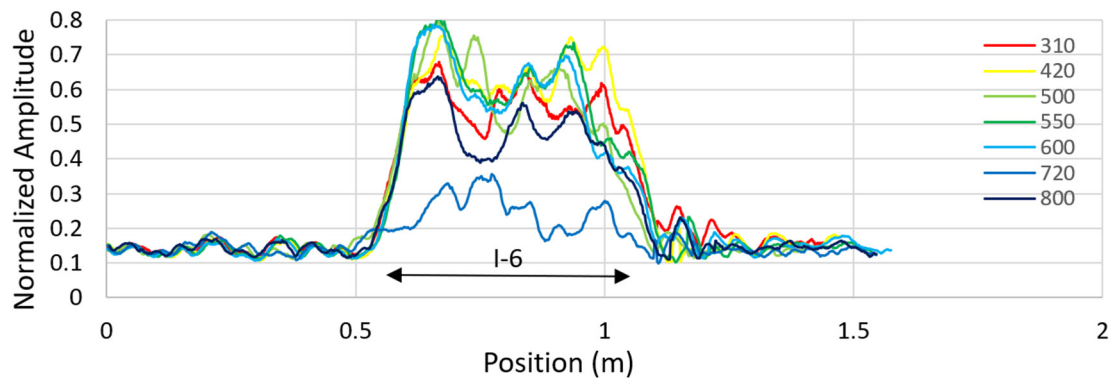
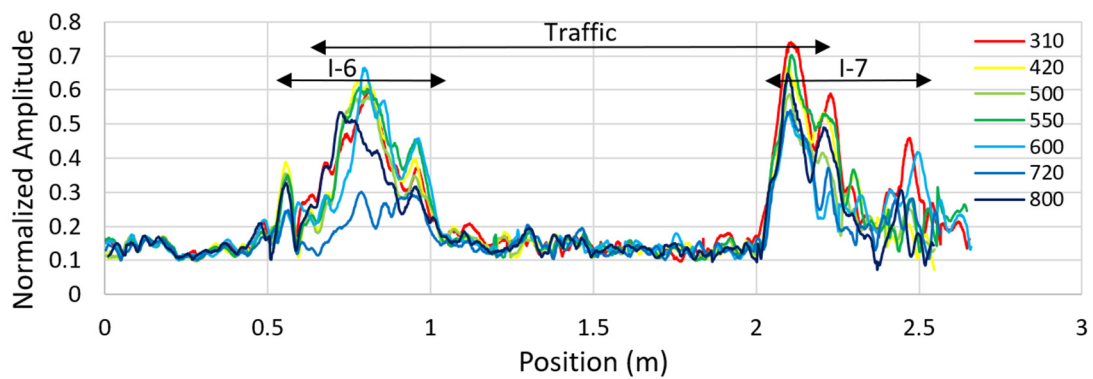
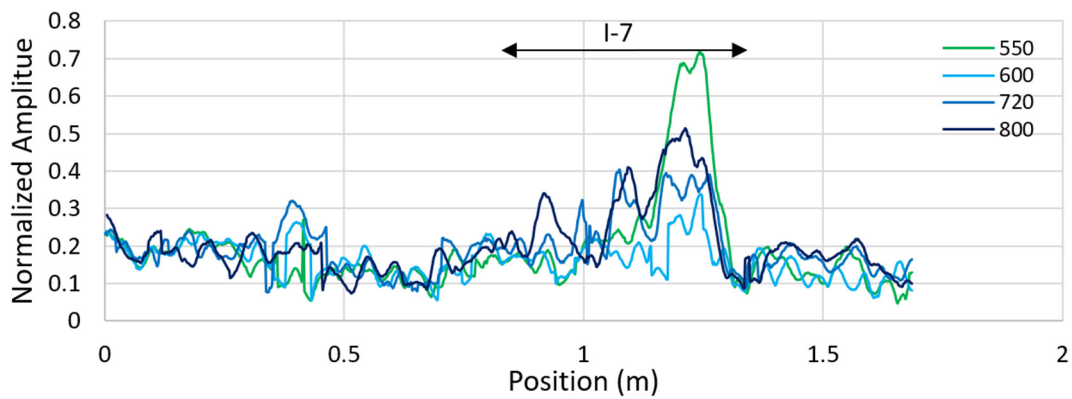
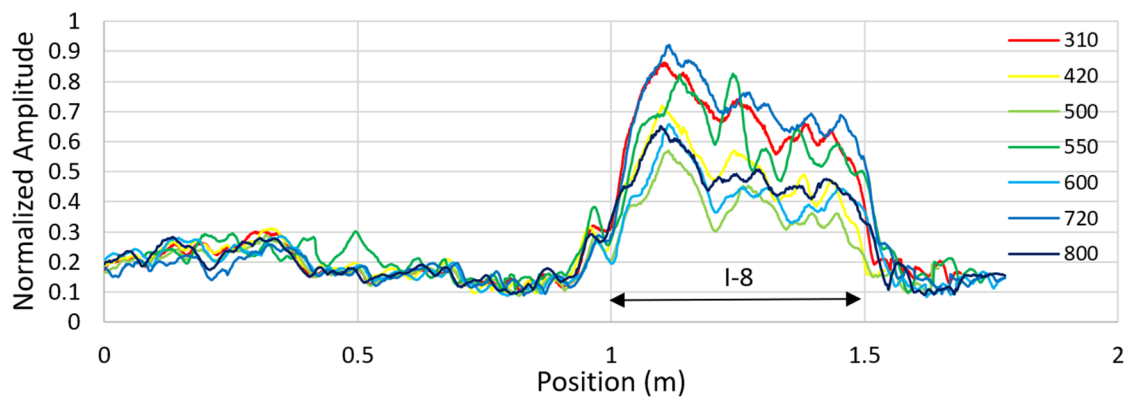
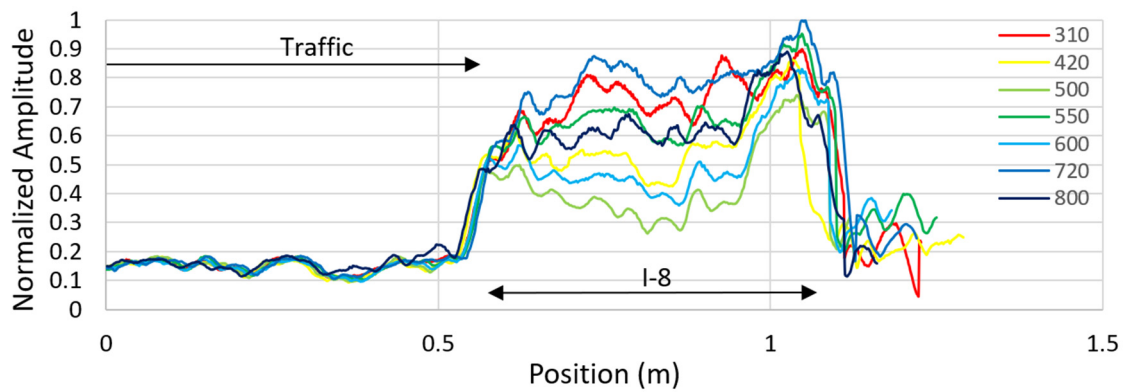
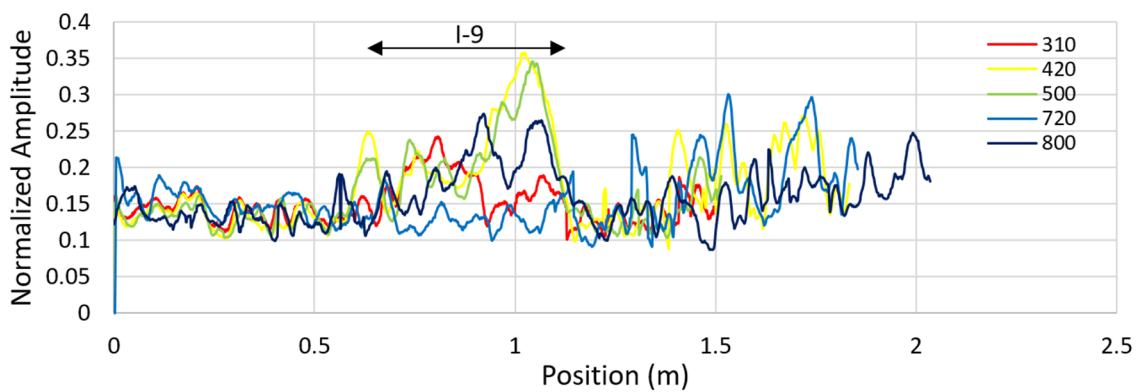
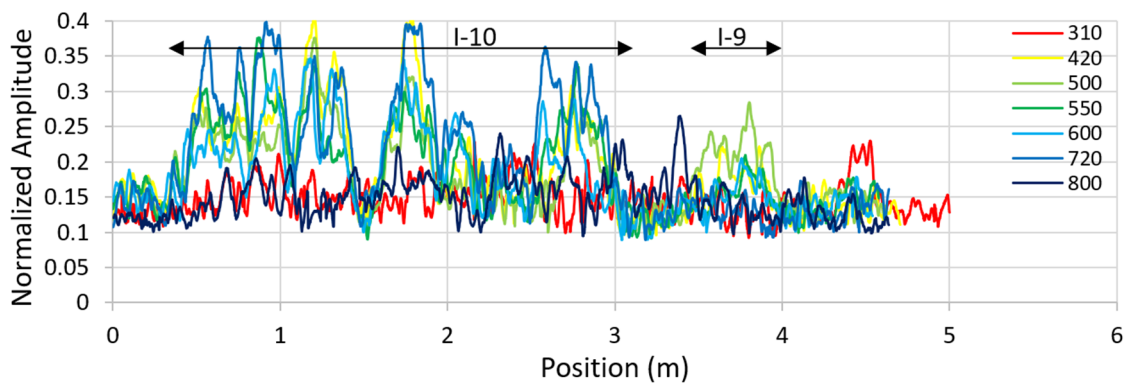
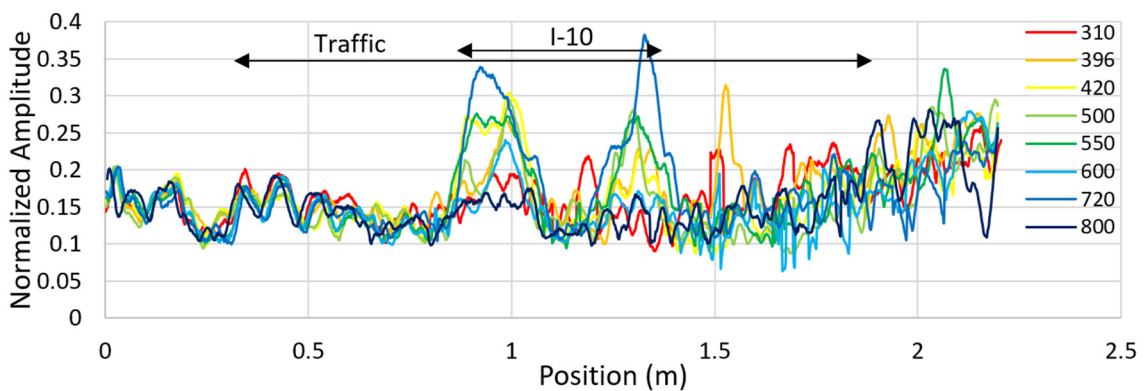
Figures 29–38 show strong variations of normalized amplitudes from defect I-4 to I-10, depending on the loading step and the location of the defect. As a reminder, defects I-4, I-9, and I-10 are centered on the axis of the major loading traffic. Defects I-6 and I-7 are off-center, even out of traffic, and at last, defects I-5 and I-8 are out of traffic.

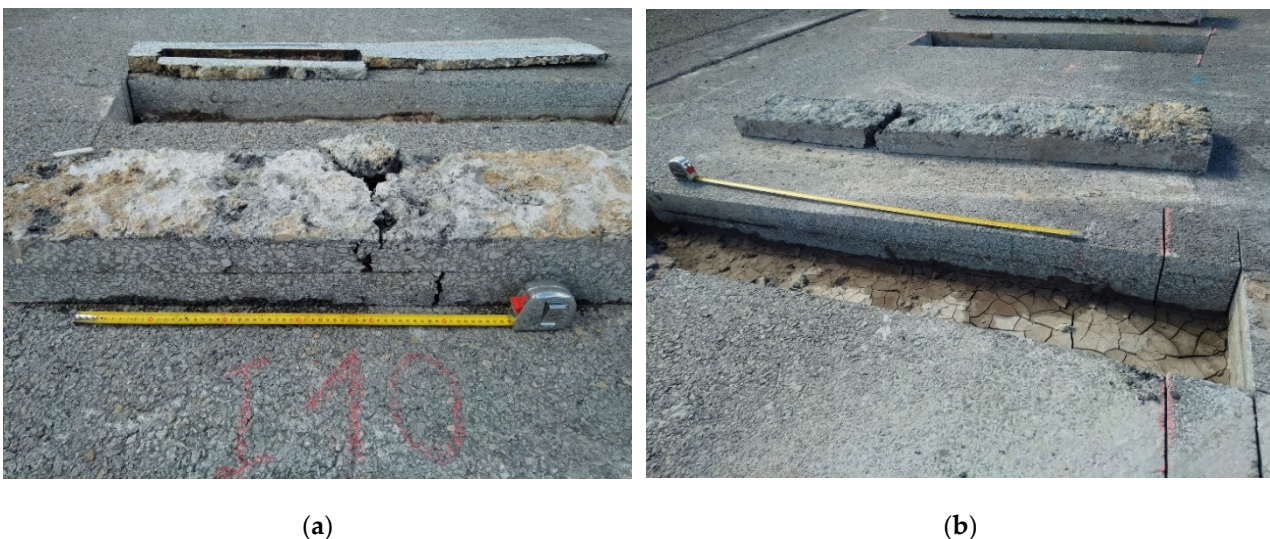
Figure 39. Transverse trenches and corresponding asphalt slabs of (a) defect I-10 and (b) defects I-12.

At the end of the loading series and GPR experiments, several trench cores were sampled to get a ground truth of the damaged structure, and first of all, the real thickness of the defects and their lateral length. Six trenches have been realized in the area of the largest defects. Four transverse trenches were located at the center of defects I-10, I-11, I-12, and I-13, at the level of the GPR profiles, and dimensions of approximately as follows: $1.30 \times 0.25 \times 0.15$ m (Figure 39). One transverse trench was done between defects I-11 and I-12 to obtain information of the traffic effect on a healthy zone. The last one was sawn longitudinally from the center of I-12 towards I-13, 1.2 m long.

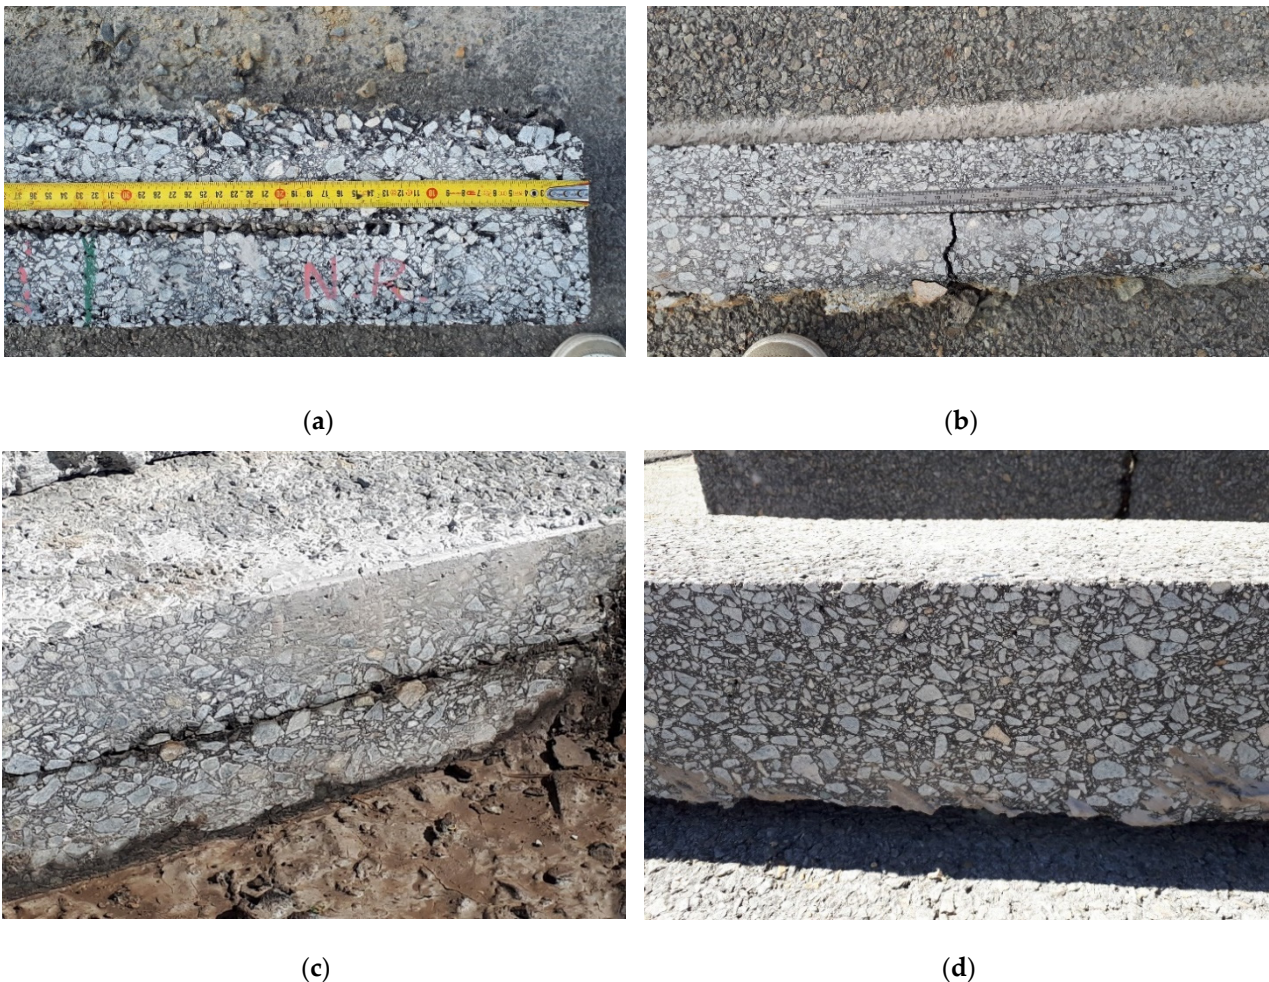
Figure 40. Details of defects visible on the side of asphalt slabs, based on (a) sand (I-11), (b) geotextile (I-10), (c) tack-coat free (I-13), and (d) healthy zone.

To conclude, the extracted blocks and the trenches have shown no losing of material from asphalt layers, but only micro-cracks, mainly vertically oriented.

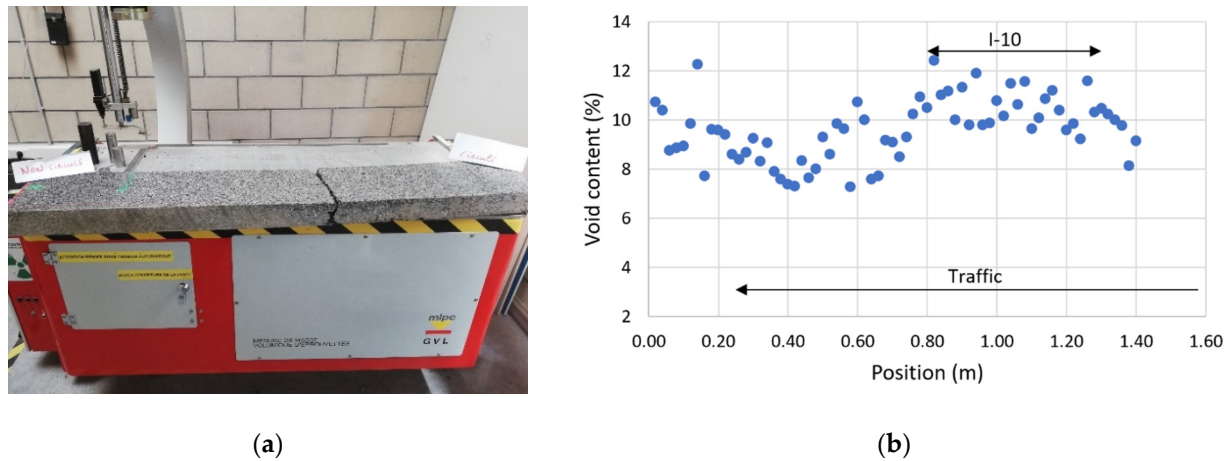
Figure 41. (a) Gammadensimetric acquisition on asphalt layer, (b) void content estimation vs. of lateral location.

after its extraction. Gammadensimetry, a semi-destructive radiation method (Figure 41a), is viewed as a reliable laboratory testing method and considered as a reference in the field of the bulk density variation measurement [19].

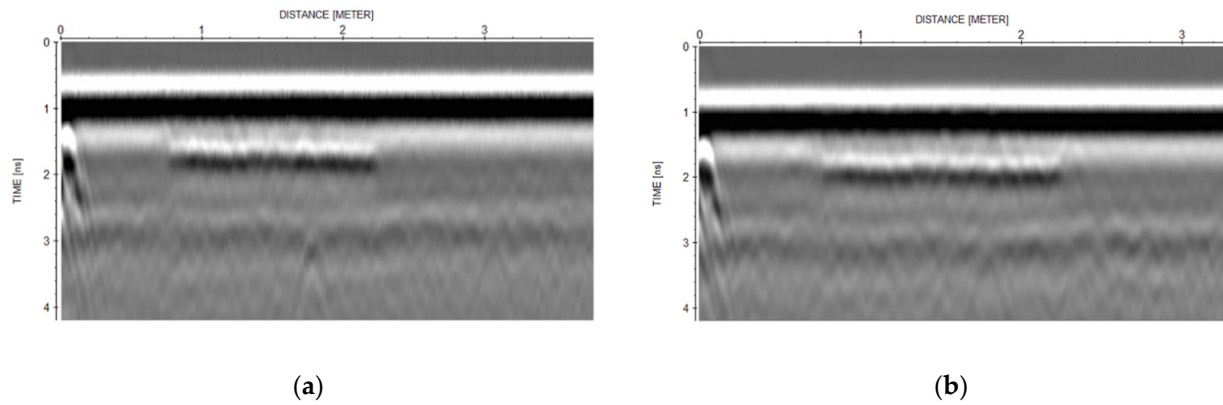
Figure A1. 1.5 GHz impulse B-scans performed on geotextile (I-12) at (a) 396 K and (b) 720 K loadings.

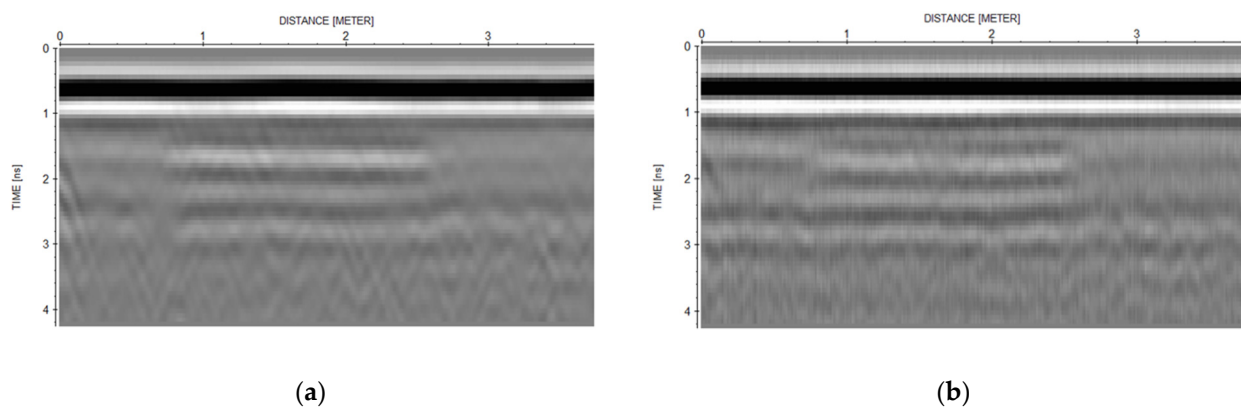
Figure A2. 1.5 GHz stepped-frequency B-scans performed on geotextile (I-12) at (a) 396 K and (b) 720 K loadings.

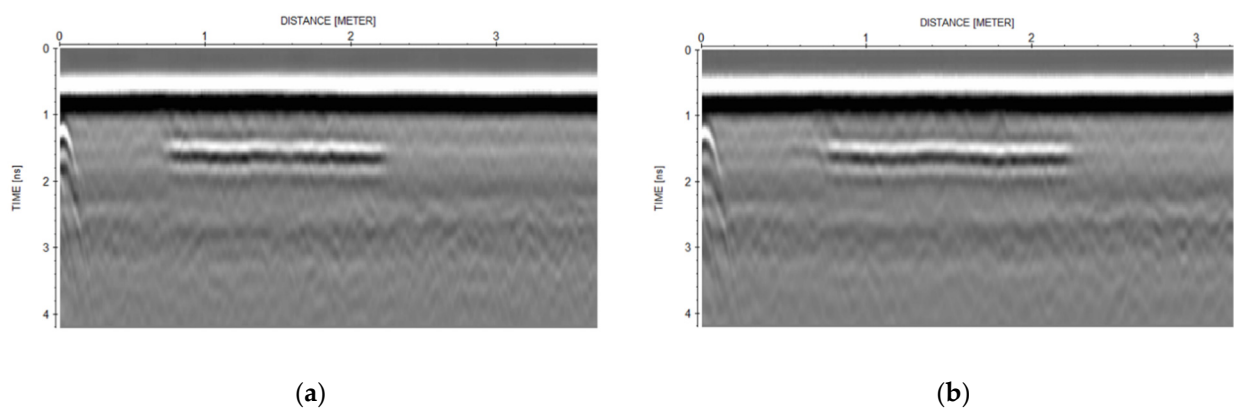
Figure A3. 2.6 GHz impulse B-scans performed on geotextile (I-12) at (a) 396 K and (b) 720 K loadings.

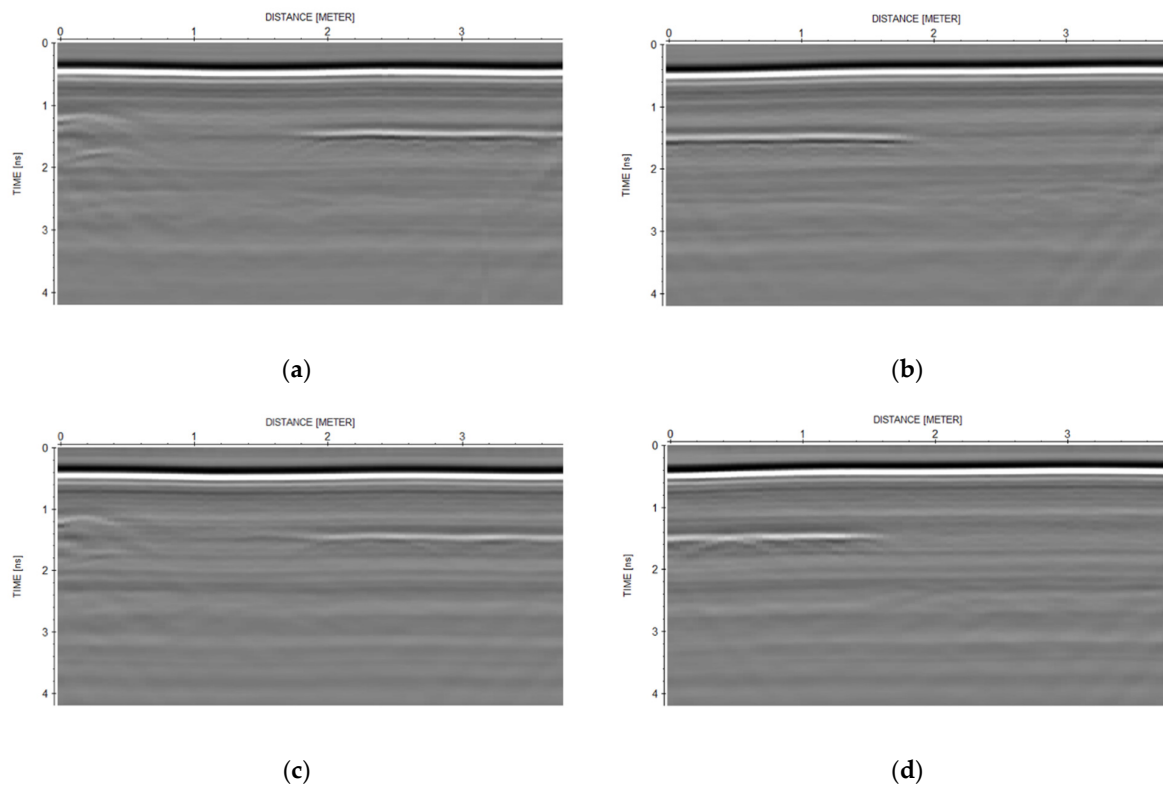
Figure A4. 5 GHz stepped-frequency B-scans performed on geotextile (I-12) in two steps at (a,b) 420 K and (c,d) 720 K loadings.

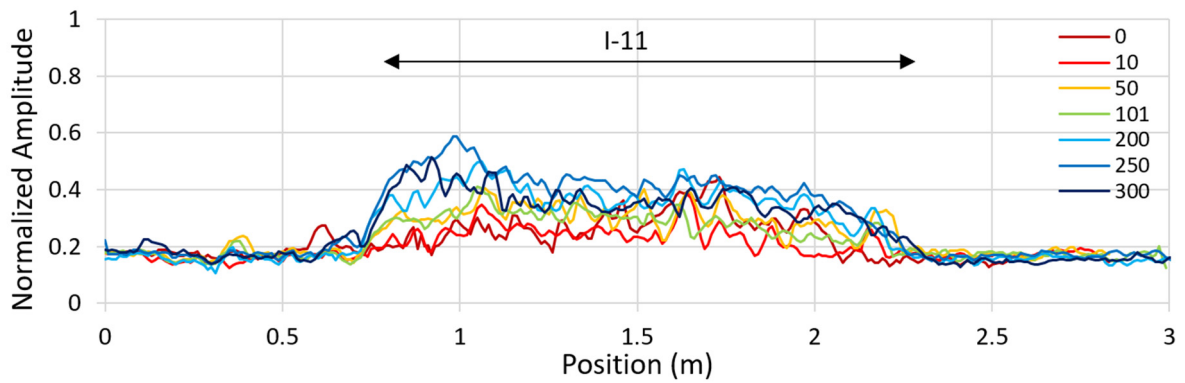
Figure A5. 2.6 GHz normalized RW amplitudes on sand (I-11) in the longitudinal direction vs. K loadings.

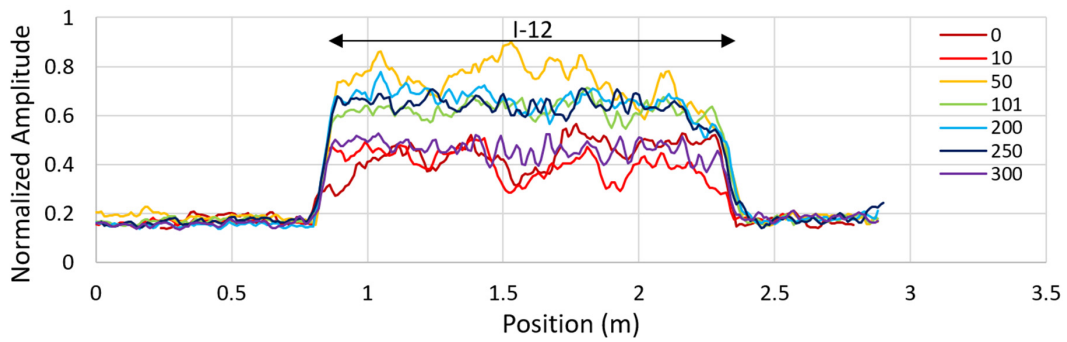
Figure A6. 2.6 GHz normalized RW amplitudes on geotextile (I-12) in the longitudinal direction vs. K loadings.

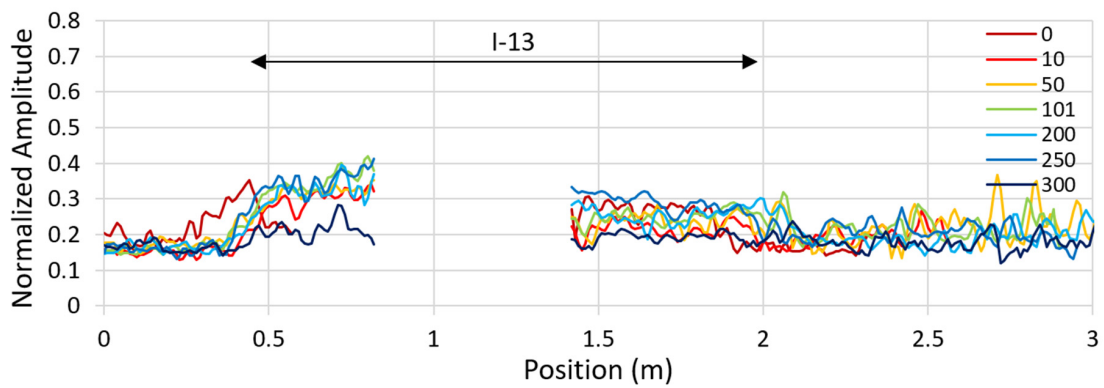
Figure A7. 2.6 GHz normalized RW amplitudes on tack-coat free (I-13) in the long. direction vs. K loadings.

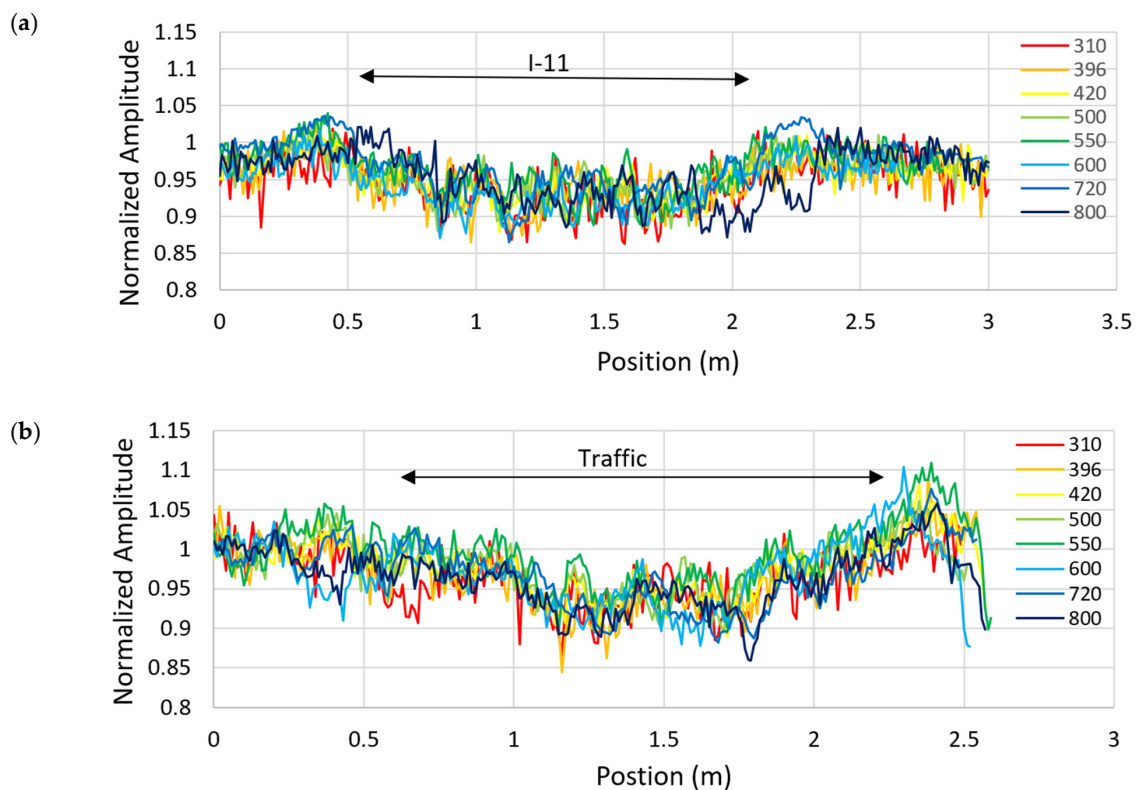
Figure A8. 1.5 GHz Norm. DW amplitudes on sand (I-11) in the (a) long. and (b) transv. direction vs. K loadings.

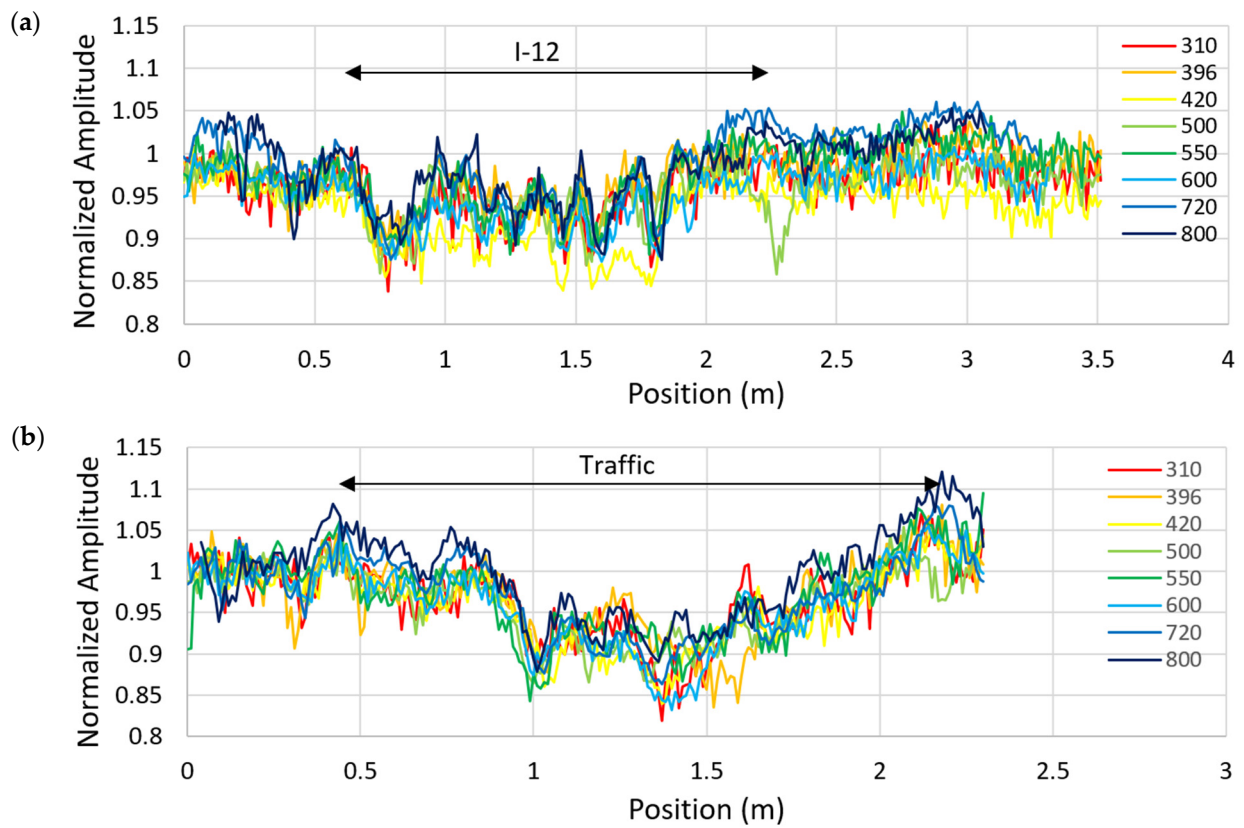
Figure A9. 1.5 GHz Norm. DW amplitudes on geotextile (I-12) in the (a) long. and (b) transv. direction vs. K loadings.

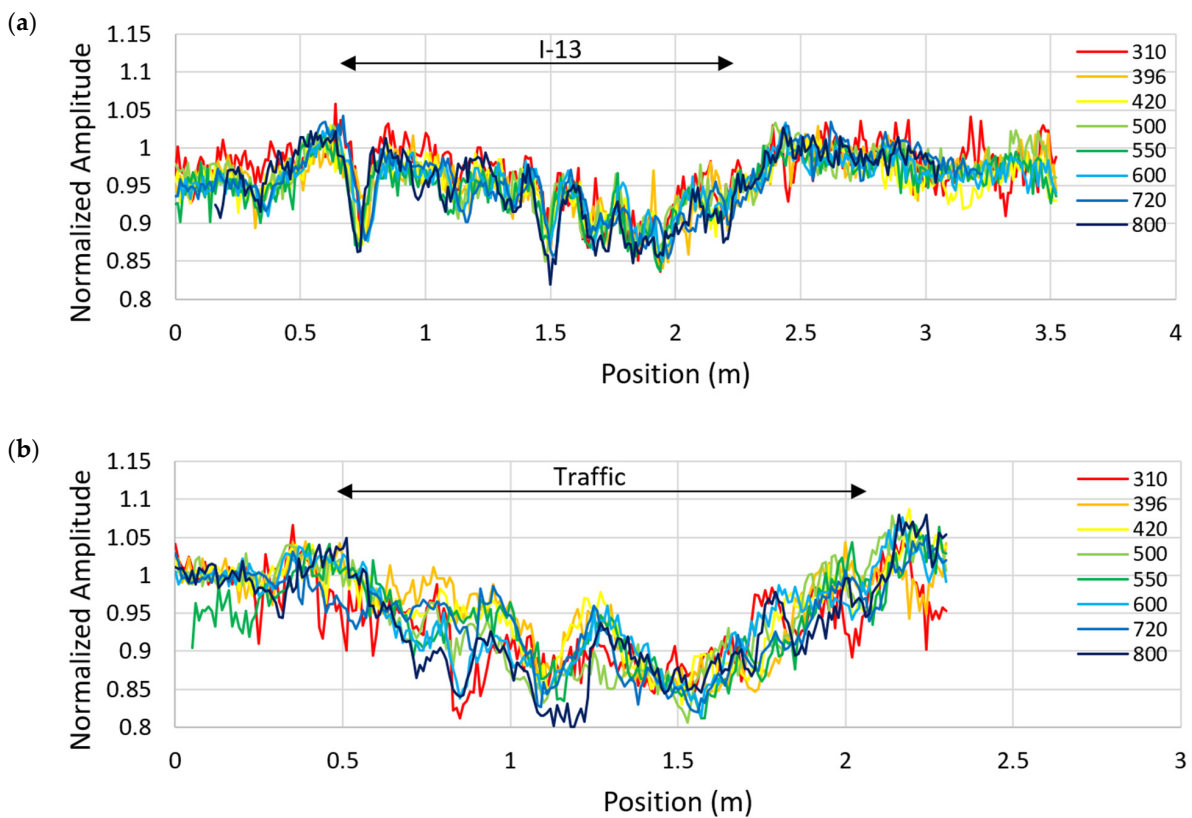
Figure A10. 1.5 GHz Norm. DW amplitudes on tack-coat free (I-13) in the (a) long. and (b) transverse direction vs. K loadings.

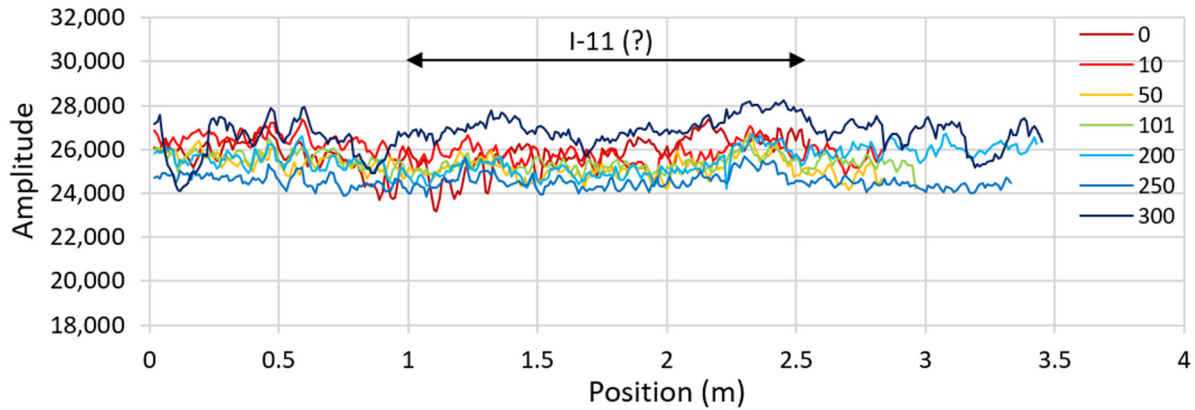
Figure A11. 2.6 GHz DW amplitudes on sand (I-11) in the longitudinal direction vs. K loadings.

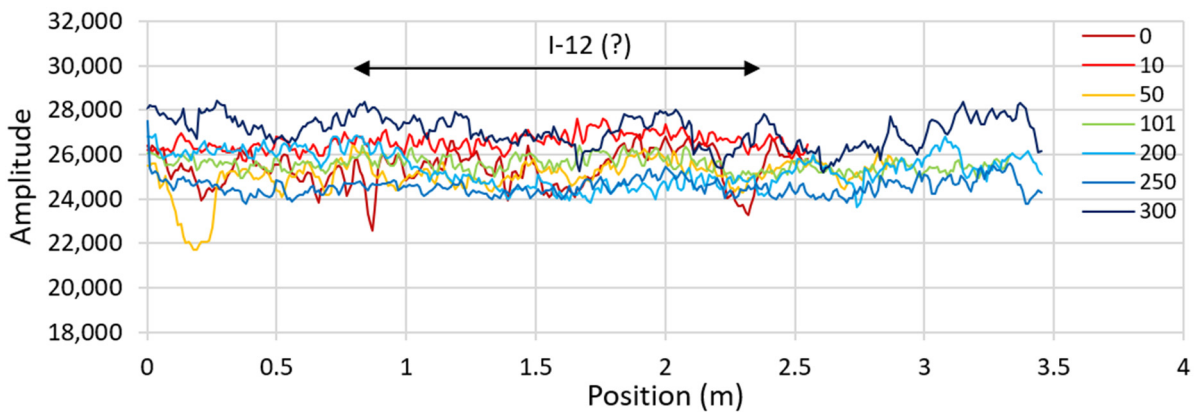
Figure A12. 2.6 GHz DW amplitudes on geotextile (I-12) in the longitudinal direction vs. K loadings.

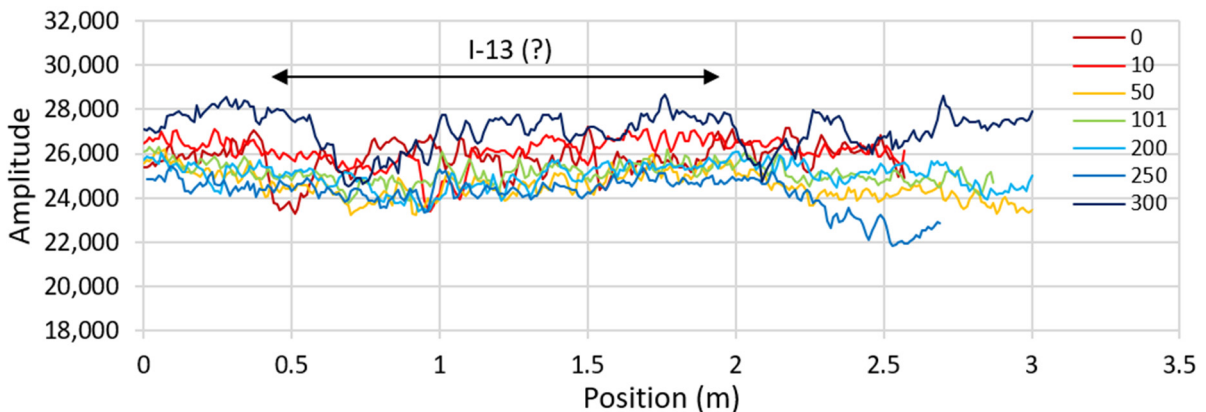
Figure A13. 2.6 GHz DW amplitudes on tack-coat free (I-13) in the longitudinal direction vs. K loadings.
