GPR Monitoring of Artificial Debonded Pavement Structures throughout Its Life Cycle during Accelerated Pavement Testing

Xavier Dérobert, Vincent Baltazart, Jean-Michel Simonin, Shreedhar Savant Todkar, Christophe Norgeot, Ho-Yan Hui

Xavier Dérobert, Vincent Baltazart, Jean-Michel Simonin, Shreedhar Savant Todkar, Christophe Norgeot, et al. GPR Monitoring of Artificial Debonded Pavement Structures throughout Its Life Cycle during Accelerated Pavement Testing. *Remote Sensing*, 2021, 13 (8), pp.1474. 10.3390/rs13081474 . hal-04278503

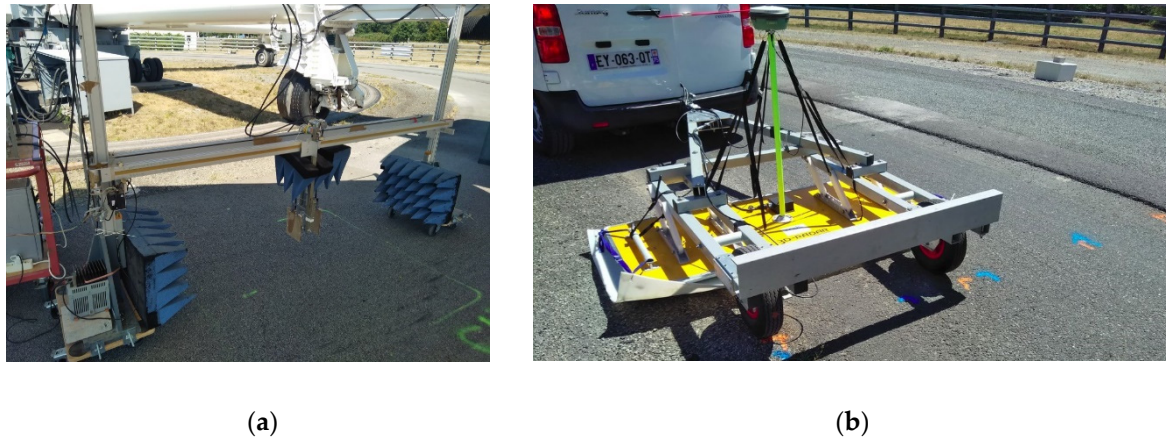
Figure 4. (a) Univ. Eiffel's robotic antenna-holder system associated to the stepped-frequency radar (SFR) with ultra-wide-band (UWB) antennas (surrounding blue cones are electromagnetic (EM) absorbing foams). (b) 3D-radar system during acquisition.

range of frequency, leading, after an inverse Fourier transform, to radar data equivalent to multiple 1.5 GHz B-scan. The array system is pulled behind a vehicle and localized by an RTK centimetric global positioning system.

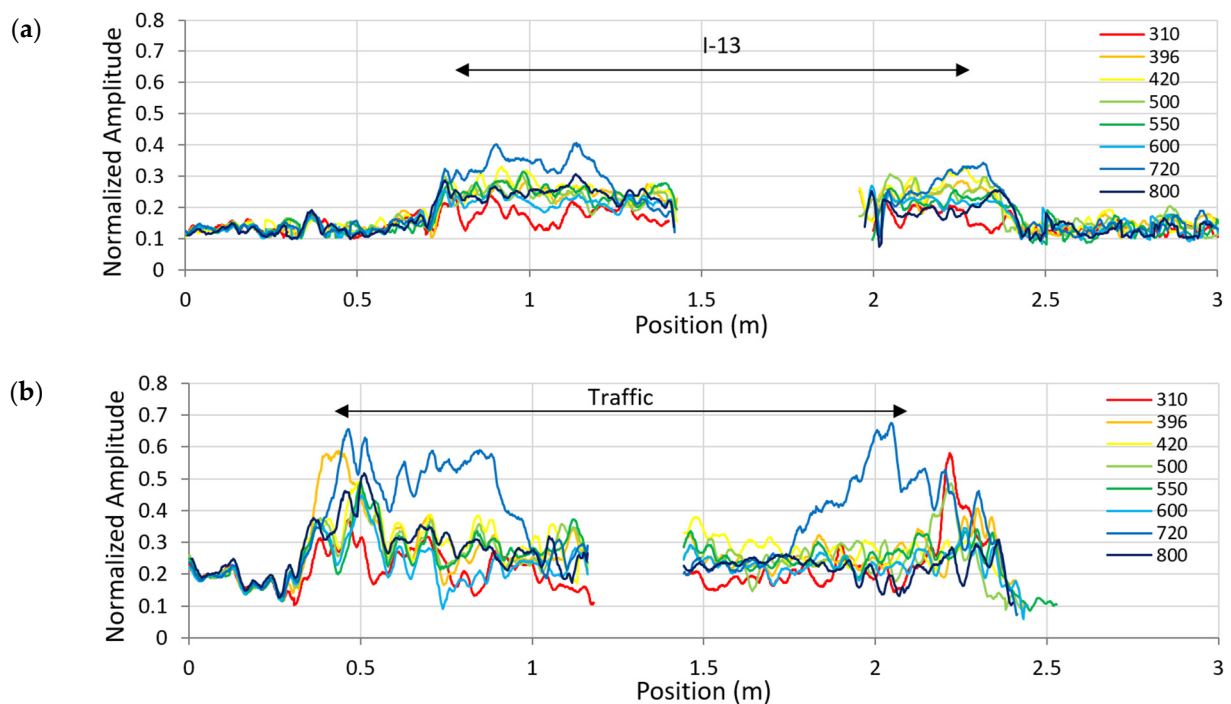
Figure 14. 2.6 GHz Norm. RW amplitudes on tack-coat free (I-13) in the (a) long. and (b) transv. direction vs. K loadings.

Figures 12–14 gather normalized RW amplitudes, namely RW/DW as defined in Section 2.3, picked on the defects I-11, I-12 and I-13 from the 2.6 GHz data over all the loading stages.

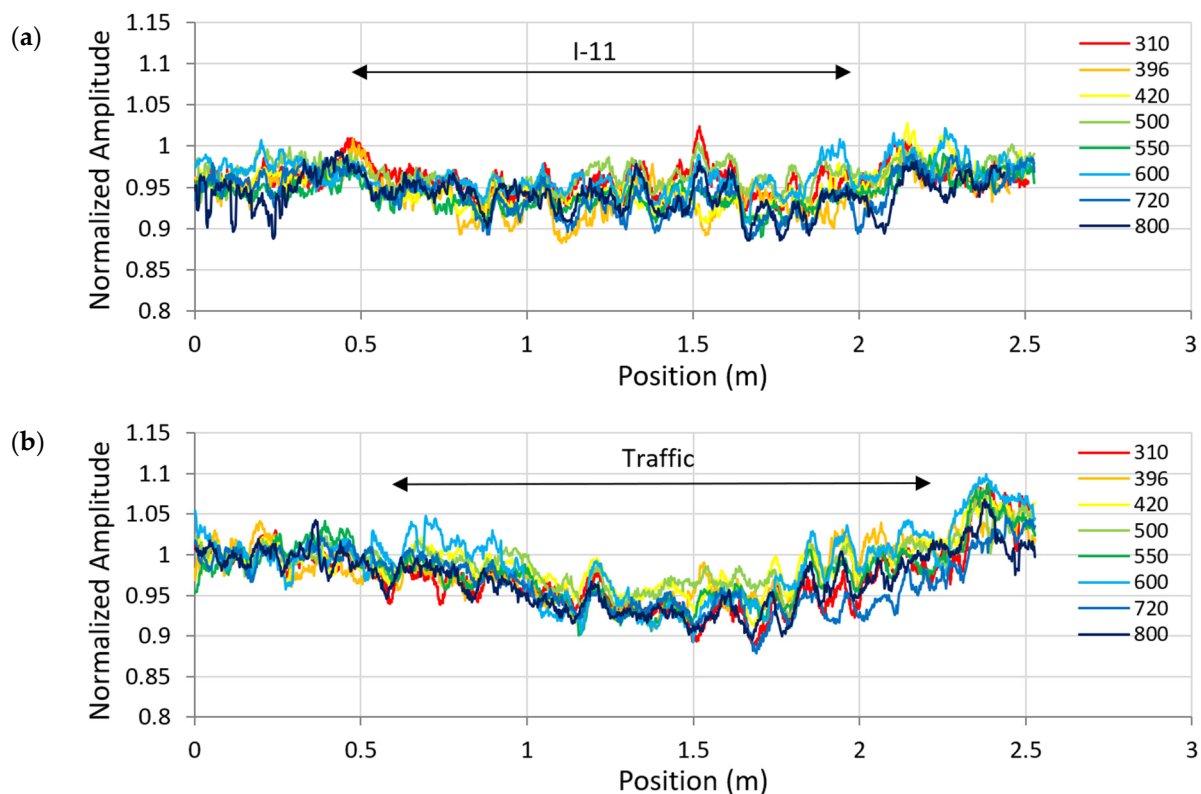
Figure 22. 2.6 GHz Norm. DW amplitudes on sand (I-11) in the (a) long. and (b) transv. direction vs. K loadings.

Concerning transverse data, we can note a general trend proportional to the traffic density, shown in Figures 22b, 23b and 24b, in a V shape with the minimum amplitude corresponding to the maximum of traffic. As the data come from ground-coupled acquisition, the decrease of the normalized amplitudes could be associated with an increase of the relative permittivity of the first asphalt, which narrows the radiation pattern and thus decreases the DW amplitude. This finding, when associated with the increase of cracks in the first layer, can be interpreted as an increase of moisture content trapped in this opened porosity.

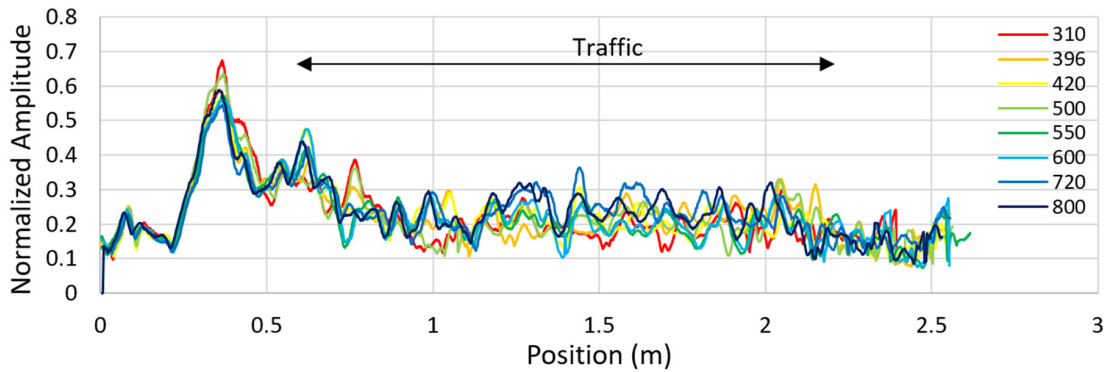
Figure 26. 2.6 GHz Normalized RW amplitudes on sand (I-1), in the transversal direction vs. K loadings.

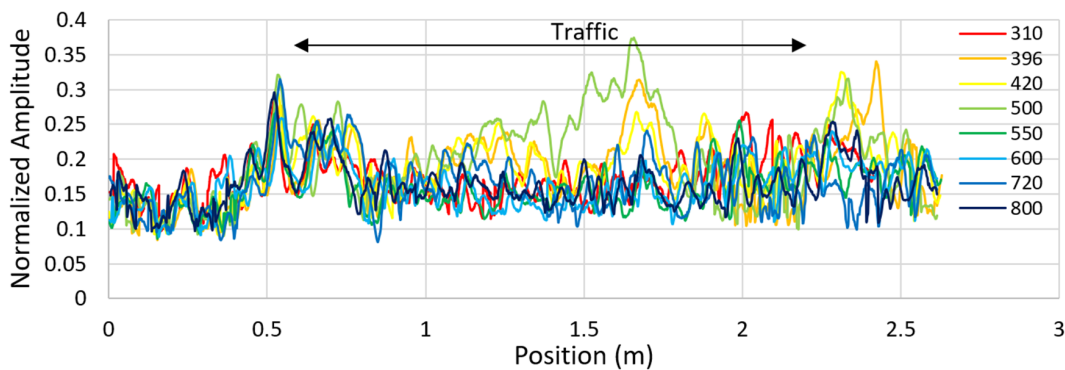
Figure 27. 2.6 GHz Normalized RW amplitudes on geotextile (I-2), in the transversal direction vs. K loadings.

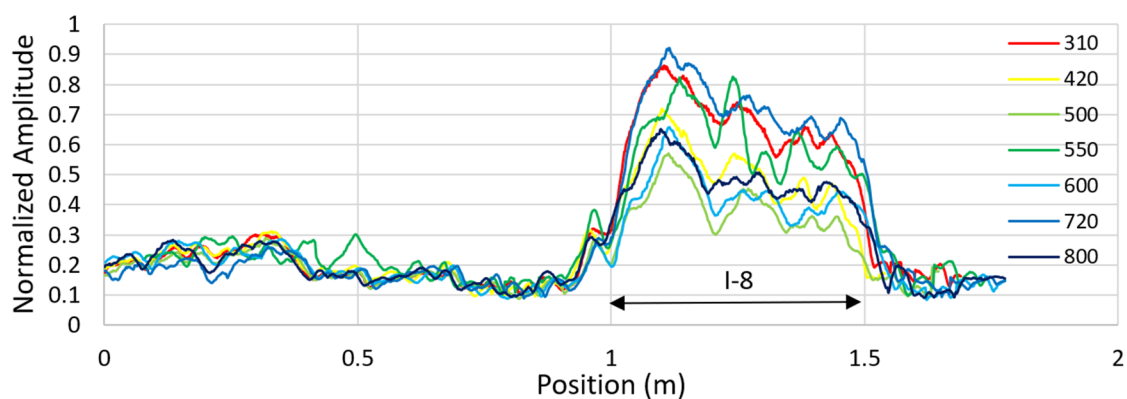
Figure 34. 2.6 GHz Normalized RW amplitudes on defect I-8, in the longitudinal direction vs. K loadings.

Figures 29–38 show strong variations of normalized amplitudes from defect I-4 to I-10, depending on the loading step and the location of the defect. As a reminder, defects I-4, I-9, and I-10 are centered on the axis of the major loading traffic. Defects I-6 and I-7 are off-center, even out of traffic, and at last, defects I-5 and I-8 are out of traffic.

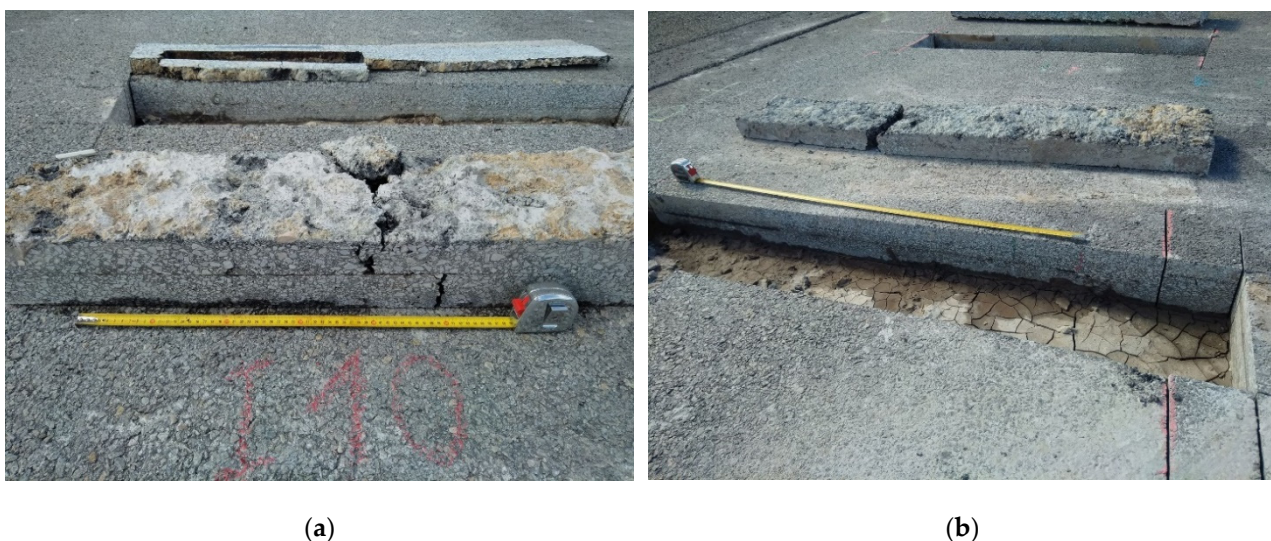
Figure 39. Transverse trenches and corresponding asphalt slabs of (a) defect I-10 and (b) defects I-12.

At the end of the loading series and GPR experiments, several trench cores were sampled to get a ground truth of the damaged structure, and first of all, the real thickness of the defects and their lateral length. Six trenches have been realized in the area of the largest defects. Four transverse trenches were located at the center of defects I-10, I-11, I-12, and I-13, at the level of the GPR profiles, and dimensions of approximately as follows: $1.30 \times 0.25 \times 0.15$ m (Figure 39). One transverse trench was done between defects I-11 and I-12 to obtain information of the traffic effect on a healthy zone. The last one was sawn longitudinally from the center of I-12 towards I-13, 1.2 m long.

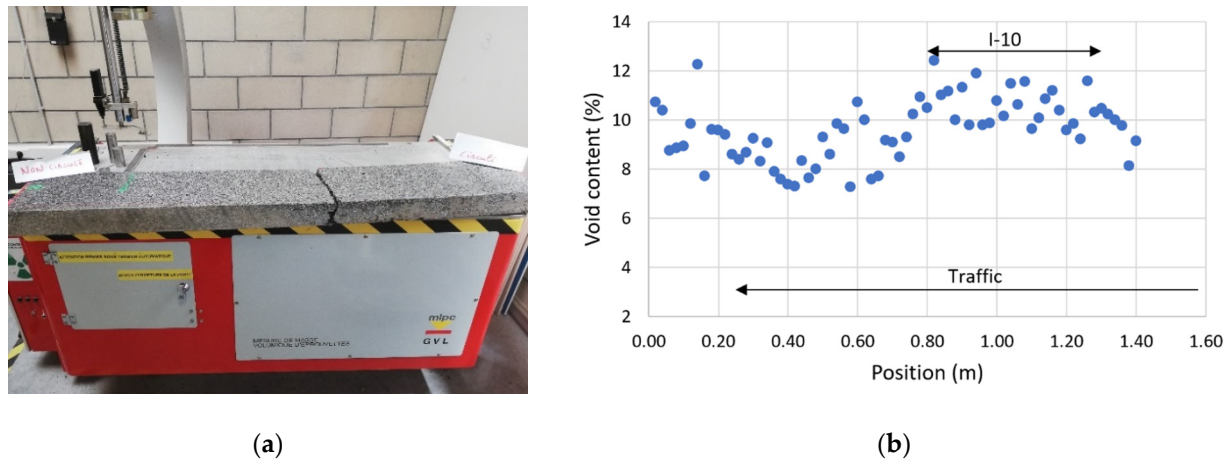
Figure 41. (a) Gammadensimetric acquisition on asphalt layer, (b) void content estimation vs. of lateral location.

after its extraction. Gammadensimetry, a semi-destructive radiation method (Figure 41a), is viewed as a reliable laboratory testing method and considered as a reference in the field of the bulk density variation measurement [19].

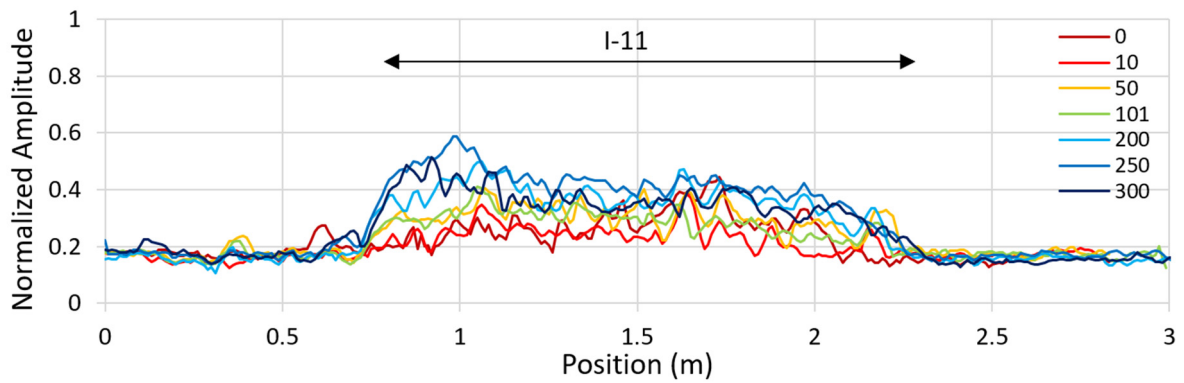
Figure A5. 2.6 GHz normalized RW amplitudes on sand (I-11) in the longitudinal direction vs. K loadings.
