GPR Monitoring of Artificial Debonded Pavement Structures throughout Its Life Cycle during Accelerated Pavement Testing

Xavier Dérobert, Vincent Baltazart, Jean-Michel Simonin, Shreedhar Savant Todkar, Christophe Norgeot, Ho-Yan Hui

Xavier Dérobert, Vincent Baltazart, Jean-Michel Simonin, Shreedhar Savant Todkar, Christophe Norgeot, et al. GPR Monitoring of Artificial Debonded Pavement Structures throughout Its Life Cycle during Accelerated Pavement Testing. *Remote Sensing*, 2021, 13 (8), pp.1474. 10.3390/rs13081474 . hal-04278503

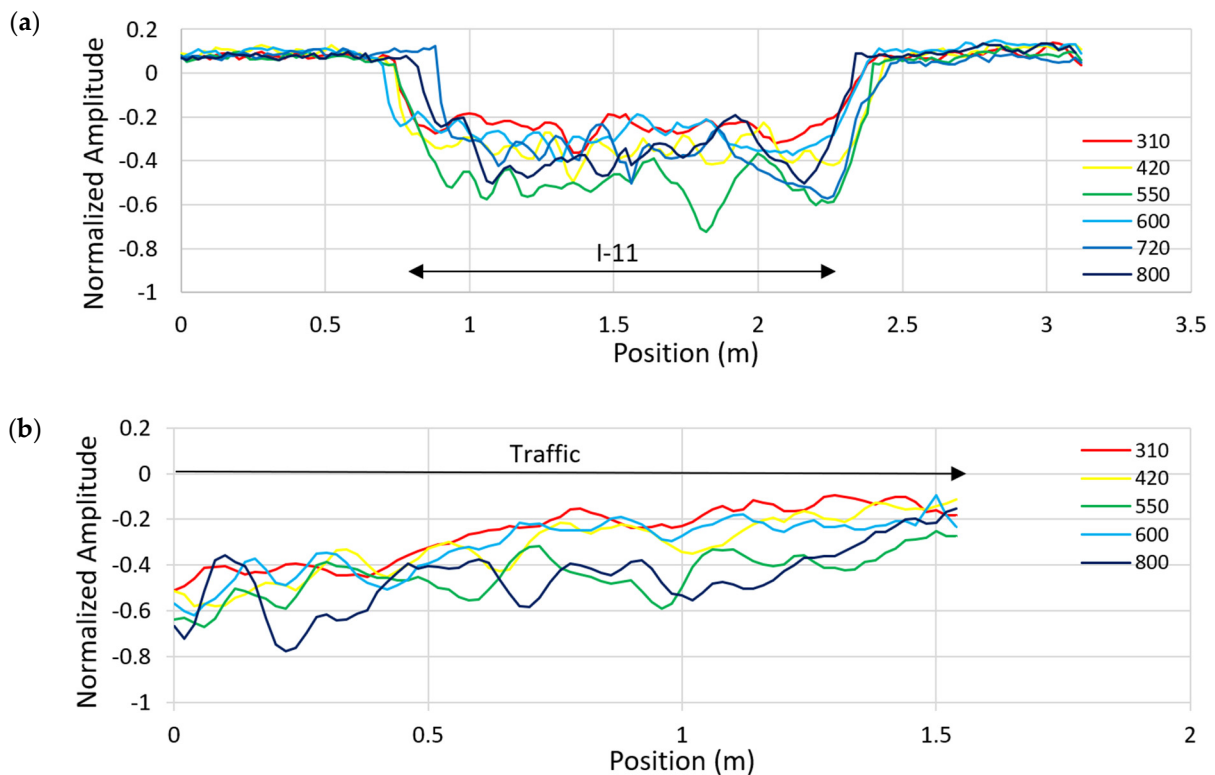
Figure 19. 5 GHz Norm. RW amplitudes on sand (I-11) in the (a) long. and (b) transv. direction vs. K loadings.

When measurements are done with air-coupled antennas, the polarity of the DW and RW are inverted and the amplitude ratios present negative values. We observed, in Figures 19–21, similar results to those from 2.6 GHz, with stable values for longitudinal profiles and a general trend for the transverse ones. As the acquisition length of the univ. Eiffel’s robotic antenna-holder system is limited to 1.6 m, longitudinal acquisitions were performed twice per defect. For the processing of these B-scans, they were gathered before picking, with the results being shown in Figures 19a, 20a and 21a. Results obtained at 5 GHz show the same trend as the 2.6 and 1.5 GHz ones.

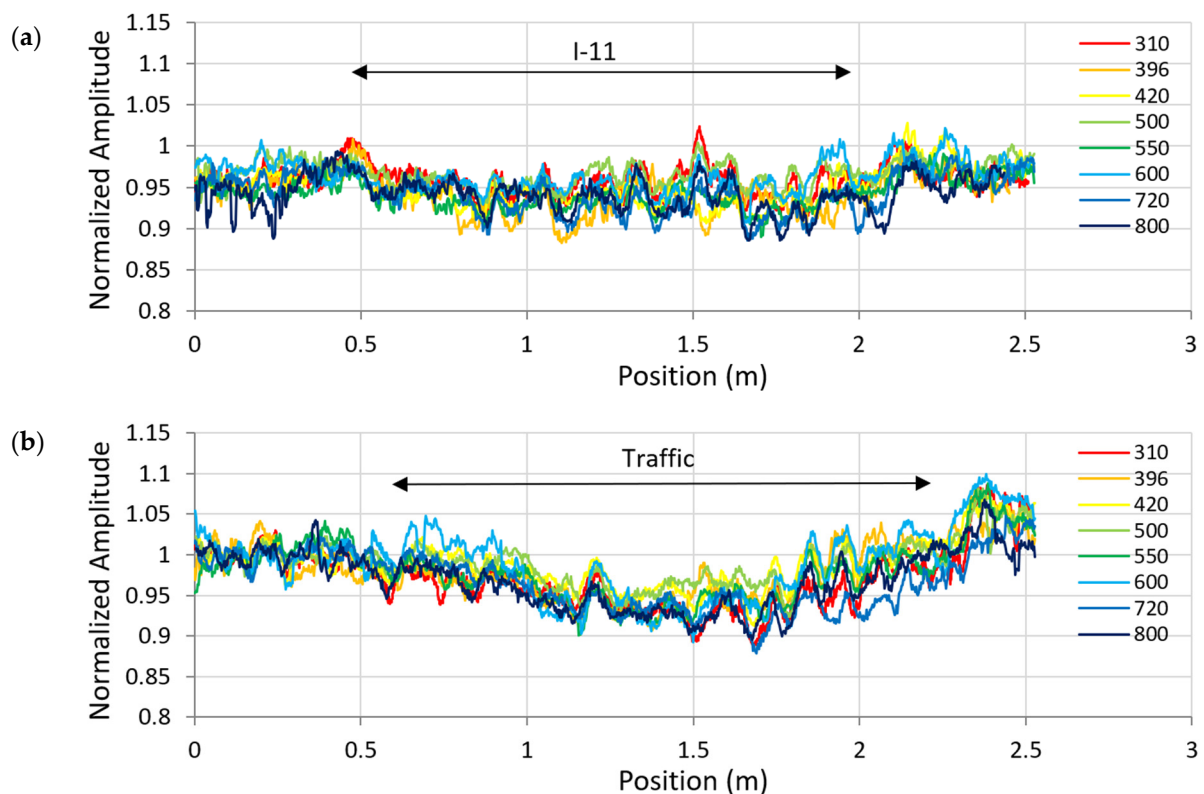
Figure 22. 2.6 GHz Norm. DW amplitudes on sand (I-11) in the (a) long. and (b) transv. direction vs. K loadings.

Concerning transverse data, we can note a general trend proportional to the traffic density, shown in Figures 22b, 23b and 24b, in a V shape with the minimum amplitude corresponding to the maximum of traffic. As the data come from ground-coupled acquisition, the decrease of the normalized amplitudes could be associated with an increase of the relative permittivity of the first asphalt, which narrows the radiation pattern and thus decreases the DW amplitude. This finding, when associated with the increase of cracks in the first layer, can be interpreted as an increase of moisture content trapped in this opened porosity.

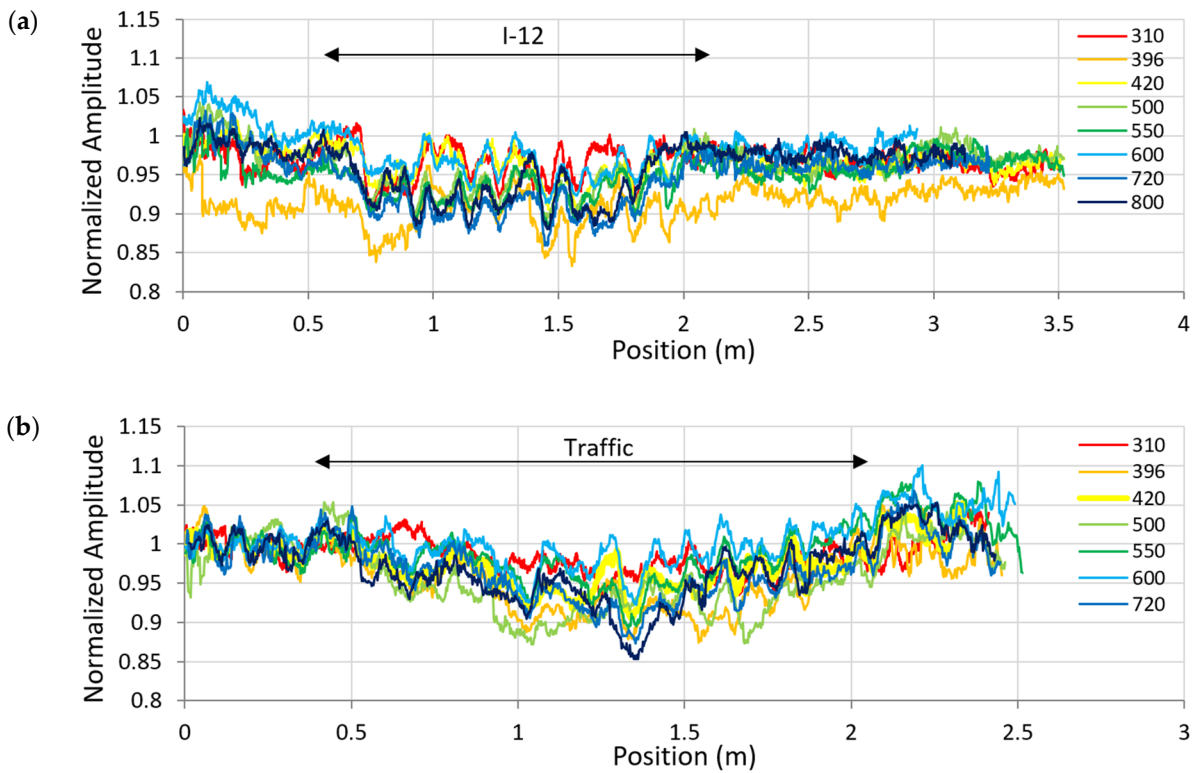
Figure 23. 2.6 GHz Norm. DW amplitudes on geotextile (I-12) in the (a) long. and (b) transv. direction vs. K loadings.

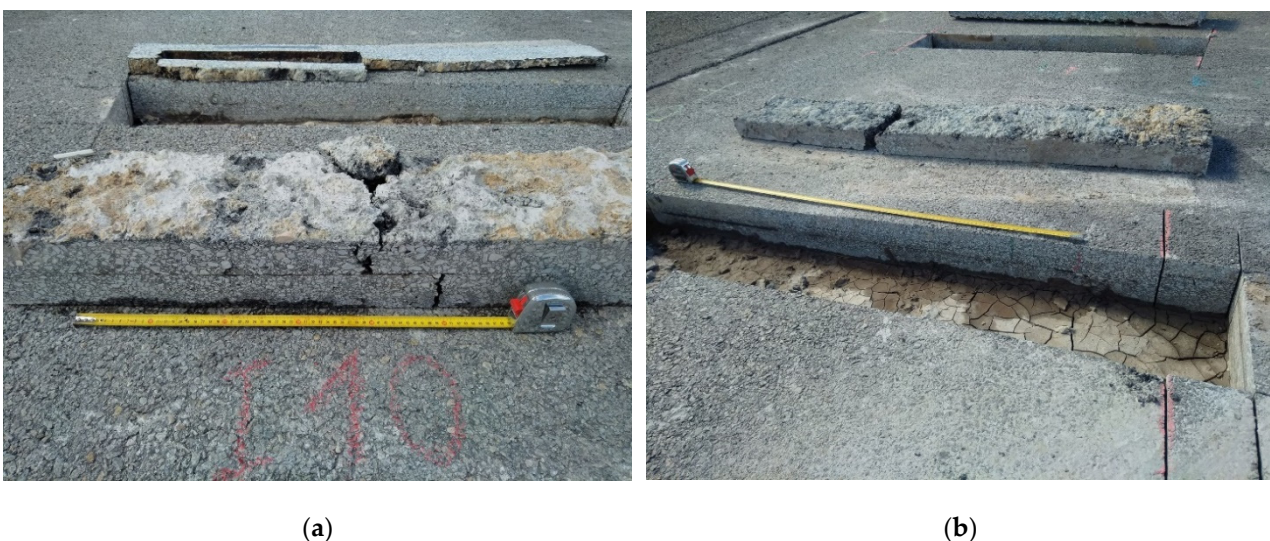
Figure 39. Transverse trenches and corresponding asphalt slabs of (a) defect I-10 and (b) defects I-12.

At the end of the loading series and GPR experiments, several trench cores were sampled to get a ground truth of the damaged structure, and first of all, the real thickness of the defects and their lateral length. Six trenches have been realized in the area of the largest defects. Four transverse trenches were located at the center of defects I-10, I-11, I-12, and I-13, at the level of the GPR profiles, and dimensions of approximately as follows: $1.30 \times 0.25 \times 0.15$ m (Figure 39). One transverse trench was done between defects I-11 and I-12 to obtain information of the traffic effect on a healthy zone. The last one was sawn longitudinally from the center of I-12 towards I-13, 1.2 m long.

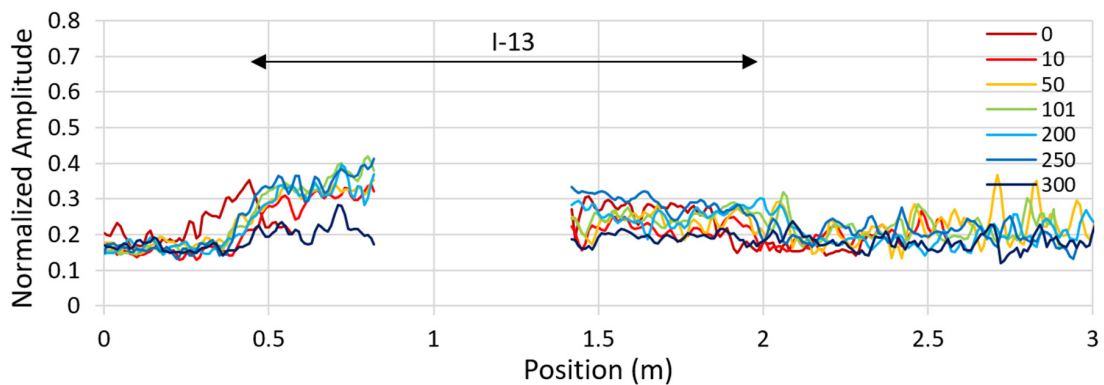
Figure A5. 2.6 GHz normalized RW amplitudes on sand (I-11) in the longitudinal direction vs. K loadings.

Figure A6. 2.6 GHz normalized RW amplitudes on geotextile (I-12) in the longitudinal direction vs. K loadings.

Figure A7. 2.6 GHz normalized RW amplitudes on tack-coat free (I-13) in the long. direction vs. K loadings.

Presentation of normalized RW amplitudes of 2.6 GHz GPR profiles done on defects I-11 to I-13 during the 2012 series.
