GPR Monitoring of Artificial Debonded Pavement Structures throughout Its Life Cycle during Accelerated Pavement Testing

Xavier Dérobert, Vincent Baltazart, Jean-Michel Simonin, Shreedhar Savant Todkar, Christophe Norgeot, Ho-Yan Hui

Article

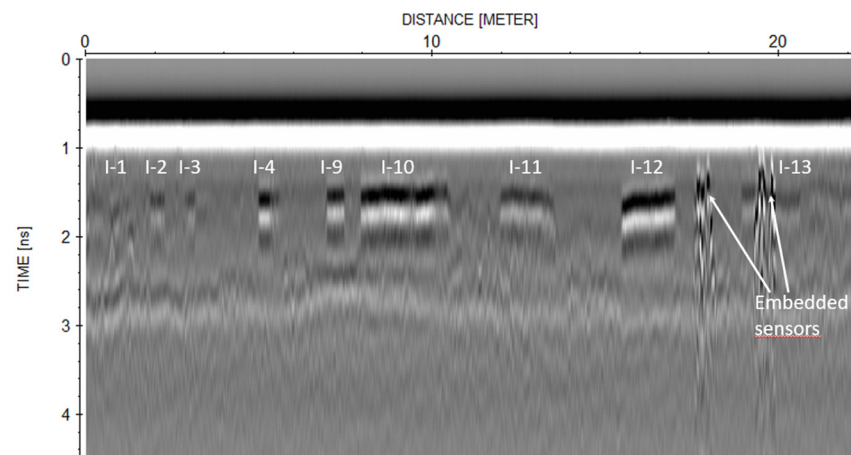
Figure 8. Example of longitudinal B-scan performed at 2.6 GHz along the complete test section.

Figure 8 presents a longitudinal profile along the center of the test section at 2.6 GHz. We note that every defect is detected (I-1 location being more ambiguous) and that defects composed of geotextile (I-4, I-9, I-10, and I-12, but not I-2) show similar echoes stronger than the others, explained by stronger dielectric contrasts. Several sensors, embedded to monitor the stress under the heavy traffic, are located in the center of I-13 and between I-12 and I-13. This is why results presented for defect I-13 in the next section will show a lack of values in the center of the data.

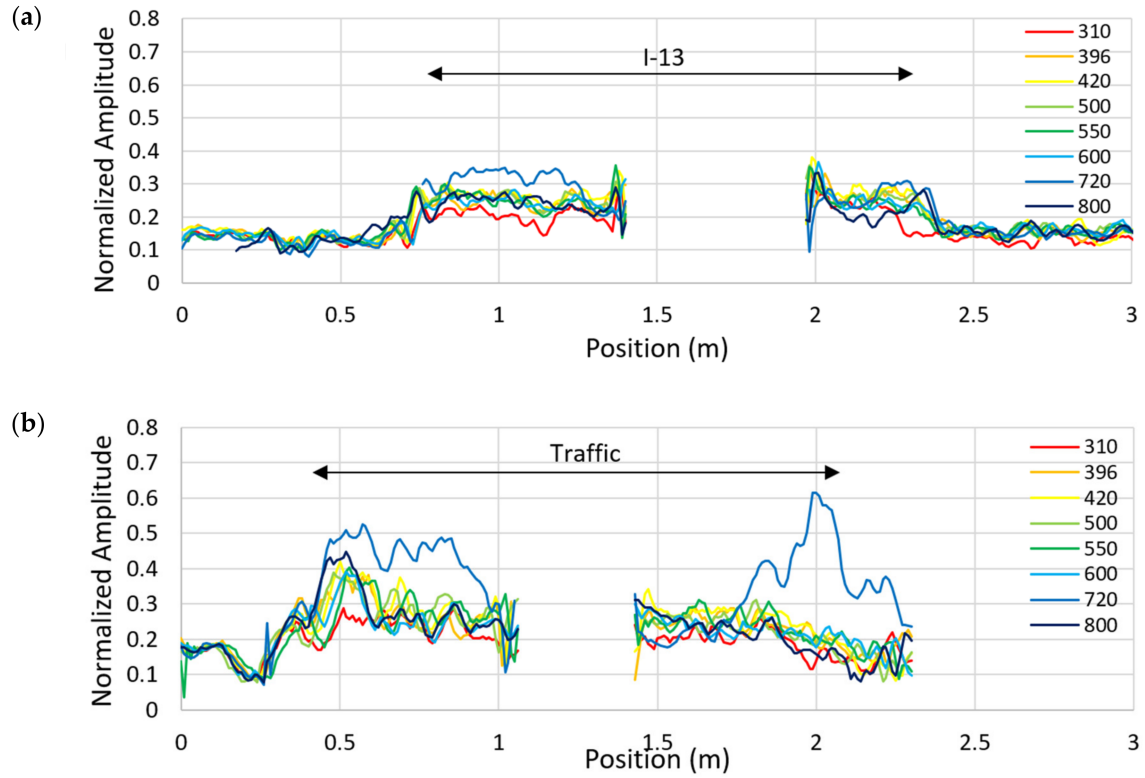
Figure 16. 1.5 GHz Norm. RW amplitudes on sand (I-11) in the (a) long. and (b) transv. direction vs. K loadings.

Figure 17. 1.5 GHz Norm. RW amplitudes on geotextile (I-12) in the (a) long, and (b) transv. direction vs. K loadings.

Figure 18. 1.5 GHz Norm. RW amplitudes on tack-coat free (I-13) in the (a) long, and (b) transv. direction vs. K loadings.

Figures 16–18 gather normalized RW amplitudes picked on the defects I-11, I-12, and I-13 vs. loading, from the 1.5 GHz data. Considering longitudinal results on the central axis of the traffic, we observe roughly stable levels without any general trend vs. traffic. Similar to 2.6 GHz results, transversal 1.5 GHz values present a general trend of RW decrease while moving towards the outer edge of the test track.

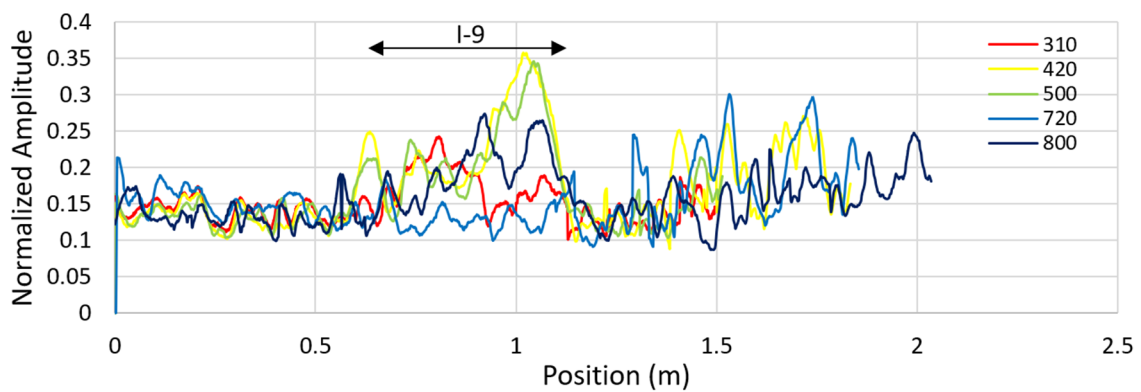
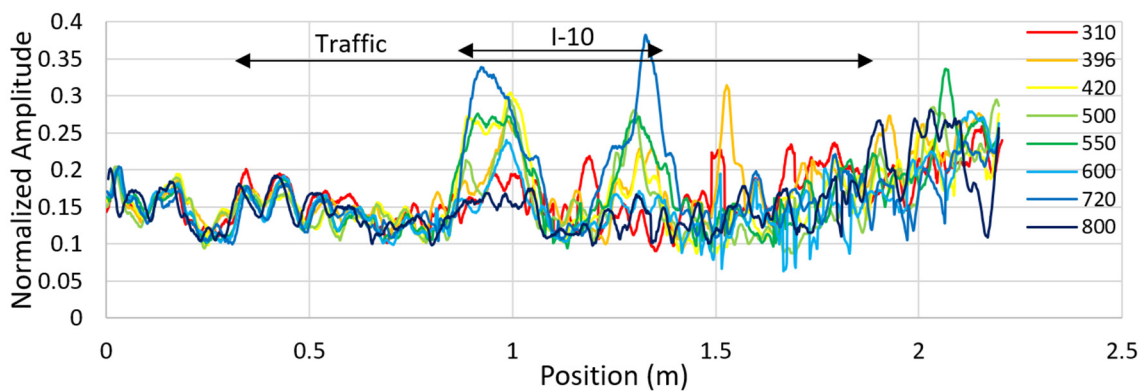
Figure 29. 2.6 GHz Normalized RW amplitudes on defect I-4, in the longitudinal direction vs. K loadings.

Figure 30. 2.6 GHz Normalized RW amplitudes on defect I-5, in the longitudinal direction vs. K loadings.

Figure 31. 2.6 GHz Normalized RW amplitudes on defect I-6, in the longitudinal direction vs. K loadings.

Figure 32. 2.6 GHz Normalized RW amplitudes on defects I-6 and I-7, in the transversal direction vs. K loadings.

Figure 33. 2.6 GHz Normalized RW amplitudes on defect I-7, in the longitudinal direction vs. K loadings.

Figure 34. 2.6 GHz Normalized RW amplitudes on defect I-8, in the longitudinal direction vs. K loadings.

Figure 35. 2.6 GHz Normalized RW amplitudes on defect I-8, in the transversal direction vs. K loadings.

Figure 36. 2.6 GHz Normalized RW amplitudes on defect I-9, in the transversal direction vs. K loadings.

Figure 37. 2.6 GHz Normalized RW amplitudes on defects I-9 and I-10, in the longitudinal direction vs. K loadings.

Figure 38. 2.6 GHz Normalized RW amplitudes on defect I-10, in the transversal direction vs. K loadings.

Figures 29–38 show strong variations of normalized amplitudes from defect I-4 to I-10, depending on the loading step and the location of the defect. As a reminder, defects I-4, I-9, and I-10 are centered on the axis of the major loading traffic. Defects I-6 and I-7 are off-center, even out of traffic, and at last, defects I-5 and I-8 are out of traffic.

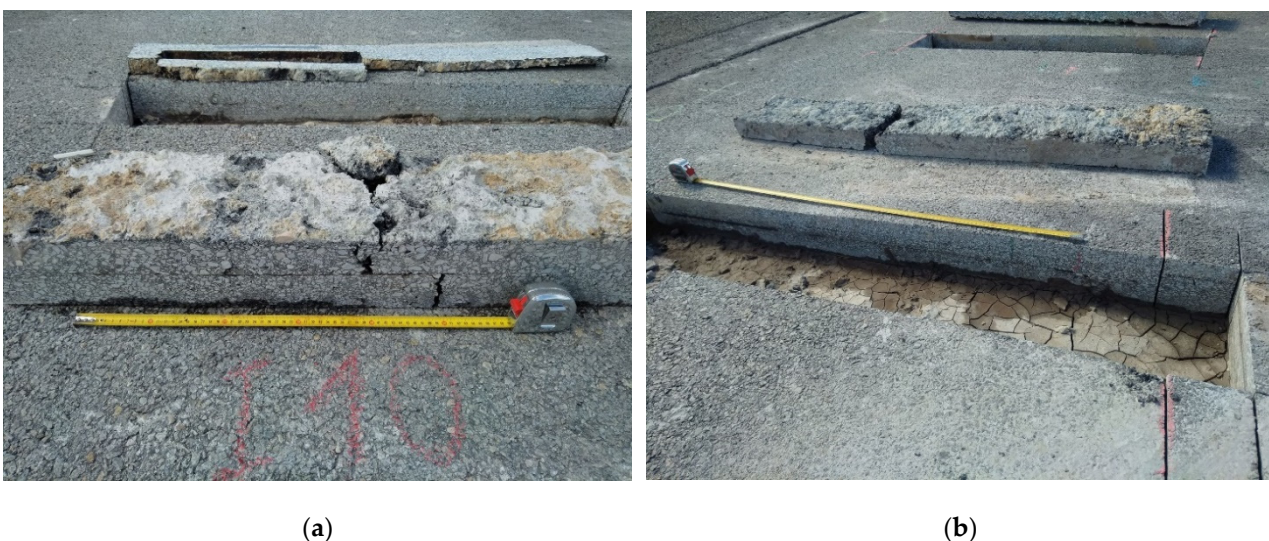
Figure 39. Transverse trenches and corresponding asphalt slabs of (a) defect I-10 and (b) defects I-12.

At the end of the loading series and GPR experiments, several trench cores were sampled to get a ground truth of the damaged structure, and first of all, the real thickness of the defects and their lateral length. Six trenches have been realized in the area of the largest defects. Four transverse trenches were located at the center of defects I-10, I-11, I-12, and I-13, at the level of the GPR profiles, and dimensions of approximately as follows: $1.30 \times 0.25 \times 0.15$ m (Figure 39). One transverse trench was done between defects I-11 and I-12 to obtain information of the traffic effect on a healthy zone. The last one was sawn longitudinally from the center of I-12 towards I-13, 1.2 m long.
