# The influence of geosynthetics design on the behavior of reinforced soil embankments subjected to rockfall impacts

# 1 **The influence of geosynthetics design on the behavior of reinforced** 2 **soil embankments subjected to rockfall impacts**

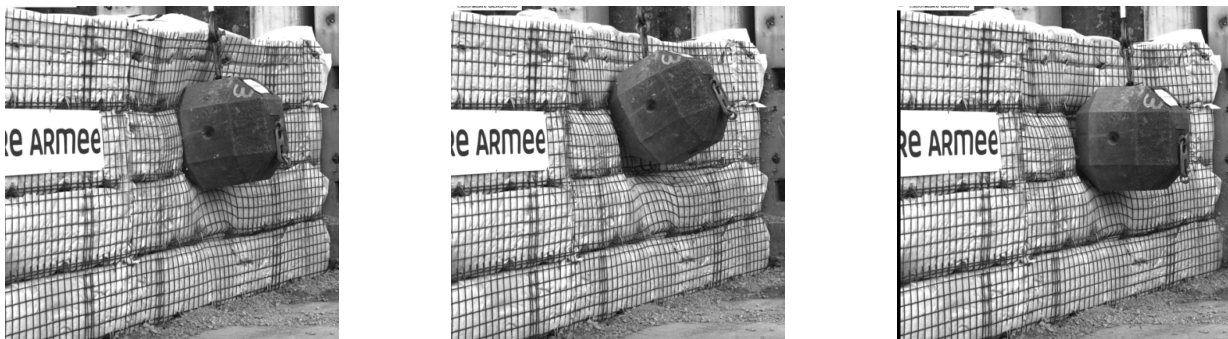
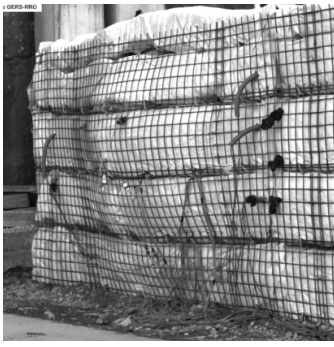
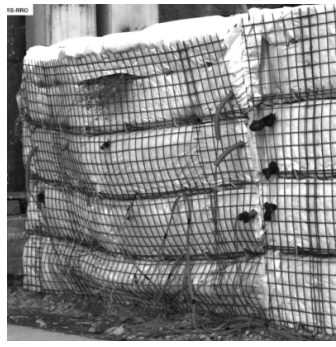
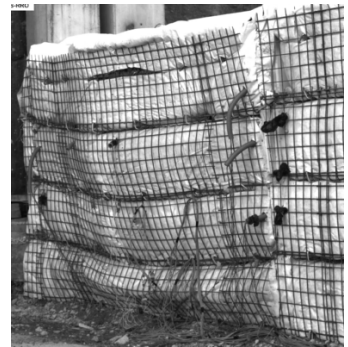
217 accompanied by the buckling of the welded steel mesh at the bottom of the rear face of the embankment. During this time,  
218 the block is still in contact with the embankment, but has already lost most of its initial speed. At the third phase, a partial  
219 return of the embankments was observed, while the impacting block moved slightly backwards without touching the  
220 embankment.

221 For the two embankments, the entire duration of the three phases was approximately one second. For Embankment 1, the  
222 duration of the penetration was about 0.150 s and the duration of the backward leaning phase was about 0.420 s. For  
223 Embankment 2, both phases were shorter compared to the ones of Embankment 1, with a duration was about 0.120 s for the  
224 penetration and about 0.390 s for the backward leaning.

226  
227 **Figure 4. Embankment 1 deformation at the end of: a) the first phase; b) the second phase; c) the third phase.**  
228

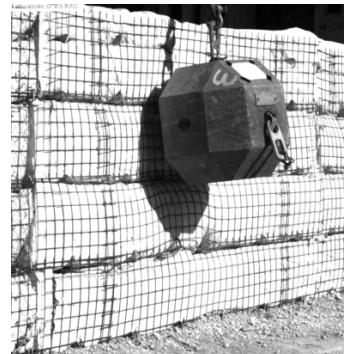
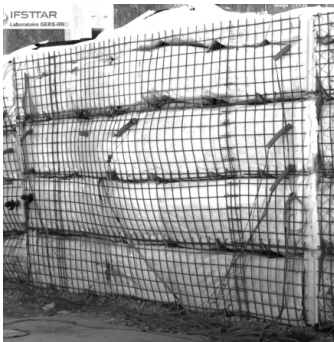
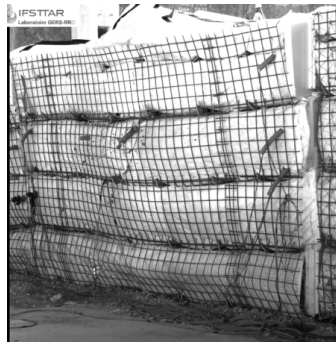
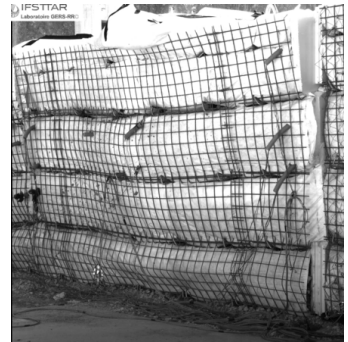
229  
230 **Figure 5. Embankment 2 deformation at the end of: a) the first phase; b) the second phase; c) the third phase.**  
231

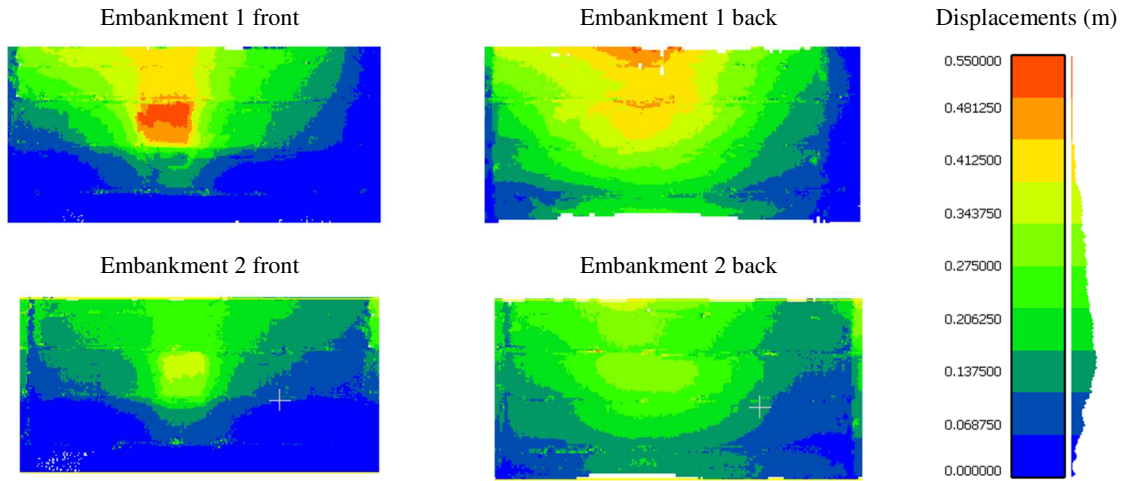
232 The residual deformations of the embankments are digitized using a 3D scan device that is able to produce point clouds with  
233 a resolution in the order of a few millimeters. In order to find the displacement field (Figure 6), the data points are treated  
234 with a 3D image correlation technique. The images show that the two embankments have undergone significant  
235 displacements after the impact. The position of the penetration is clearly visible on the front faces. The displacement at the  
236 impact position for Embankment 1 (approximately 0.55 m) is greater than the one of Embankment 2 (approximately 0.40 m).  
237 The shape of the rear displacement field illustrates the backward leaning of the embankments through a gradual increase of

238 the displacements towards the top, as it was observed by the camera. This phenomenon is more important for Embankment 1  
239 than for Embankment 2.

247 **Figure 6. 3D displacements of the front and back faces for Embankment 1 and Embankment 2 derived from laser scan data**

359 During the reduced-scale tests the impacting block was successfully stopped by each of the two 2.40 m high embankments,  
 360 which indicates that the impact resistance of these two embankments is greater than 0.17 MJ.  
 361 The 3D displacements during the impacts (Figure 6) being considered, no displacement of the embankments is observed at  
 362 the base. This shows that the embankments did not experience sliding at the base. The displacements after the tests are more  
 363 concentrated in the upper part of the embankments. According to the recordings of the cameras, they may be described as a  
 364 combination of local shear deformation due to the penetration of the block and a backwards leaning of the embankment.  
 365 The front deformations of the embankments are higher at the impact position and gradually decline in the surrounding area  
 366 (Figure 6). By observing the back extrusion of the impacted embankments, one can identify that it presents a smooth

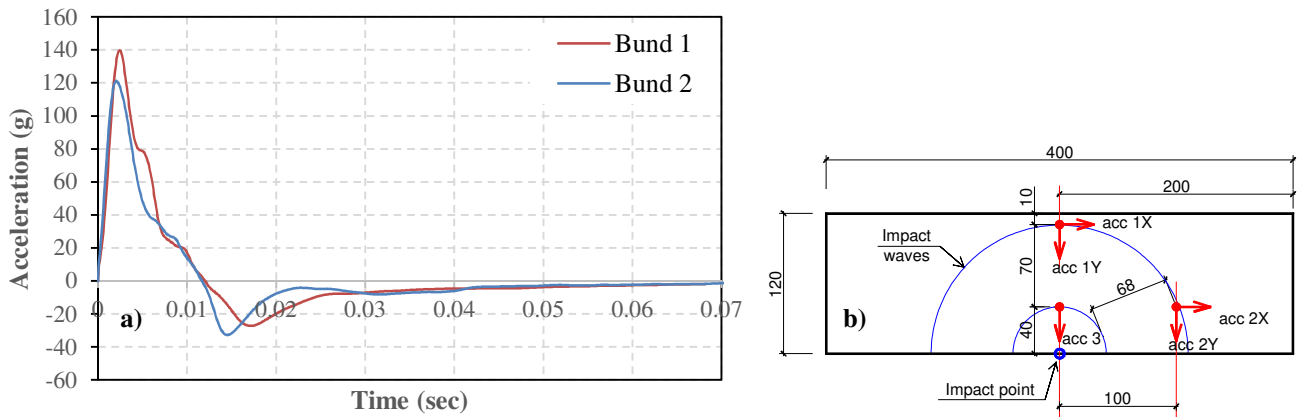
257 The uniaxial accelerometer that was placed 0.4 m far from the front face in the axis of the impact (Figure 8b: ‘acc3’)  
258 provided measurements that are close to each other for the two embankments (Figure 8a). A peak has occurred at 0.002 s for  
259 Embankment 2 and at 0.003 s for Embankment 1 after the beginning of the accelerometer loading. In both cases the duration  
260 of the peaks is around 0.01 s, whereas the peak value for the Embankment 1 is slightly higher (17 %) than that for the  
261 Embankment 2.

262  
263 **Figure 8. a) Acceleration of acc3 sensor for both embankments and b) position of the sensors in plan view**

265 The speed of the impact wave can be calculated using the propagation distance between the accelerometers and the  
266 corresponding time interval. Assuming that this wave propagates in a spherical front which started at the axis of impact, the  
267 speed of the wave is calculated using the distance crossed by the wave from the accelerometer "acc3 "(Figure 8b) and the

307 During the impact, the pressure sensors are loaded between 0.001 s and 0.002 s after the loading of the accelerometer “acc3”  
308 that is located close to the impact position (Figure 8b). For each sensor, a similar signal is observed (Figure 9). Considering  
309 the rapid variation of the pressures, it is thought that the main cause of the initial oscillation is the propagation of the impact  
310 waves in the embankments. For the two embankments, the duration of the peak is larger for the back sensor (~ 0.040 s) than  
311 for the front one (~ 0.015 s/ 0.020 s). A possible explanation for this occurrence may be obtained by making an analogy of  
312 the impact wave propagation with the seismic wave propagation in soils. In the latter, it is observed a decrease of the signal’s  
313 frequency (or increase of period) as the distance from the source increases (Kramer, 1996). Similarly, in our case the

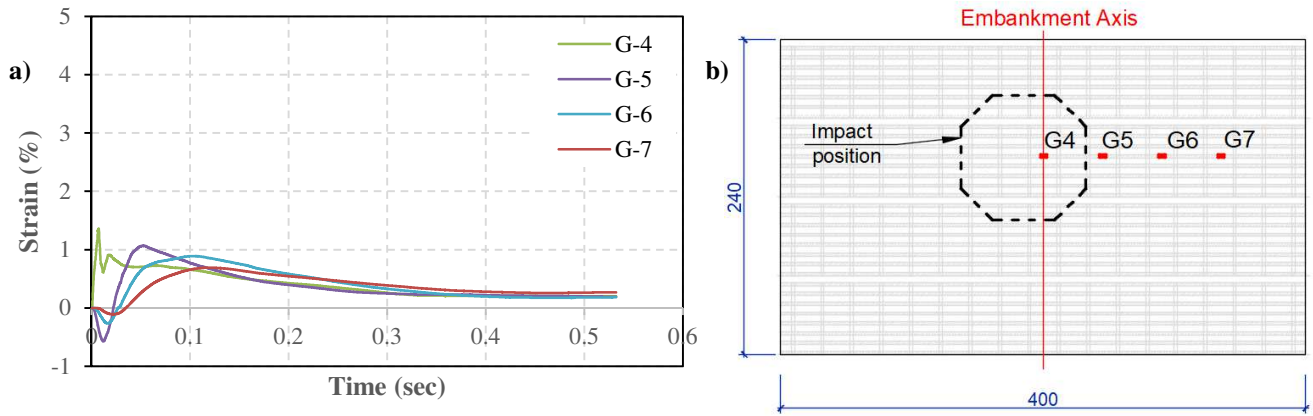
The strain gauges located outside the impact zone of both embankments underwent three successive deformation stages (Figures 10 and 11). During the first stage of approximately 0.01 s, a rapid relaxation of the strains was observed at a higher rate the closer the gauges were to the impact position. In the second stage, the gauges were mobilized in tension with a peak that was again higher for the strain gauges closer to the impact position. In the last stage, a progressive strain relaxation was noted, and the measurements were stabilized at low residual values. For the strain gauges in the impact zones of both embankments (G4, G15 and G16), the first stage of relaxation did not occur, but instead they experienced a very rapid tensile loading.

342  
343 **Figure 10. a) Measurements of the front strain gauges of Embankment 1 and b) their position**

378 This phase initiated at the moment when the impacting block touched the embankment's facing and lasted for a few tenths of  
379 a second (§4.1). During the first hundredths of a second of this phase, there are observed oscillations on multiple sensors  
380 inside the embankment probably due to the propagation of the impact waves. According to the accelerometers in the  
381 embankments (§4.3), the soil close to the impact position experienced a peak acceleration higher than 100 g (Figure 8). The  
382 front and back pressure sensors reacted after the accelerometers with single transient peaks (Figure 9). These peaks do not  
383 correspond to the embankment's backwards leaning, which happens at a later moment according to the rapid cameras. The  
384 impact waves' effect is also observed at the measurements of the strain gauges glued on the geogrids outside the impact  
385 zone, which indicated a peak strain relaxation in the first moments of the impact (Figures 10 and 11). The moment of this

417 During this phase (approximately between 0.1 – 0.5 s), the measurements of the strain gauges show a slight decline (Figures  
418 10 and 11). This means that unless they slide towards the soil, the geogrids slightly oppose the deformation that the  
419 embankment experienced during the block penetration phase. It should be noted that this contribution of the geogrids in the  
420 reduction of the embankments' deformation is restricted in the longitudinal direction of the embankment, since the geogrid  
421 strips are discontinuous and do not have the necessary embedment length in the vertical direction.

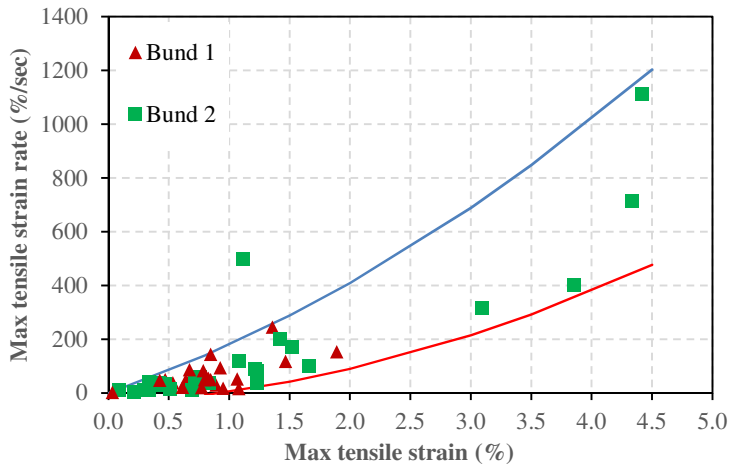
521 No failure is observed on the installed geogrids of both embankments after the tests, so the ultimate resistance of the  
 522 geogrids under dynamic loading conditions is not reached. In order to obtain the dynamic failure criteria for the geogrids,  
 523 multiple rapid loading tests need to be performed on them so that the couple maximal strain – maximal strain rate is obtained  
 524 for different loading conditions. The presence of this curve on Figure 14 would allow to judge how far the geogrids are from  
 525 failure.

529 encompass the maximal loading conditions of Figure 14 would be steeper if the soil – geogrid interaction is more efficient  
 530 and vice versa.

531  
 532 **Figure 14. Strain rate – max strain for all the gauges of the two embankments**

564 The strain rate is an important parameter for the characterization of the dynamic loading of the geogrids. By combining it  
565 with the corresponding maximal strain, it is obtained the peak dynamic loading condition for the geogrid. It would be  
566 beneficial to perform more experiments in order to build the dynamic failure curve using these two parameters. This curve  
567 could be used for design purposes to choose the appropriate geogrid that will resist a specific dynamic loading.
