The influence of geosynthetics design on the behavior of reinforced soil embankments subjected to rockfall impacts

Oltion Korini, Marion Bost, Jean-Pierre Rajot, Yassine Bennani, Nicolas Freitag. The influence of geosynthetics design on the behavior of reinforced soil embankments subjected to rockfall impacts. *Engineering Geology*, 2021, 286, pp.106054. 10.1016/j.enggeo.2021.106054 . hal-04404439

1 **The influence of geosynthetics design on the behavior of reinforced** 2 **soil embankments subjected to rockfall impacts**

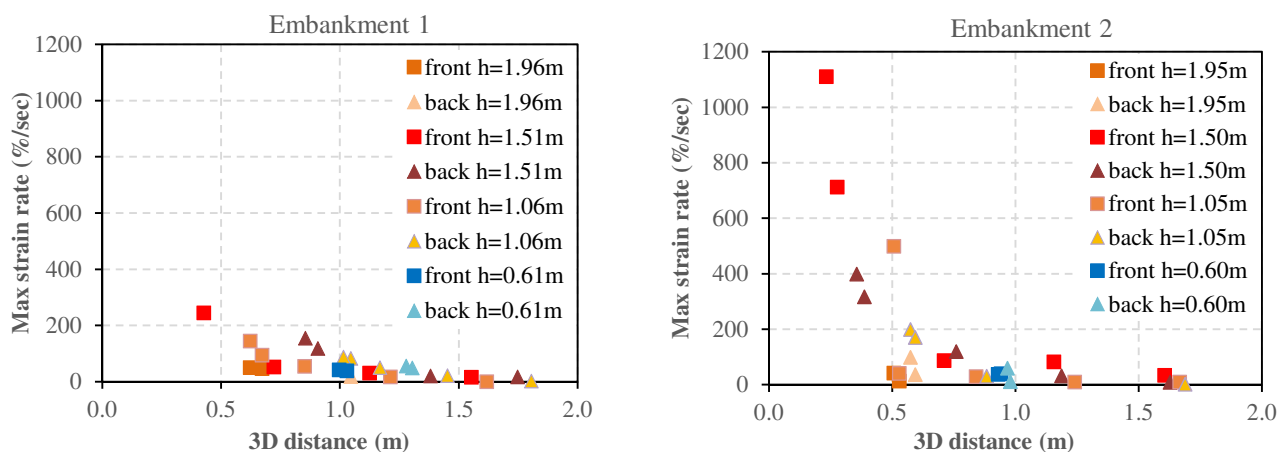
508
 509 **Figure 13. Relation of maximal strain rate with the distance to the impact position for the two embankments**

505 orientation at high loading rates cannot be adequately compared between the two embankments. For the strain gauges

506 located at distances greater than 0.5 m from the impact position, the loading rates of the geogrids are similar between the two
 507 embankments.

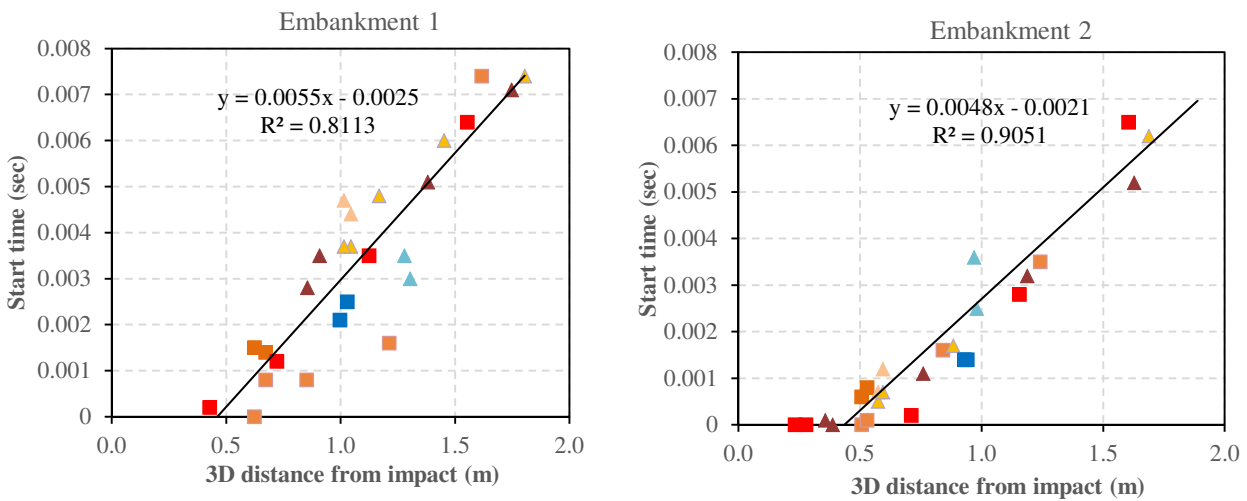
540
 541 **Figure 15. Strain gauges start of mobilization in function of their distance from the impact for the two embankments**

533
 534 The speed of the impact wave may be also evaluated using the strain gauges measurements. Similarly, as with the
 535 accelerometers and the pressure sensors, the arrival time of the signal to each strain gauge was identified. By plotting this
 536 time versus the 3D distance to the impact position, a linear relationship is obtained (Figure 15). The inverse of the slope of
 537 this line is equal to the speed of the propagation of the impact wave. For Embankment 1, it is 182 m/s and for Embankment 2
 538 it is 208 m/s. These values are close to the ones obtained from the accelerometers (Table 3).
