French Metallic Train Sheds of 1850 to 1930: Structural Specificities and the Evolution of the Restoration Practices

French metallic train sheds of 1850 to 1930: structural specificities and the evolution of the restoration practices

H. Franz^{ab*}, M. Rinke^c, J.-L. Martin^b, S. Chataigner^a and L. Dieng^a

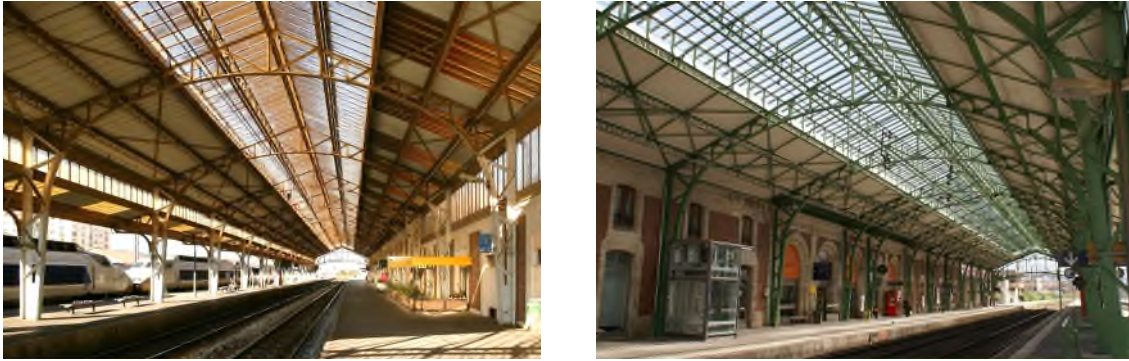
Figure 1: Gare de Perpignan, built in 1896, Perpignan, France (Pictures from SNCF-AREP by D. Boy de la Tour and A. Striffling). (a) Before and (b) after restoration of 2013.

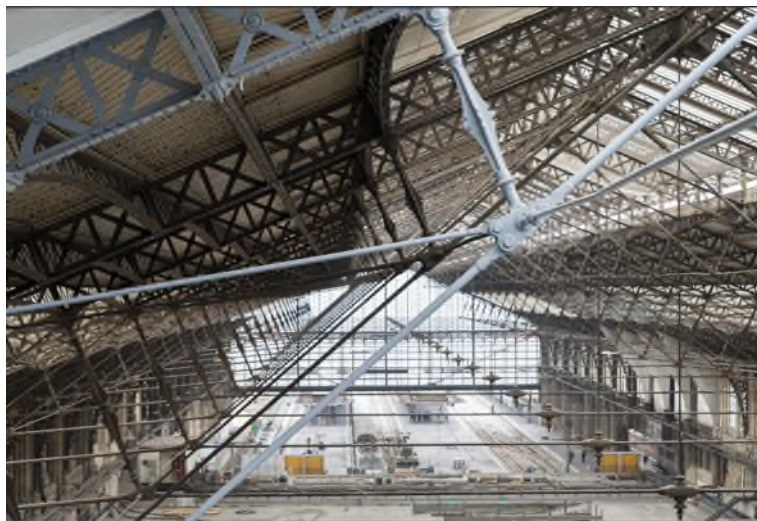
Figure 2: Gare de Paris-Austerlitz, built in 1869, under restoration in 2016, Paris, France (Picture from SNCF-AREP by M. Lee-Vigneau).

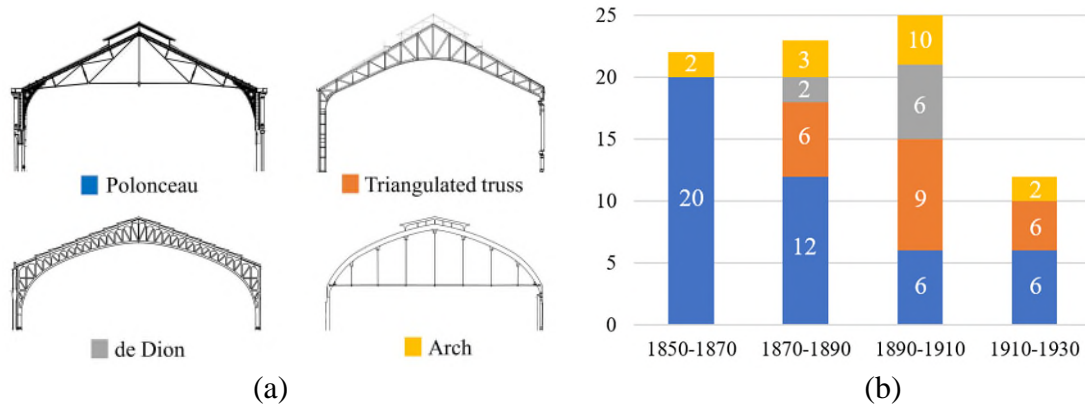
Figure 6: (a) Typologies of roof trusses used for French train sheds (Drawings from SNCF-AREP, heritage department); (b) Number of sheds of each type built in 20-year periods ranging from 1850 to 1930.

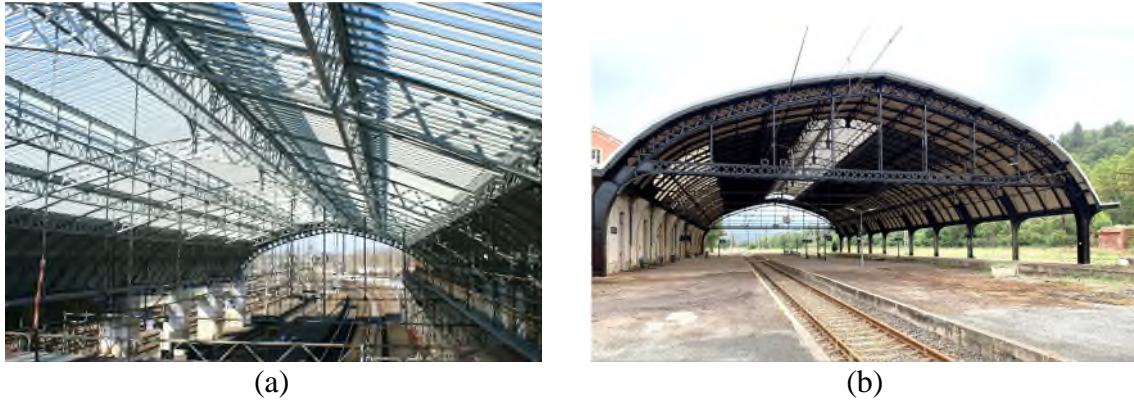
Figure 8: Series of similar train sheds (Pictures from SNCF-AREP). (a) Gare de Montauban, full view, Montauban, France; (b) Gare de Bédarieux, full view, Bédarieux, France.

feature and were therefore key to this territorial identity. As an example, in the South-West of France, the Compagnie du Midi commissioned a series of train sheds with pointed truss arches, with or without tension chord, that is still well-preserved.

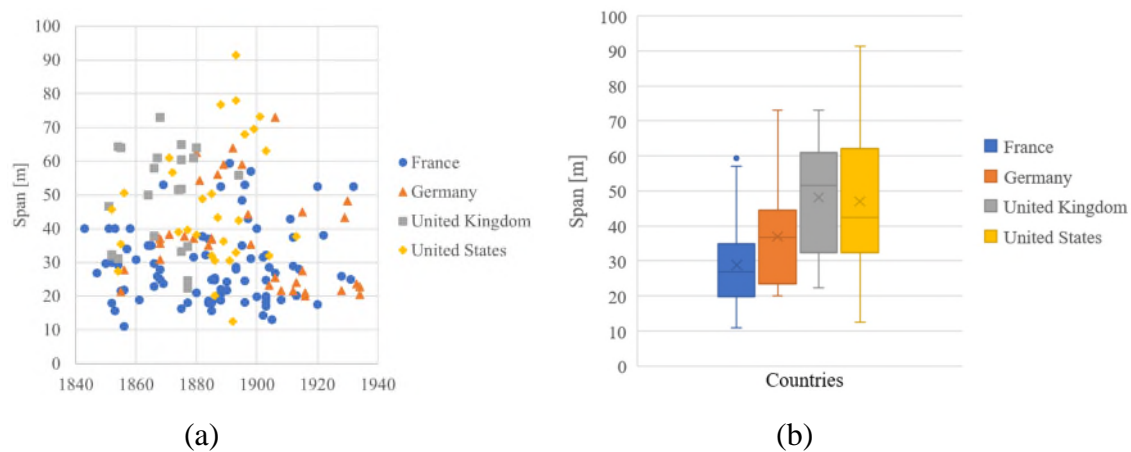
Figure 9: (a) Largest spans featured by sheds of railway stations built between 1840 and 1940 in France, Germany, United Kingdom and United States, according to the date of construction; (b) Statistical distribution represented as box-and-whisker chart.

Beyond the type of roof truss, differences between France and other countries are also revealed by the spans. Figure 9(a) shows the largest spans of roof trusses for train sheds built between 1840 and 1940 in France, Germany, the United Kingdom and the United States, according to their date of construction⁶. With a box and whisker chart, Figure 9(b) underlines the fact that the spans in France were significantly smaller, while the longest spans were built in the United States. This could be interpreted as French designs being more inclined towards delicacy than monumentalism. However, the ratio of height compared to width was higher for French train sheds than English ones (Kanai

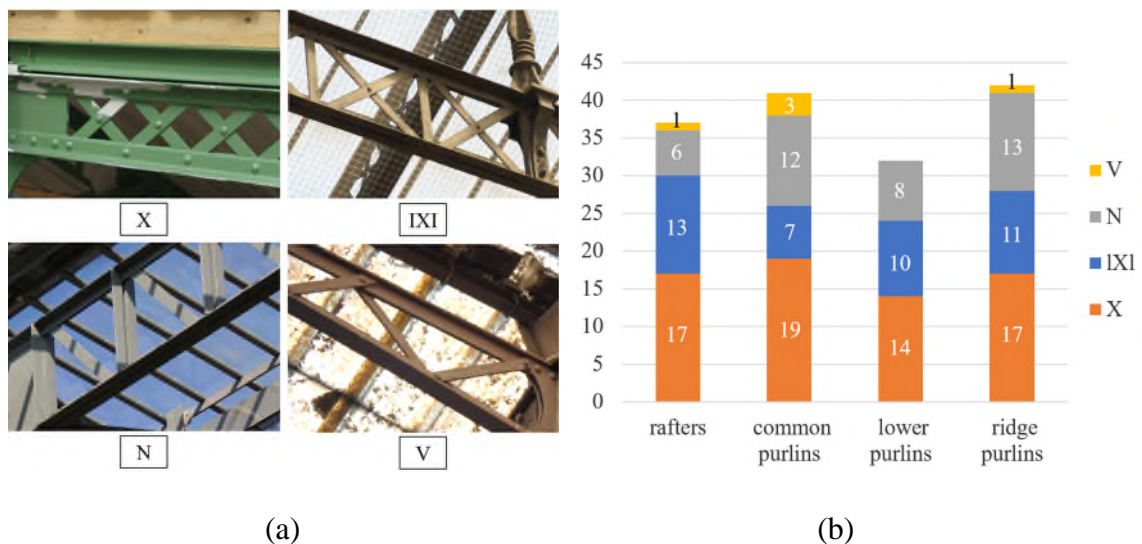
Figure 10: (a) Examples of the 4 types of lattice purlins and rafters: X (Gare de Cerbère, Cerbère, France), IXI (Gare de Paris-Austerlitz, Paris, France), N (Gare d'Etampes, Etampes, France), V (Gare d'Agen, Agen, France) (Pictures from SNCF-AREP). (b) Number of sheds featuring rafters or purlins of each truss type.

specificity of being very simple assemblies of flat and angle bars, jointed with single rivets. Displaying a wide variety of geometries based on a narrow range of basic elements, these girders bear witness to the morphological type-based understanding of trusses by designers, as opposed to a structural understanding, as evidenced by Rinke and Kotnik (2013). Using a classification based on the geometry of the webs (Cordeau 1901; Klasen 1876), lattice purlins and rafters from French train sheds fall into 4 categories, that can be named after their inventor or after their closest related shape: the Town type with or without vertical elements (IXI or X-shaped), the Howe or Pratt type (N-shaped), the Warren or Neville type (V-shaped). Examples are displayed on Figure 10(a). Figure 10(b) details the number of surviving sheds featuring lattice girders, differentiated according to their function. A distinction is made between common, lower and ridge purlins as some sheds feature lattice girders only for the ridge or the lower purlins while all other purlins are laminated profiles. Figure 10(b) shows that the X and IXI types are in the majority, despite representing a more intricate structural system.

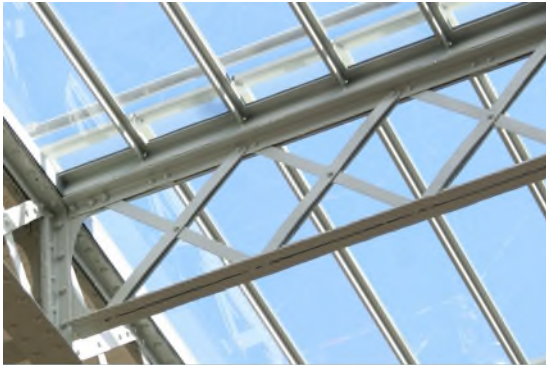
Figure 12: Repeated construction details in train sheds built by same contractor Daydé et Pillé (Picture from SNCF-AREP, archive plan from SNCF archives). (a) Gare de Montaubau, detail of a lattice purlin, Montauban, France; (b) Gare de Bédarieux, detail of a lattice purlin from an archive plan, Bédarieux, France.

Back to France, lattice purlins and rafters also contributed to the territorial identity discussed for roof trusses. Railway companies regularly employed the same contractors to build several train sheds. Consequently, not only the architectural shape, especially the roof truss typology, was repeated, but also construction details. This is particularly visible on lattice girders. Taking again the example of the Compagnie du Midi, the contractor Daydé et Pillé built train sheds for at least six railway stations around 1900. When comparing the sheds of the Gare de Montauban and the Gare de Bédarieux, not only the general aspect of their metallic structure is similar (see Figure 8), but several details also appear to be the same. The lattice purlins feature diagonals made out of flat bars with rounded extremities, which is original. Also, in the three crosses closest to the support, the diagonals pointing downwards towards the support consist of two flat bars instead of one (see Figure 12). This last detail was a constructive measure against buckling, as these diagonals work in compression but were not formally verified against buckling in the calculation notes (Franz et al. 2022).

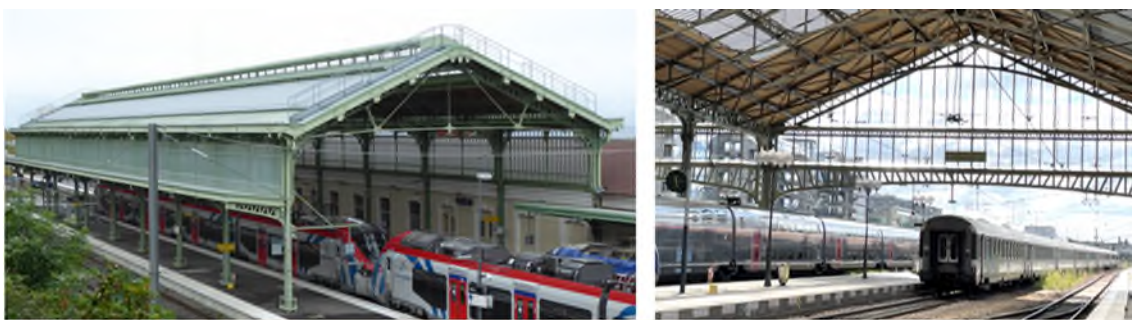
Figure 14 : (a) Skylight along the ridge (Gare d'Evian, Evian, France) (Picture from SNCF). (b) Glazed gable (Gare de Tours, Tours, France) (Picture from H. Franz).

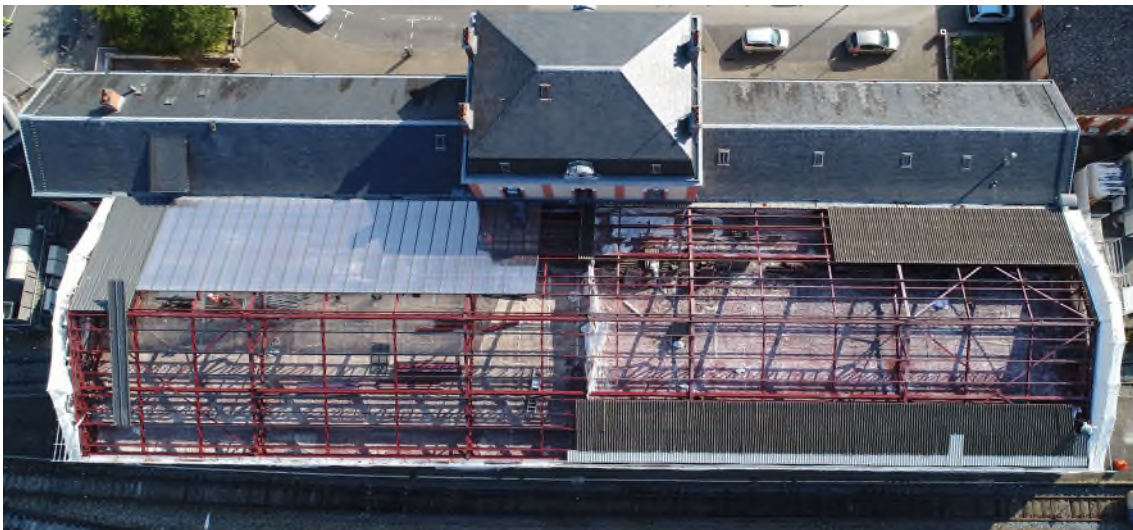
Figure 15 : Example of complete replacement of the roofing: aerial view of the restoration of the shed of the Gare de Tulle in 2019, Tulle, France (Picture from SNCF). Right side: old fibre cement panels. Left side: new steel decks and polycarbonate panels.

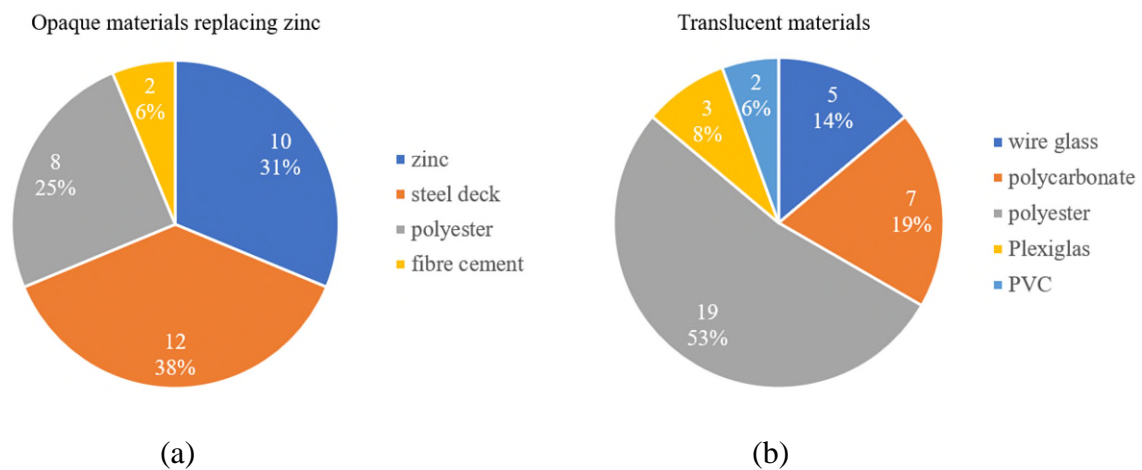
Figure 18 : Proportional amounts of roofing materials used in the restoration wave of the 1970s-1980s (the absolute amounts correspond to the number of railway stations in which those roofing materials were implemented).

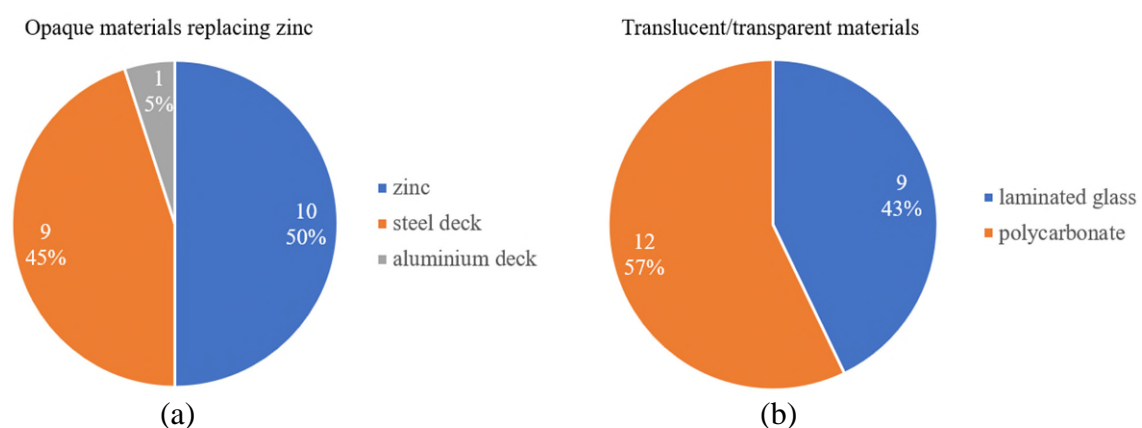
Figure 19 : Proportional amounts of roofing materials used in restoration projects since 2005 (the absolute amounts correspond to the number of railway stations in which those roofing materials were implemented).

notes for the restoration of train sheds of 20 stations since 2005. It appeared that, proportionally, the original materials zinc and glass reclaimed their place (Figure 19). Zinc roofs were rebuilt with the traditional roll cap system, even though standing seams are much more common today. Sometimes steel decks were implemented with timber boarding underneath, to preserve the original aspect seen from below. Glazed parts made use of laminated glass. Fixation systems were developed to preserve the existing glazing bars or to replace them with similar profiles, while ensuring waterproofness according to current standards. Even though they restore a sense of authenticity, zinc roofs and glazing are still a minority because they are more expensive than metal decks and plastic panels. Moreover, improvements were made in the manufacturing technology of polycarbonate sheets (Figure 17(c)), in the form of protection from environmental degradation by UV radiation, so that their suitability as an alternative to glass has increased (Schwartz 2014). Future restoration projects might implement glass panels with embedded photovoltaic cells, to exploit the vast surface of train shed roofs for energy production. Such panels have been used for example for a shed of the newbuilt railway station of Le Bourget in 2008 (Figure 17(d)).

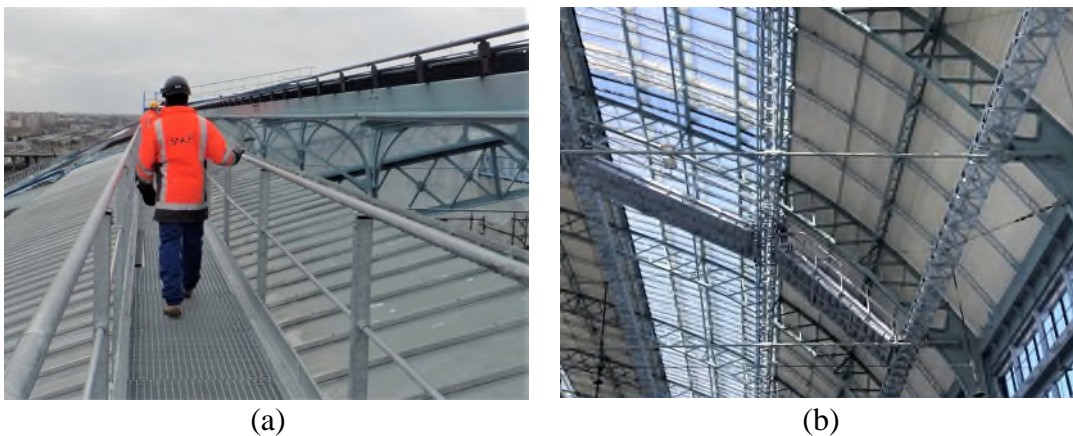
Figure 22 : Maintenance equipment added on the course of restoration projects in the train shed of Bordeaux Saint-Jean, Bordeaux, France (Pictures from SNCF and by H. Franz). (a) Maintenance platform and lifeline system over the roof, added in 2016 (picture: SNCF); (b) Metallic stairs and rails below the roof, added in 1928.

In the course of restoration projects, equipment was added to train sheds, to provide more safety for the workers carrying out inspection and maintenance tasks. Some equipment such as lifeline systems have negligible weight, but maintenance platforms must usually be taken into account. This type of equipment installed over the roof is discrete and does not have any impact on the aspect of the train shed for passengers (Figure 22(a)). A counterexample is given by the stairs that were added below the roof surface in the railway station of Bordeaux Saint-Jean in 1928, with a relatively massive railing system to allow the stairs to move in the longitudinal direction. Such invasive measures were avoided in more recent restoration projects. However, in the restoration of Bordeaux Saint-Jean in 2016, the stairs and rails of 1928 were left in place, thus endorsing a profound modification of the original aspect.

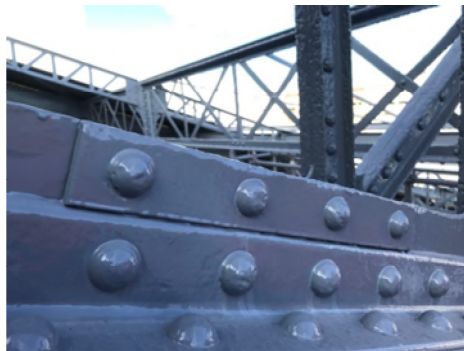
Figure 23: Local repair of a chord with added riveted plates in the train shed of Troyes renovated in 2021, Troyes, France (Picture from SNCF).

reduced because of corrosion, those elements were either repaired or replaced. Repairs often consisted in locally adding metallic plates. Figure 23 shows the example of the local riveted repair of the bottom chord of a roof truss in the railway station of Troyes, after restoration in 2021. When damaged areas were too large, structural elements were replaced, while aiming to preserve the original aspect as far as possible. Figure 24 shows the example of the purlins of the train shed of Montauban. Some of them were heavily corroded, especially their top chord (Figure 24(a)). They were then replaced (Figure 24(c)), keeping a similar aspect to the original preserved purlins (Figure 24(b)).

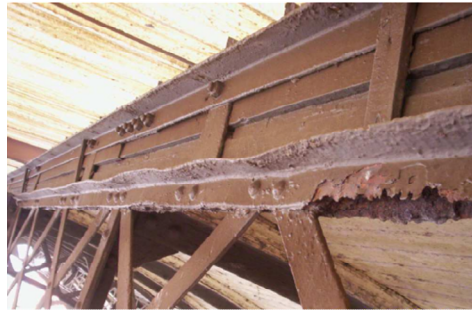
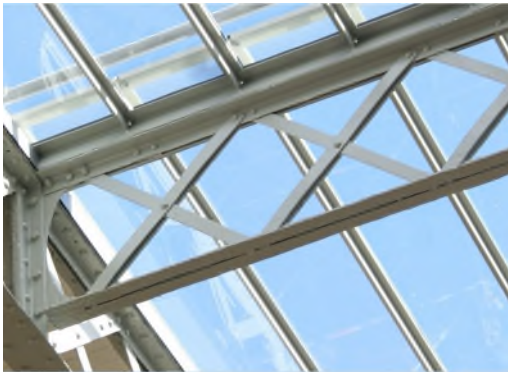
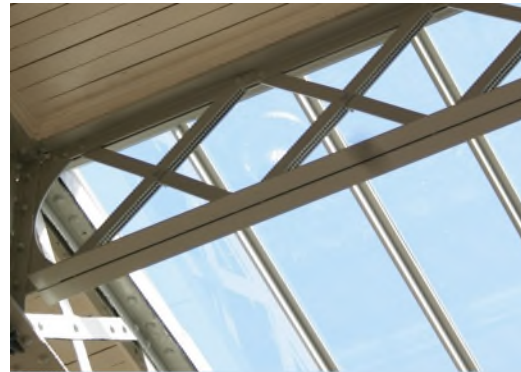
Figure 24 : Replacement of purlins in the train shed of Montauban, France (Pictures from SNCF). (a) Corroded purlin in 2007 before restoration; (b) Original non-corroded repainted purlin after restoration of 2011; (c) Corroded purlin replaced by a new purlin after restoration of 2011.

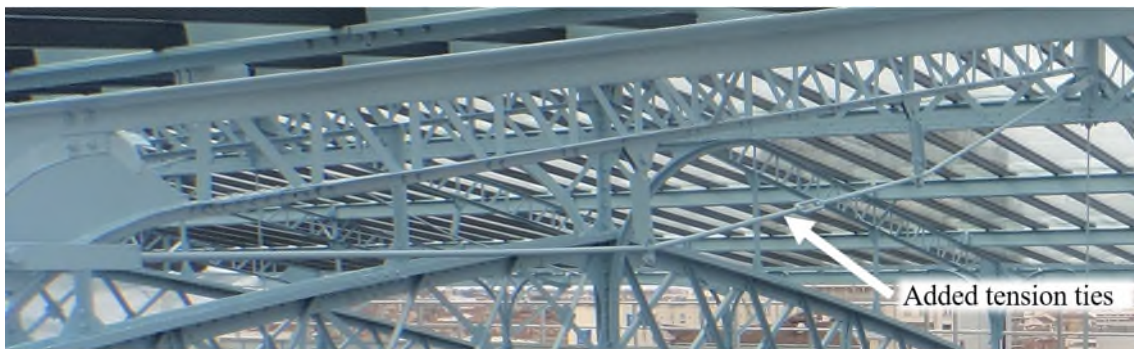
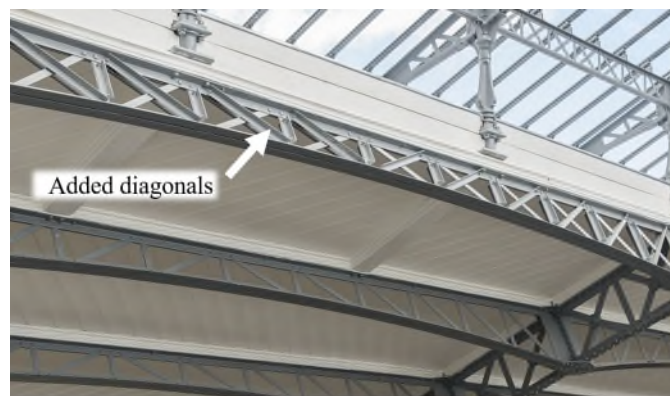
Whether it was because of the effective increase in the dead loads of the roof or because design criteria became stricter, strengthening measures were often carried out during restoration projects. Little data could be found regarding restoration projects of the 20th century. Apart from the addition of bracing systems, the strengthening measures implemented seemed to disregard the original functionality and the visual impact. In Bordeaux Saint-Jean, probably around 1980, the lattice rafters of the skylight were reinforced with tension ties, transforming them into underspanned beams (Figure 25(a)). This strengthening measure modified the functionality of the rafter, from a beam working in bending to a compression element. In Paris Austerlitz, the lattice purlins supporting the skylight were reinforced in 1983 with added diagonals (Figure 25(b)). The original lattice

purlins had only diagonals pointing upwards towards the middle of the span, thus working in compression. The added diagonals made of corner plates transformed the original lattice girders into girders with crossed out sections, thus changing their aspect considerably. Furthermore, the new diagonals worked in tension and had a much larger section than the original diagonals, so that the latter probably did not contribute to the bearing capacity anymore. These examples of strengthening measures went against the idea of authenticity: beyond being visually invasive, they modified the structural behaviour of the reinforced girders.

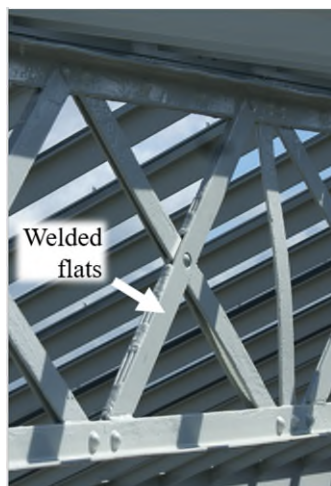
Figure 26: Interventions increasing the cross-section of existing elements or replacing them (Pictures from SNCF-AREP). (a) Welded flats, Gare de Montauban, Montauban, France; (b) Bolted flats on existing diagonals, Gare d'Hendaye, Hendaye, France; (c) Added HEA100 laminated profile on top of existing lattice purlin, Gare de Cerbère, Cerbère, France; (d) Added tubular purlins effectively replacing the existing ones, Gare de Béziers, Béziers, France.

Strengthening measures from the two last decades strived to remain discrete. Still, their impact on the authenticity of the original structures is non negligible. The less discrete variants, involving sections reinforced by bolted plates or added structural elements, can profoundly change the appearance of the structure when they accumulate. Figure 1 provides a good example. The end result of the restoration is aesthetically satisfying (Figure 1(b)). However, when compared to the original structure, it can be noticed that the restored structure, with added brackets and tension ties, has lost some of its lightness. This results in a loss of authenticity, as lightness was a key characteristic of metallic structures in the 19th century. As to the most discrete variants, they are also questionable. Welded added sections are non reversible. The addition of new purlins on top of the original ones changes the load distribution or even deactivates some structural components. A loss of functionality means a loss of authenticity.
